Identification of Natural Hazard Areas

Malaspina Peninsula / Okeover Inlet

Marion Blank, P.Geo.
Planterra Environmental Consulting

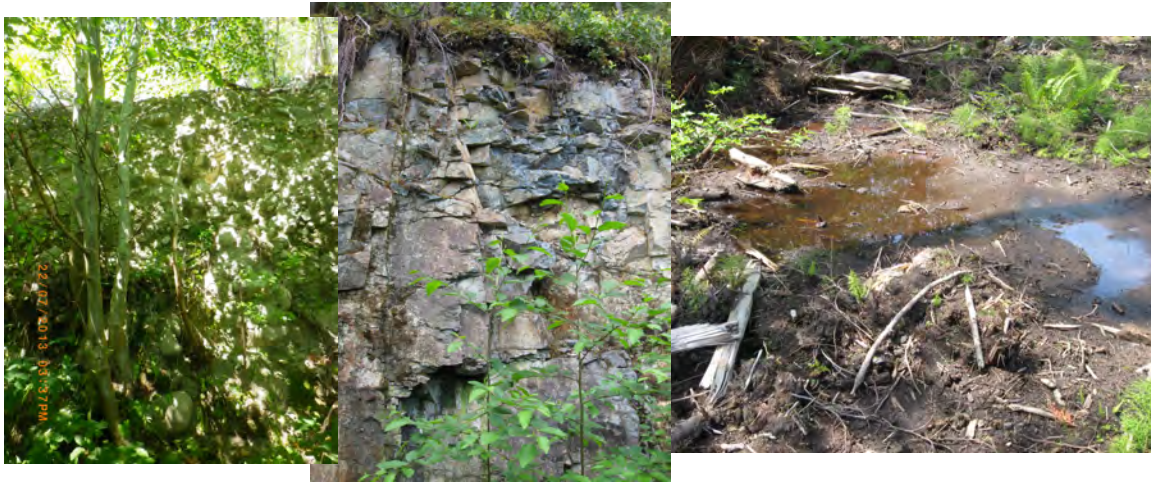
The area consists of the following types of surficial materials: colluvial (rock falls from bluffs), morainal (basal till/tills), marine (clay/silt with shells), and organic (boggy areas/raised water tables). These materials generally form a thin mantle over bedrock with localized zones having deep seated glacial tills and marine sediments.

Photo 1. Surficial materials found in the area.

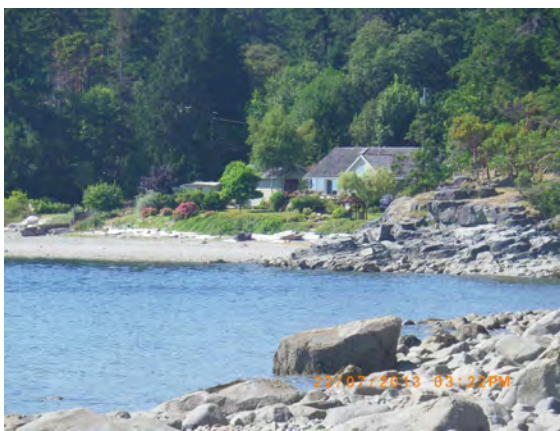
The beaches in the area generally consist of cobble size materials with limited sand deposition . They are found within small lengths of coastline and are controlled by exposed bedrock bluffs .

Photo 2. Typical beach.

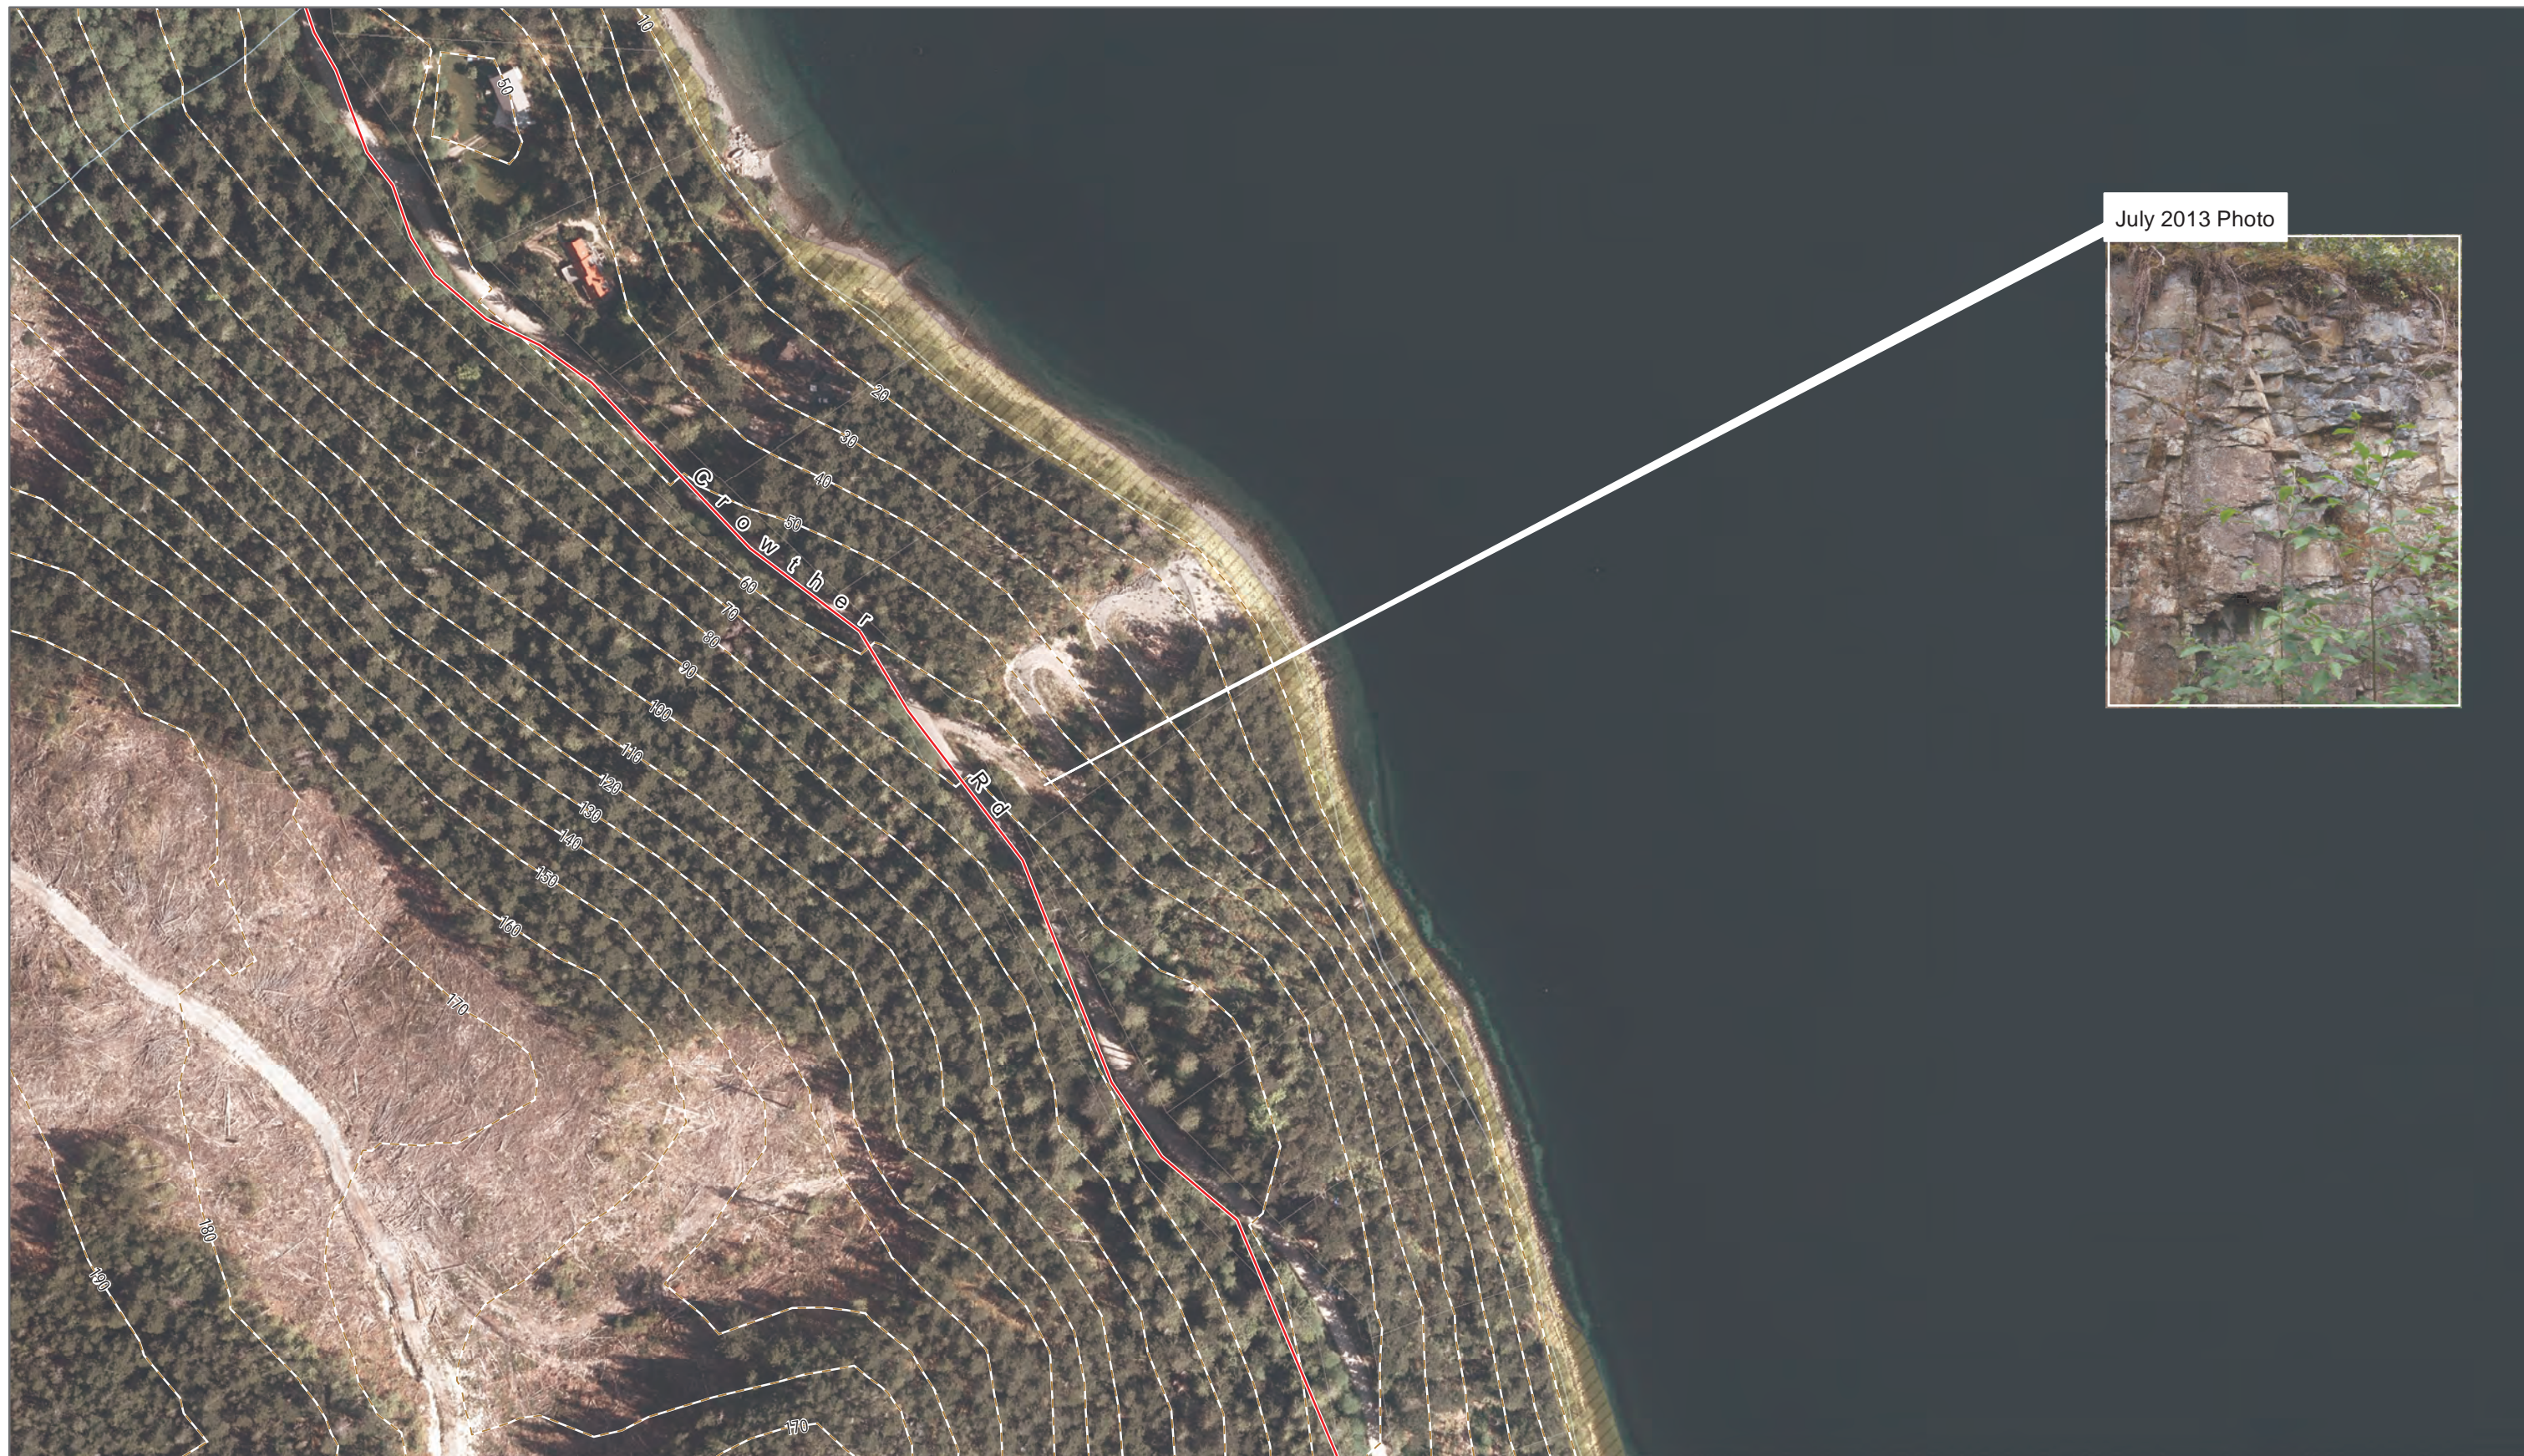
Steep Slopes Figure 2 (April 2012 Aerial Image)

Highly jointed and fractured bedrock create avenues for concentration of surface and ground water. Joint and fracture planes can create zones of weakness that provide potential failure surfaces where overlying materials can slide. Much of the steep slopes in the study area consist of bedrock bluffs with thin soil development . Figure 2, shows an access road development in steep rocky slopes in the study area. The access was developed through a highly fractured rock face. Though this development poses limited risk to the general public, it provides information regarding fracture development in the local bedrock.

Areas of steep slopes are inherently difficult to develop and can become unstable under certain conditions. A detailed assessment of surficial geology and drainage is recommended for these areas prior to development approval.

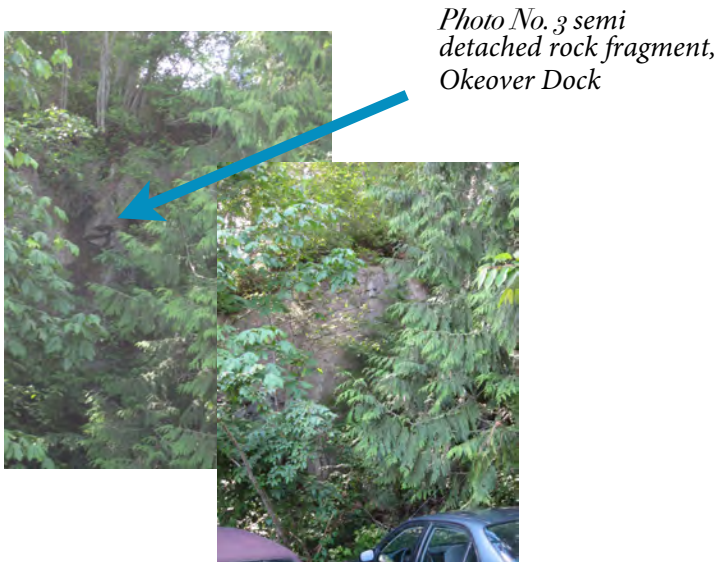
Photo 3 was taken at the Okeover dock and show cars parked under a steep rock bluff that presents some rockfall hazard issues that presently poses some risk to the general public and property.

Rock fall hazard assessments are generally completed during initial phase of property development if rockfall hazard is considered a risk. Development in steep rock bluff areas generally involve some blasting during the development phase. It is important to understand rock fractures and how blast waves travel along these fractures. Shock waves can reduce the internal shear strength of surficial material and make them more prone to failure .

Review the identified issues at Okeover Dock Area and establish a plan to address rock fall hazard and risk to the public. Seek cooperation with the Okeover Harbour Authority, Ministry of Transportation and Infrastructure to develop a plan/design that will provide long term stable road access to the Okeover Dock.

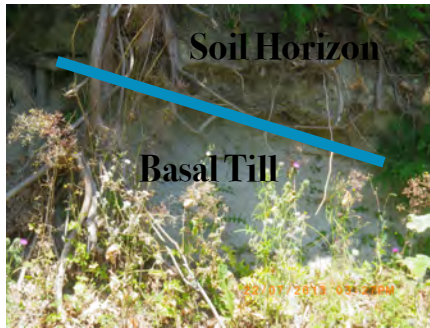
There were zones where erosional processes due to surface and subsurface drainage were observed. Photo 4 shows a road cut that is over steepened due to the drainage between the soil layer and the compacted till. The material below the soil is being washed away slowly and the bank is over steepened exposing tree roots and creating cut bank instability.

Photo 4 active erosion between units, Atrevida Road

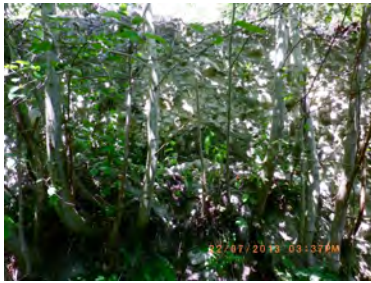
Surficial materials can have variable textures that range from fine to coarse, sorted to poorly sorted. Photo 5 illustrates the variability of texture within surficial material and how drainage patterns can form within these materials between coarse and fine textured material creating stability issues on steeper slopes.

Photo No. 5 Area of slump, Atrevida Road

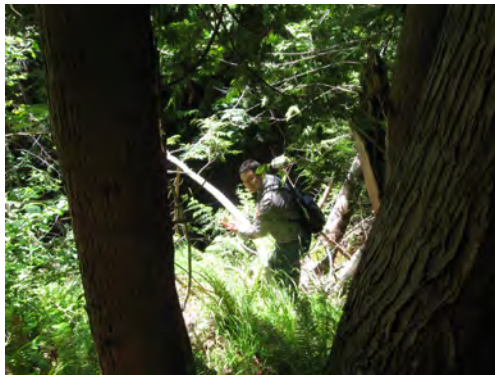
Surficial material with very fine grain textures are highly erodible in the presence of water. An example of this type of erosion is located in the study area where a large gully has formed within marine clay, probably attributed to surface drainage. Photo 6.

Photo 6. Gully headwall, active erosion in marine clay slopes, south of Atrevida Road.

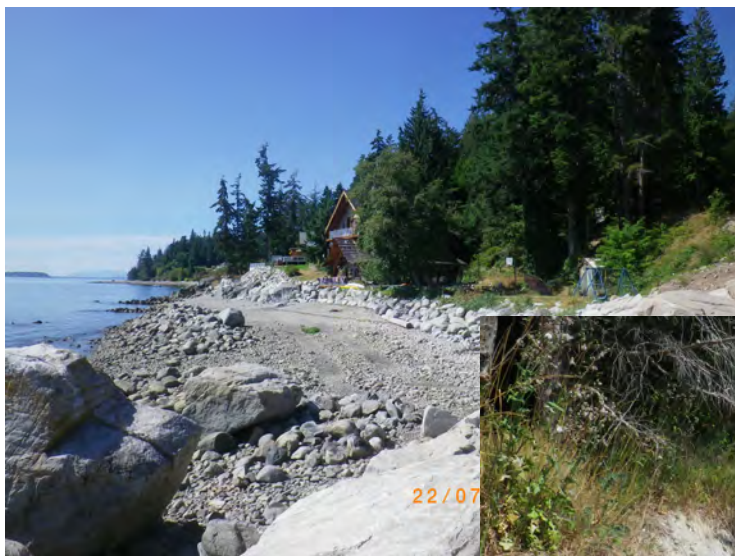
On field review of selected beach areas there was evidence that property owners had taken measures to protect their property from erosion by placing rip rap along the banks of their property and the foreshore (photos 7 and 8).

Photo 7. Rip Rap along foreshore, Sturt Rd

Property owners appear to be taking protective measure to protect their properties from erosion. These measures may protect their properties for the present but they may create issues for property owners along the same shoreline. It is important that a proper assessment be completed prior to any shoreline protection measure being taken.

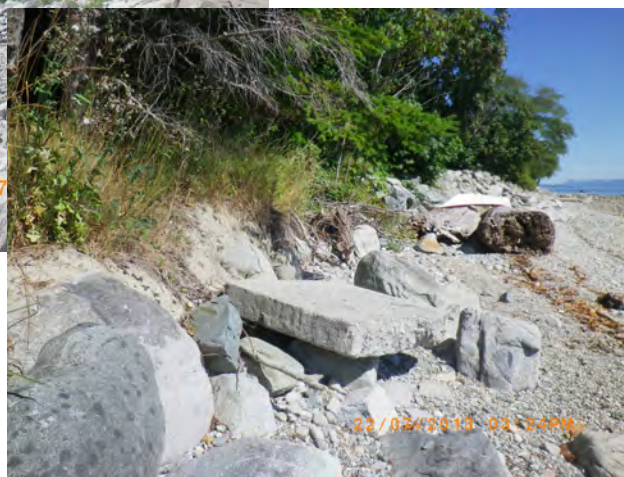
Photo 8. Shoreline erosion , Atrevida Rd.

There are presently signs of active shoreline erosion on many of the beaches within the study area. A detailed assessment of the shoreline in these beach areas should be completed by a qualified Marine Engineer to determine present and future risk to low lying development.

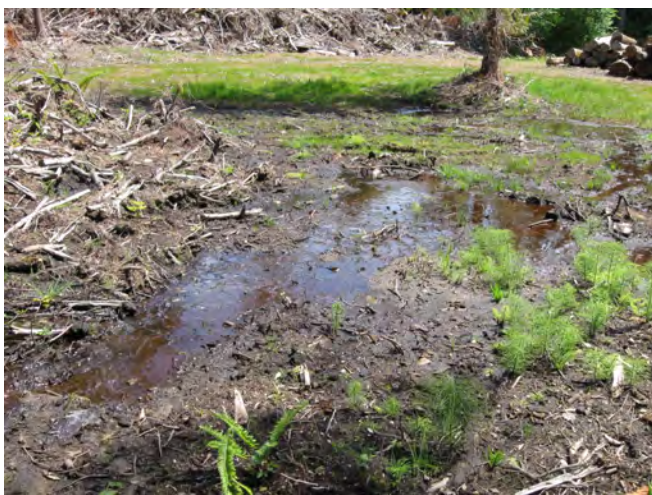
A field visit was conducted to determine the extent and cause of these features. Several traverses were completed and features were referenced on Map 2-1. Wet areas and ponds were located on a bench above the steep slopes. The wet area located on Map2-1 had active water movement at the time of the field visit (see Photo 9). The water on the property flowed over the steep escarpment to form a gully headwall as indicated (approximately 80m contour, Photo 10). The material within the gully was identified as marine clay. It appeared that the gully was formed by active erosional processes directly caused from surface drainage.

Photo 9. Surface drainage.

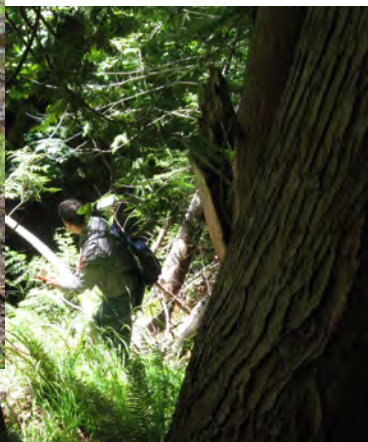
Photo 10. Gully headwall.

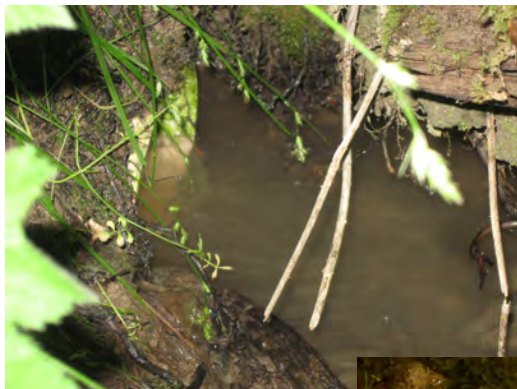
A number of abandoned access roads identified on the aerial photos were traversed to determine any present stability issues. Most of the slopes appeared saturated and water was running on the surface and through small developed ditches. There were signs of active erosion in the form of slumps. The surface layer of the clay bank material was soft and lacked cohesion (Photos 11, 12, & 13).

Photo 11. Surface drainage in ditch

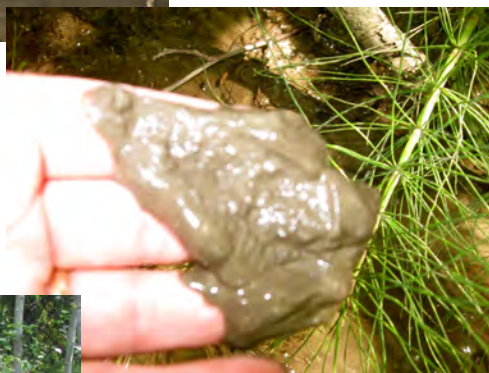
Photo 12. Clay in Road Cut

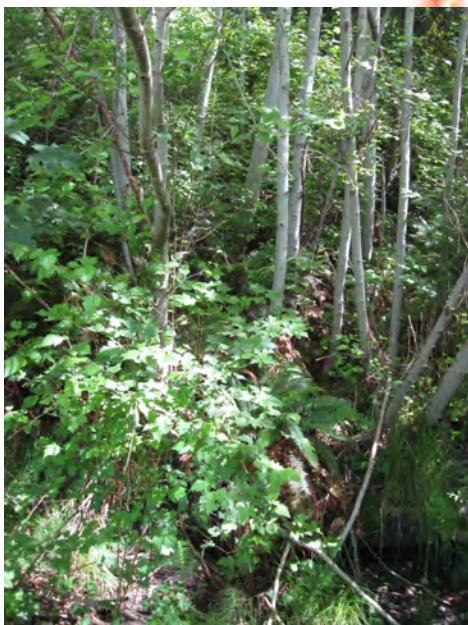
Photo 13. Small Slump

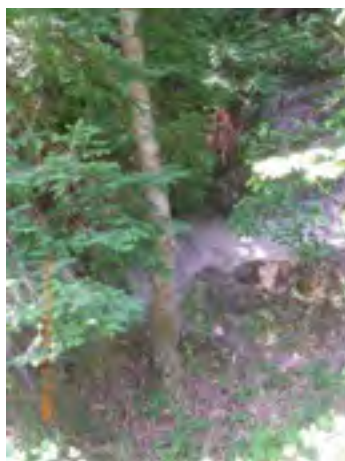
The development below Atrivida road is vulnerable to upslope development. If drainage patterns change and more water is directed to the lower slopes some slope failure could occur. There are some minor failures noted in the Atrivida Road cut-banks . Any further development upslope may create additional drainage issues for downslope properties and the existing road cuts that have already shown active erosion from small slumps /failures (see Photo 14 & 15).

Photo 14. Slump in cut bank

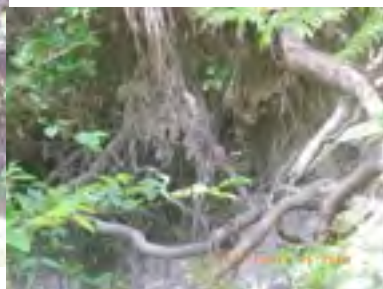
Photo 15. Cut bank erosion.

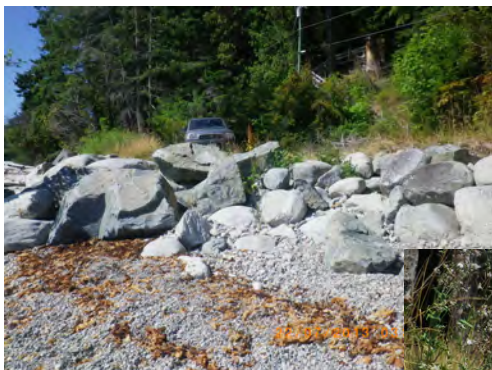
Shoreline erosion is also an issue along the northern section of the Atrevida Area. As stated many property owners have taken measures to reduce shoreline erosion by placing rip-rap.

Photo 16. Rip Rap protected shoreline

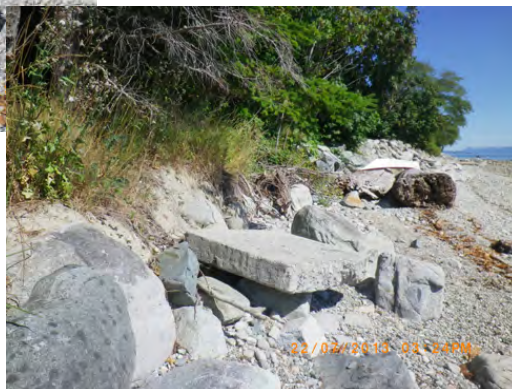
Photo 17. Erosion of unprotected shoreline

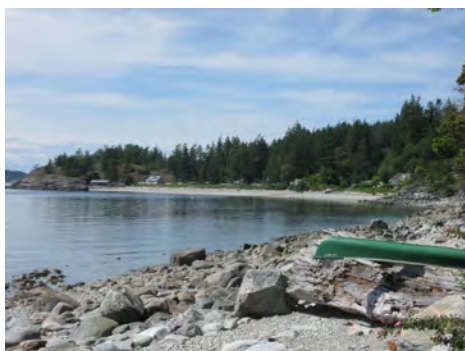
The Emmonds Beach catchment area was delineated because most of the area surface drainage is directed to a few small creeks. Using the height of land as the approximate boundary to trace out the shape, the area has been approximated at 325 ha. (Map 3). The peak volume and velocity of runoff in a storm event is a function of the soil permeability and speed of run off can be determined through a detailed analysis. Estimating watershed parameters, such as, flood frequency, or surface water flow is beyond the scope of this report.

Photo 18. Emmonds Beach

Though the risk is low for landslides and other mass movement of materials, the overall size of catchment area and the drainage concentration into a few creeks may pose some future flood risk. Based on the model of probably storm surge, the low lying area of Edmonds Beach may be vulnerable to sea water inundation.

The Emmonds Beach area appears highly developable, but it may have some risk associated with possible flooding. The area above the beach forms a relatively large catchment areas that drains into a narrow drainage. An analysis of the catch basin features should be completed to determine the flood frequency for this area.

The storm surge model indicated that the area may be at risk of sea water inundation and flooding during higher intensity storm surges. A detailed assessment is recommended to determine the extent and/or probability of seawater inundation

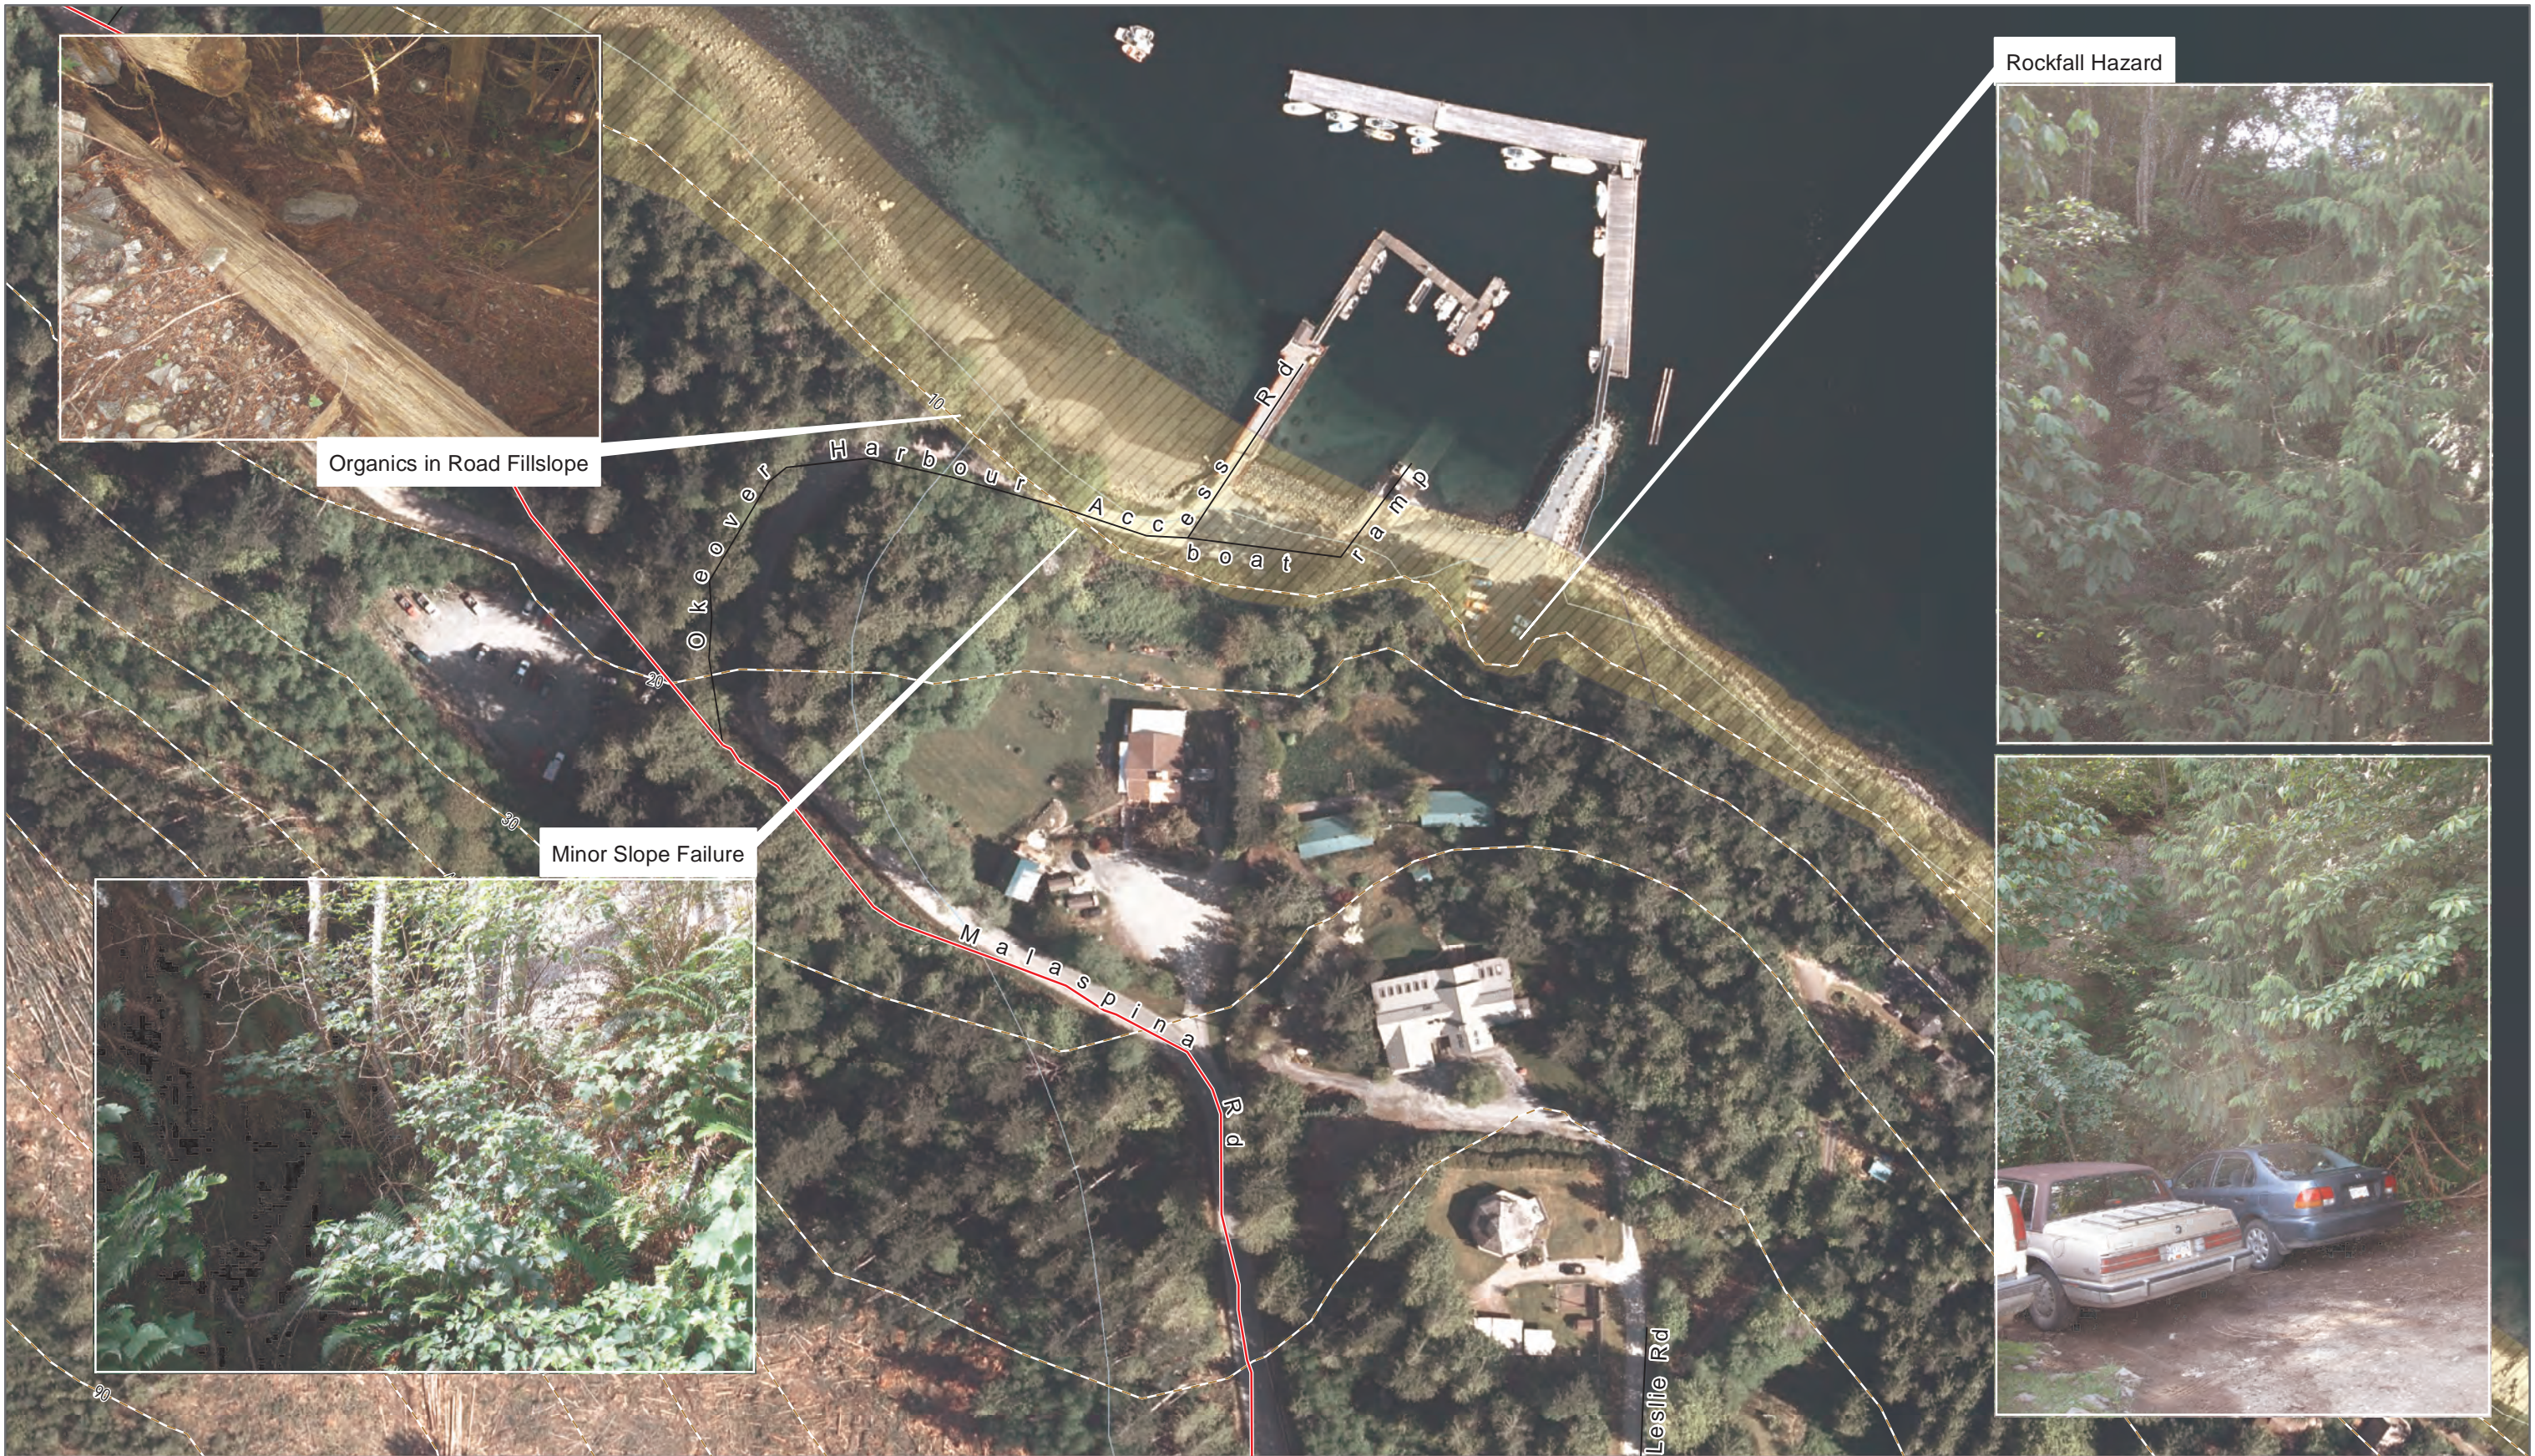
Figure 4
(April 2012 Aerial Image)

The Okeover Dock Area was selected for a field check to investigate erosional features observed on the aerial images. The field review identified three localized issues illustrated in Fig. 4.

- Rockfall Hazard/ Quarried slopes just above the Okeover dock, where the public is parking may present a risk to public safety.
- Minor slope failure above the access road indicates active erosional slope processes that may lead to further erosional events impacting access.
- Erosional processes were observed on the access road fill slope, it is presently being undercut by shoreline erosion. As the organic material in the road fill decays and the shoreline erosion advances the access to the Okeover dock may be compromised.
