July 12, 2016

**Subject: Intertidal Assessment for an Existing Barge Ramp  
Savary Island, B.C.**

Project: Savary Island Government Wharf and Barge Ramp

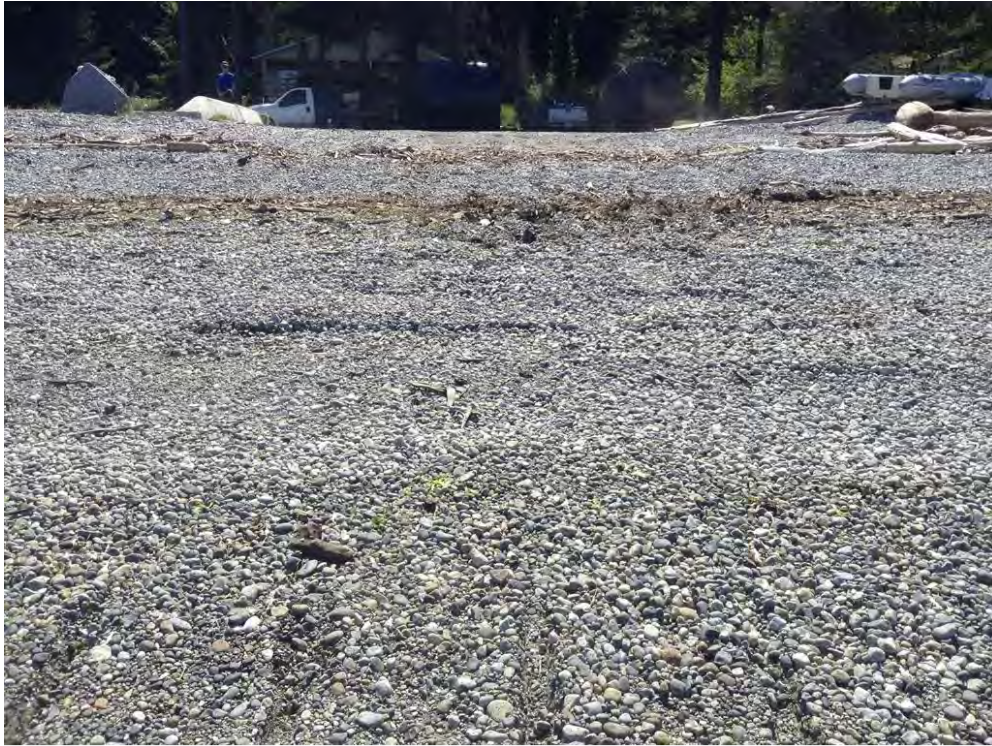
Photo: 1

Low biological productivity levels were observed both within the footprint of the barge ramp and in adjacent intertidal habitats with little to no encrusting or mobile organisms observed (Appendix 1, photos 1 – 4 and photos 12 - 18), with the exception of sea lettuce (*Ulva fenestra*) observed within the lower intertidal zone. A subtidal marine survey of the site conducted in 2006 identified biological life to be sparse in the vicinity of the ramp, likely due to the sandy substrates and relatively strong currents and wave action in the area (Hay & Company Consultants, 2006). A recent high tide debris line

Looking up the barge ramp from the 3m (chart datum) tide mark.

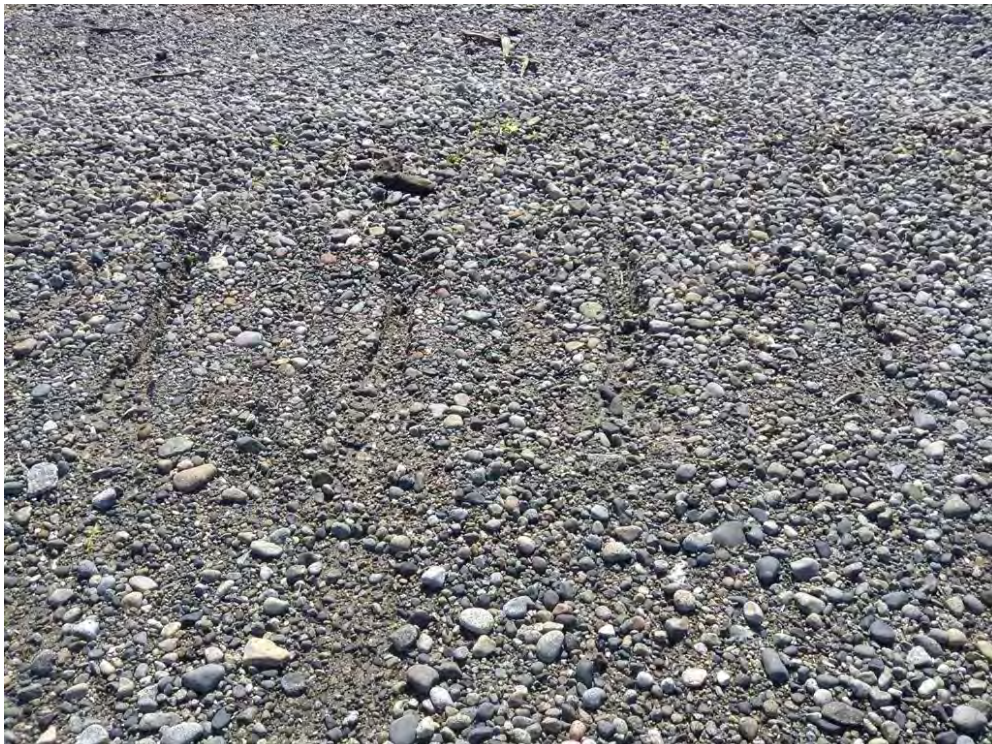
Photo: 2

While propeller wash occurred during the barge landing, no major sedimentation issues were observed that indicated significant scouring was occurring during operations. A post-field analysis of the bathymetry of the barge ramp identified gradients steep enough to prevent significant sedimentation during lower tide barge landings (Figure 1 and Appendix 2).

Depressions on the beach from a barge landing earlier this morning.

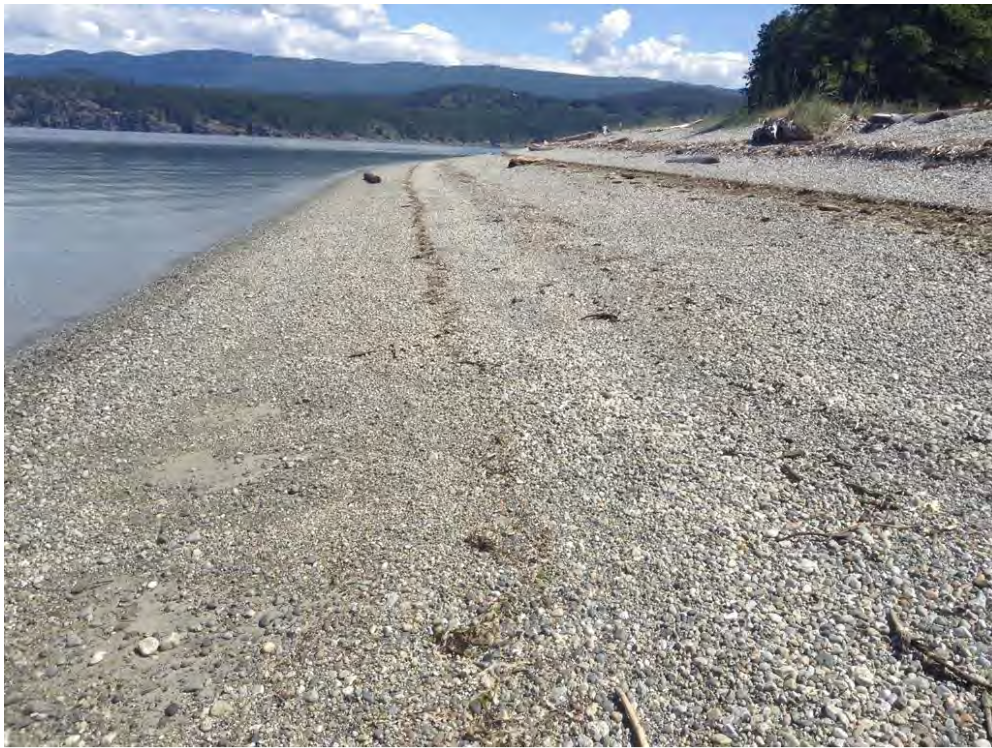
Photo: 3  
 Beach and typical habitat adjacent to the barge ramp (to the east).  
 ( Date Taken: May-12-16 12:14:56 PM, Latitude: 49°56'58.21", Longitude: -124°46'14.80" )

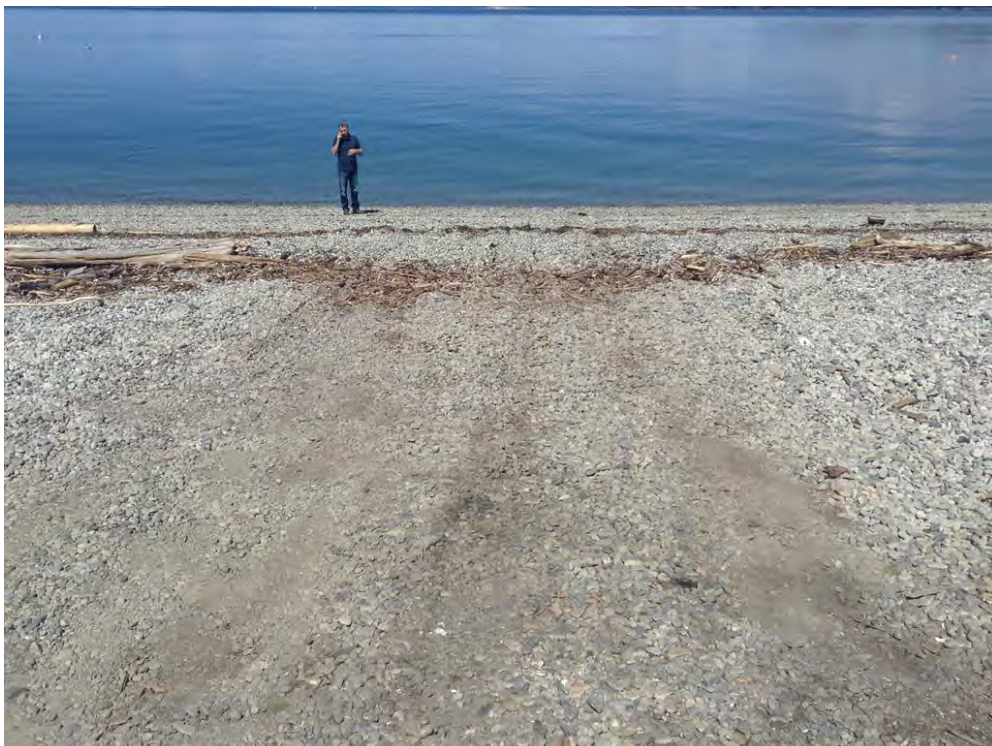
Photo: 4  
 Looking down the barge ramp from the high water mark.  
 ( Date Taken: May-12-16 12:15:46 PM, Latitude: 49°56'57.74", Longitude: -124°46'14.43" )

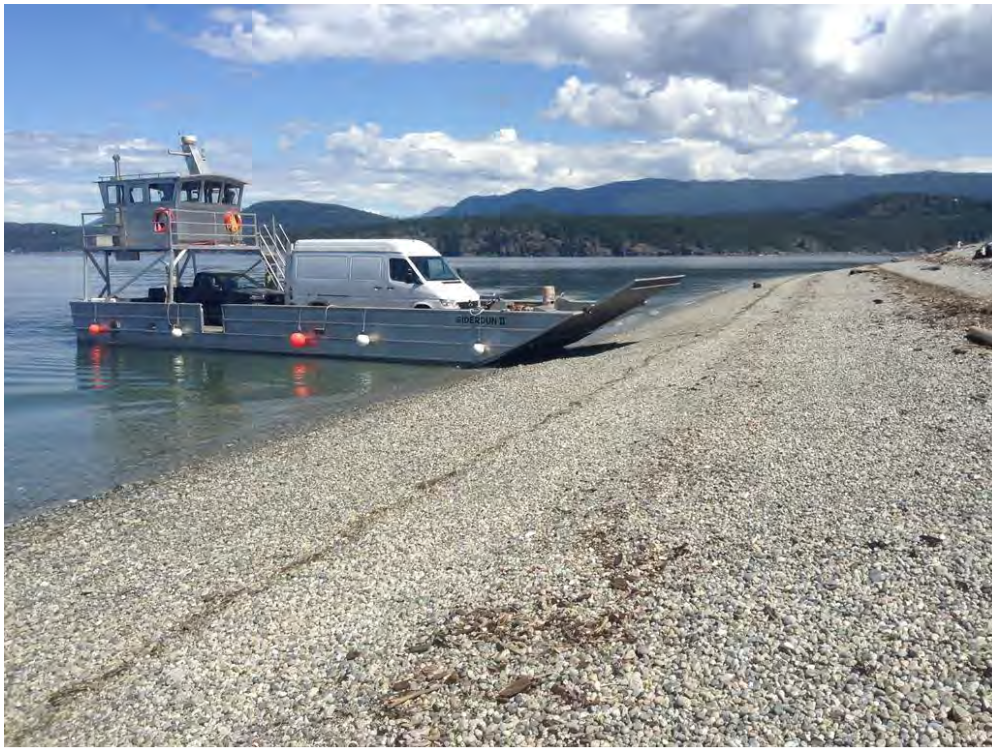
The off-load of one van and one small truck was observed during the intertidal assessment of the barge ramp at a tide height of approximately 2.3m (chart datum) (Appendix 1, photos 5 - 11), where vehicles were required to drive approximately 20m up the beach to access the road.

Photo: 5  
Barge landing at the ramp.  
( Date Taken: May-12-16 12:17:27 PM, Latitude: 49°56'57.60", Longitude: -124°46'15.85" )

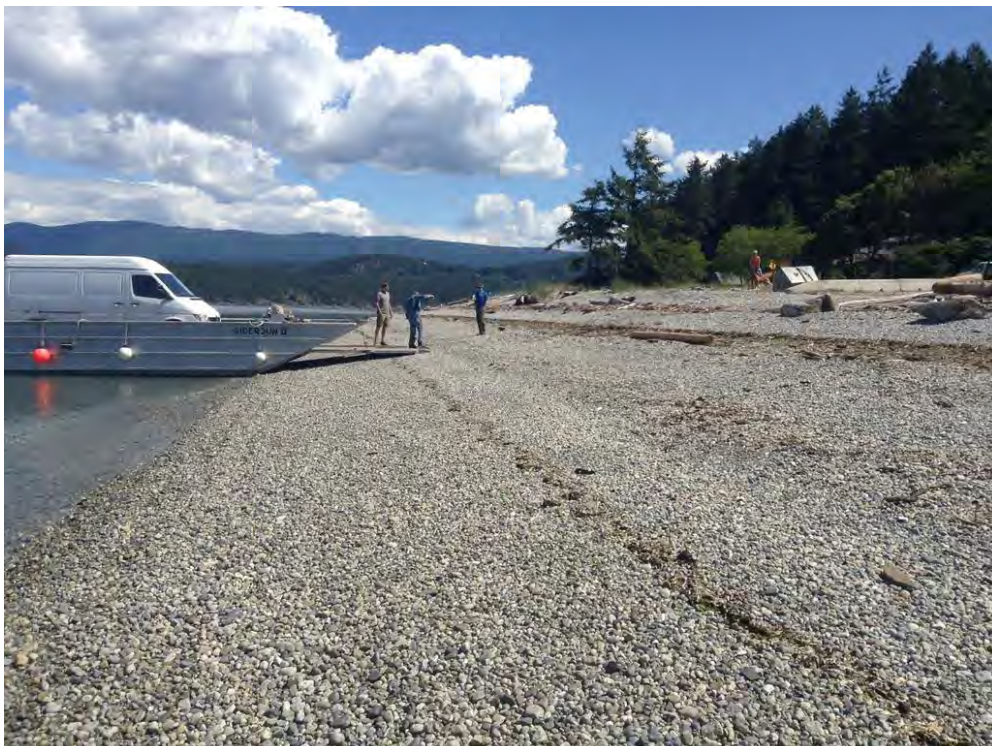
Photo: 6  
Barge landing at the ramp.  
( Date Taken: May-12-16 12:18:02 PM, Latitude: 49°56'57.64", Longitude: -124°46'15.99" )

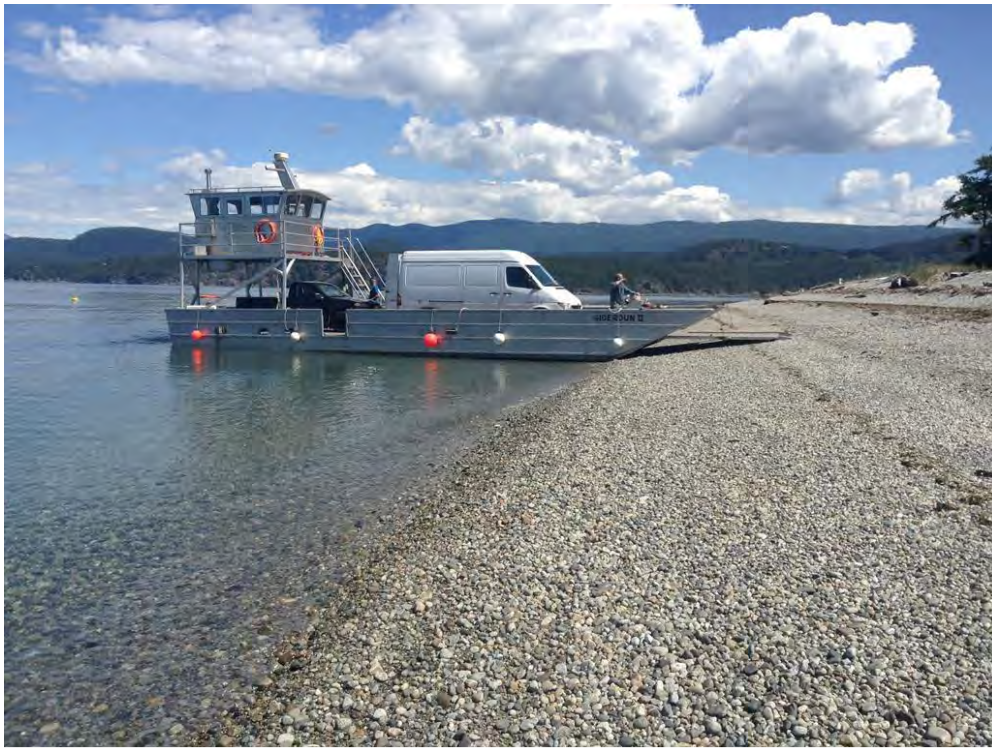
Photo: 7  
Barge landing at the ramp.  
( Date Taken: May-12-16 12:18:21 PM, Latitude: 49°56'57.63", Longitude: -124°46'15.90" )

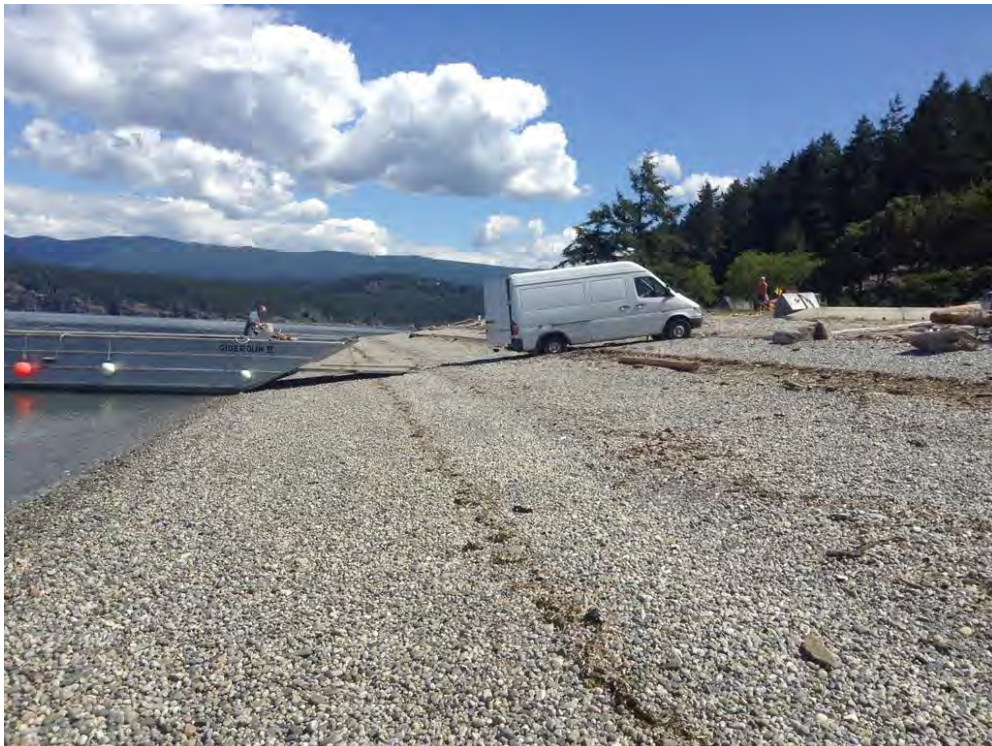
Photo: 8  
Vehicle off-loading at the ramp.  
( Date Taken: May-12-16 12:18:39 PM, Latitude: 49°56'57.70", Longitude: -124°46'15.84" )

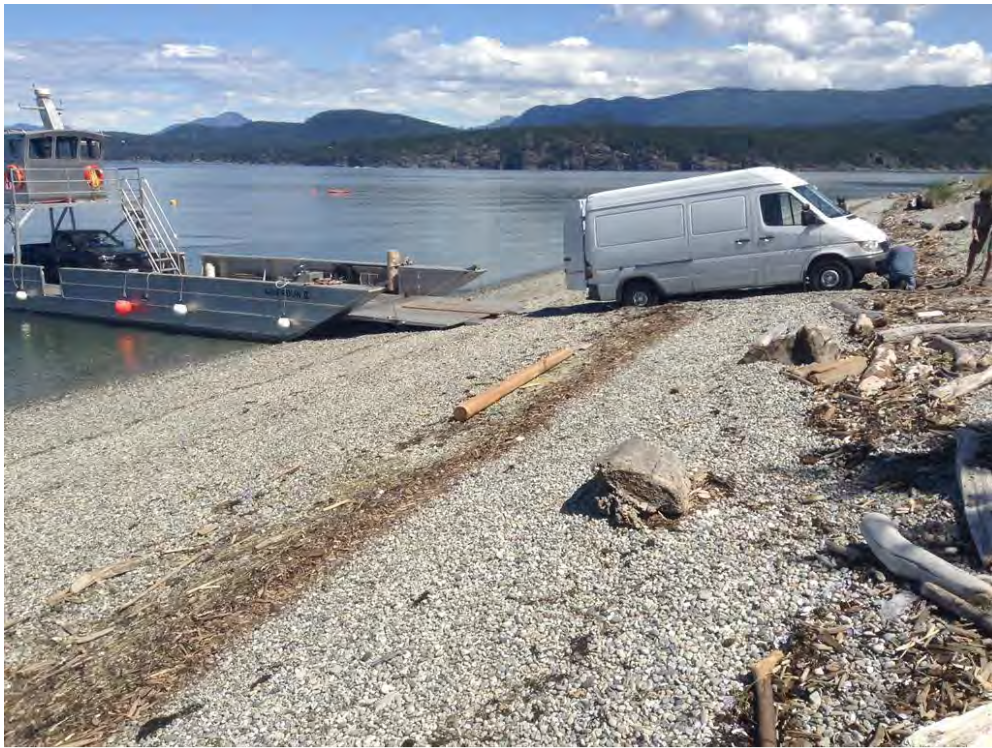
marine environment. Additional risks observed included vehicles becoming immobilized in loose beach material, which increases the exposure of marine habitats to the introduction of deleterious substances (i.e. fuel, oil, etc.).

Photo: 9  
Vehicle off-loading at the ramp. Note vehicle became stuck in loose gravel.  
( Date Taken: May-12-16 12:19:30 PM, Latitude: 49°56'57.52", Longitude: -124°46'15.29" )

In order to address the issue of vehicles becoming immobilized in loose beach material and the overall usability of the site, the proponent may want to consider hardening the running surface of the ramp by pouring a concrete ramp. Based on the observed productivity levels and under the current Fisheries Act, this infrastructure will not result in serious harm to fish and fish habitat, and may improve overall conditions by reducing the time vehicles spend on the beach. Permanent infrastructure such as a concrete ramp will also allow for use of the ramp at all matching tides and prevent the constant disturbance of native beach materials.

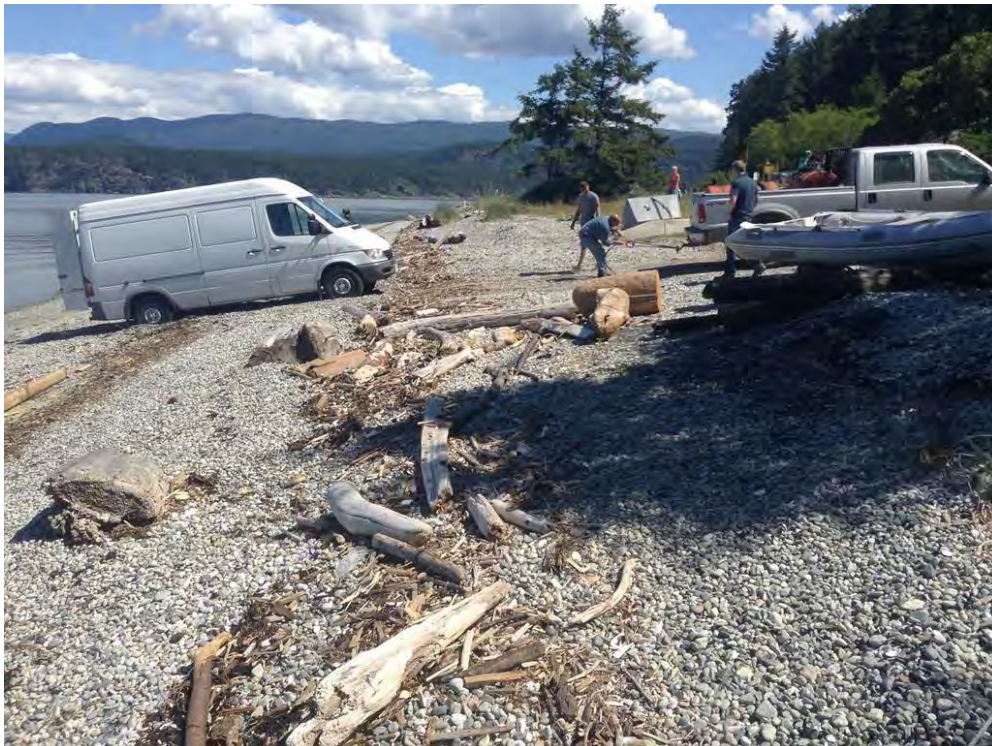
Photo: 10  
Vehicle off-loading at barge ramp. Note vehicle became stuck in loose gravel.  
( Date Taken: May-12-16 12:22:01 PM, Latitude: 49°56'57.61", Longitude: -124°46'15.29" )

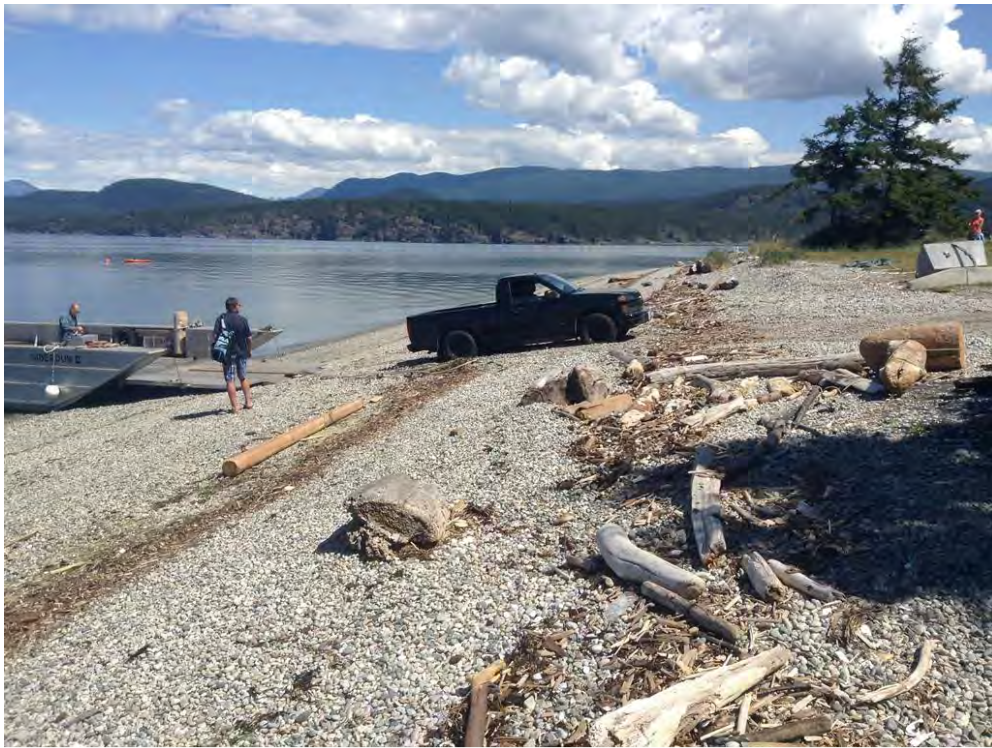
Photo: 11  
 Vehicle off-loading at the ramp.  
 ( Date Taken: May-12-16 12:23:35 PM, Latitude: 49°56'57.61", Longitude: -124°46'15.35" )

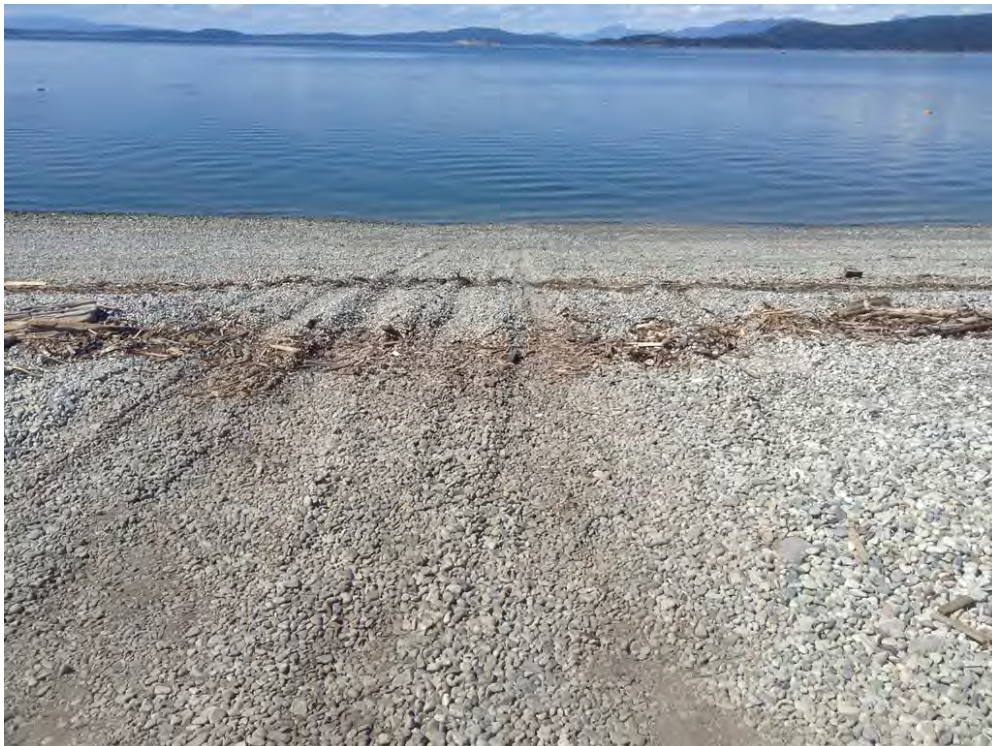
consisting of coarse woody debris, which appeared to have originated from a log handling facility, was observed in the upper intertidal zone (Appendix 1, photo 12).

Photo: 12  
 Existing barge ramp at a 2.25m tide (chart datum).  
 ( Date Taken: May-12-16 2:51:34 PM, Latitude: 49°56'57.75", Longitude: -124°46'14.20" )

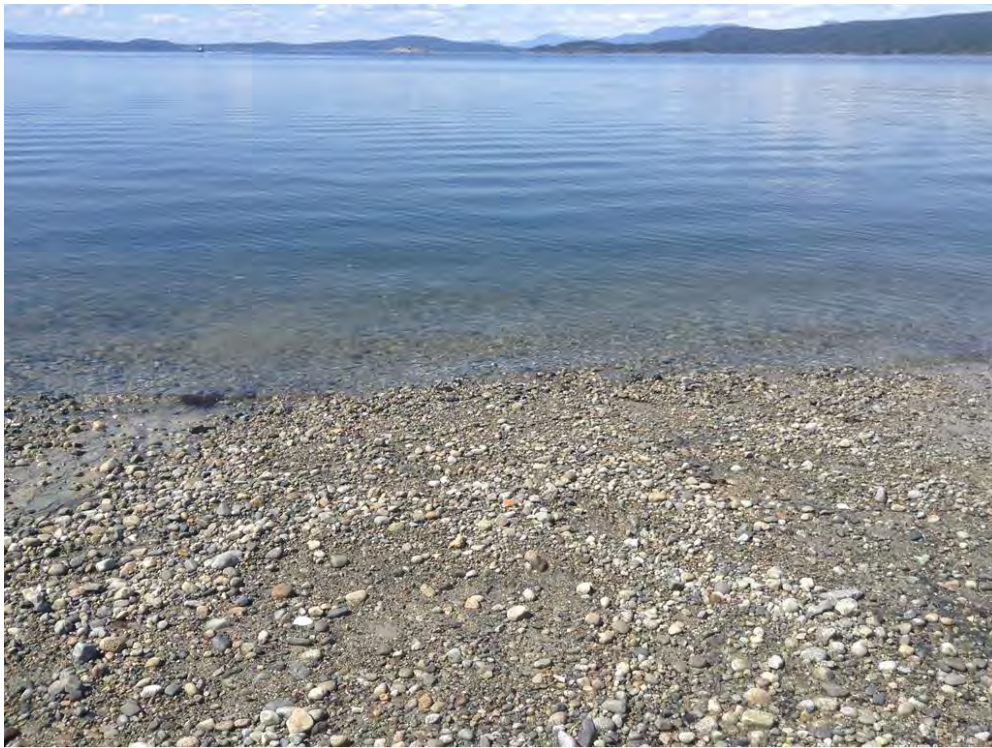
Photo: 13  
Existing barge ramp at a 2.25m tide (chart datum).  
( Date Taken: May-12-16 2:52:38 PM, Latitude: 49°56'58.32", Longitude: -124°46'15.15" )

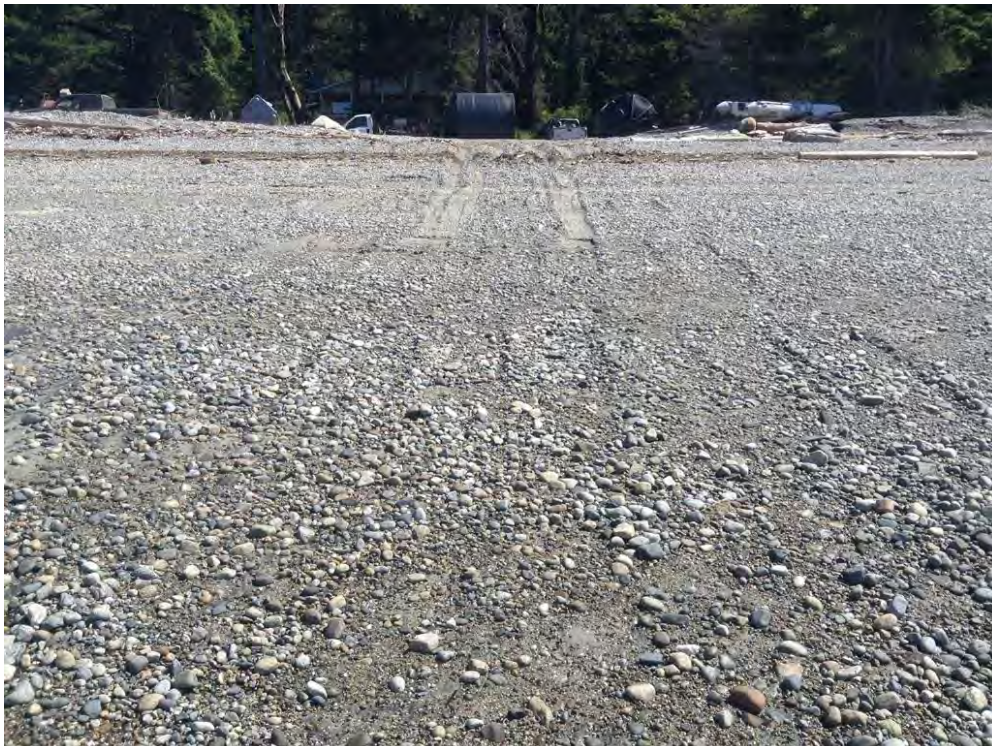
Photo: 14  
Existing barge ramp at a 2.25m tide (chart datum).  
( Date Taken: May-12-16 2:53:02 PM, Latitude: 49°56'58.44", Longitude: -124°46'15.18" )

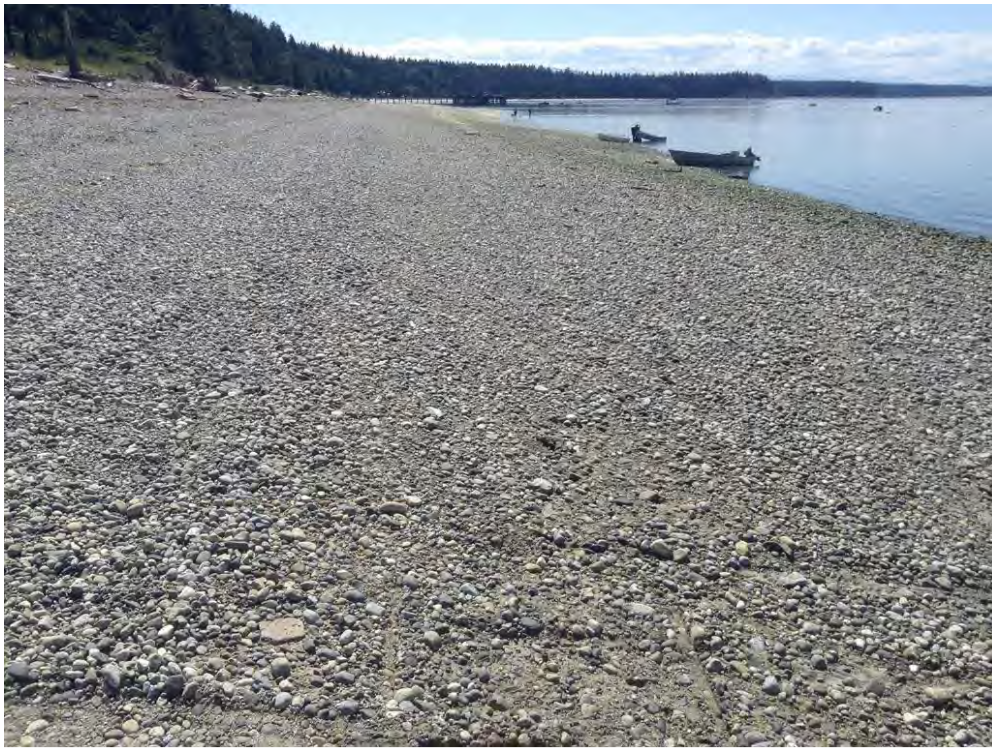
Photo: 15  
 Beach and typical habitat adjacent to the barge ramp.  
 ( Date Taken: May-12-16 2:53:32 PM, Latitude: 49°56'58.19", Longitude: -124°46'14.88" )

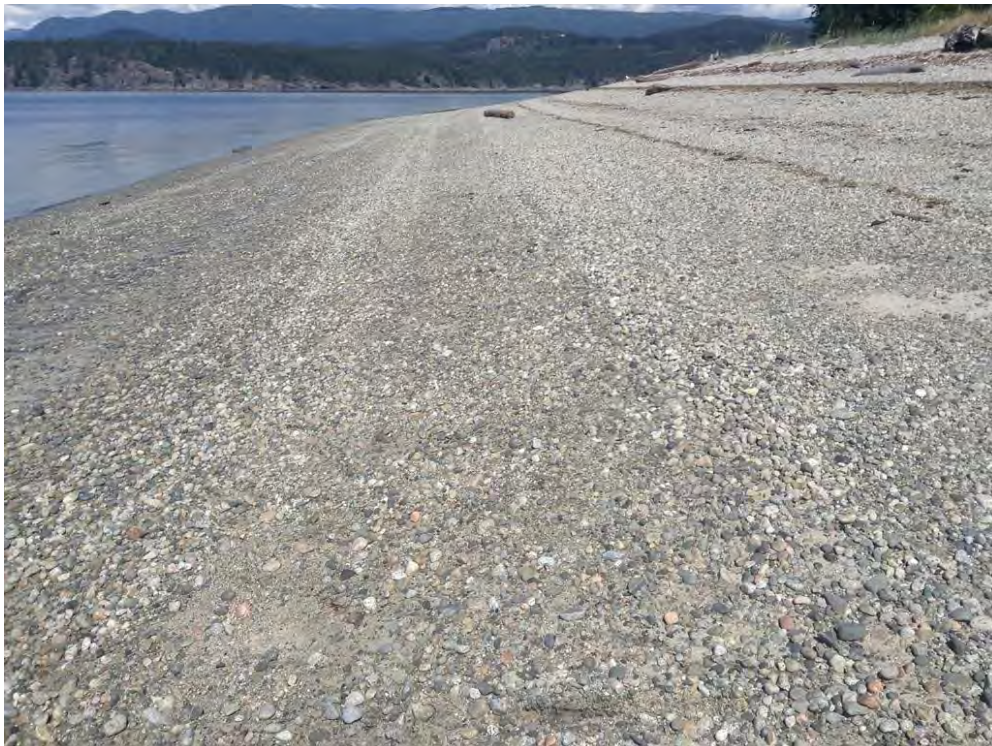
Photo: 16  
 Beach and typical habitat adjacent to the barge ramp.  
 ( Date Taken: May-12-16 2:54:10 PM, Latitude: 49°56'57.87", Longitude: -124°46'14.76" )

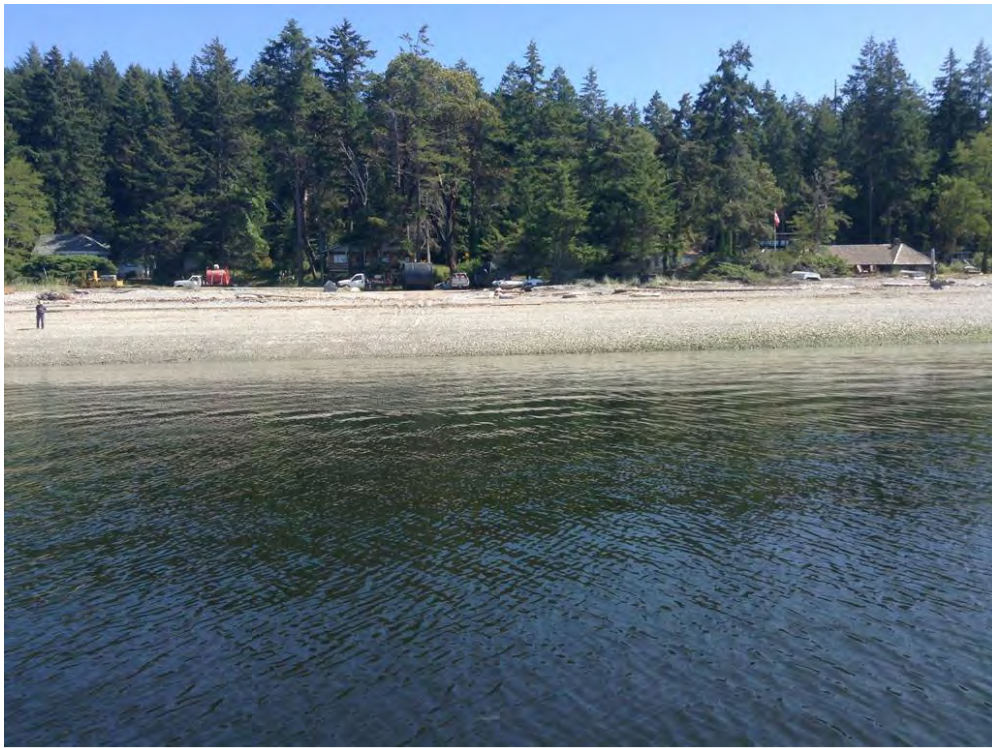
Photo: 17  
Barge ramp from the water at a 2.2m tide (chart datum).  
( Date Taken: May-12-16 3:09:18 PM, Latitude: 49°56'59.71", Longitude: -124°46'16.81" )

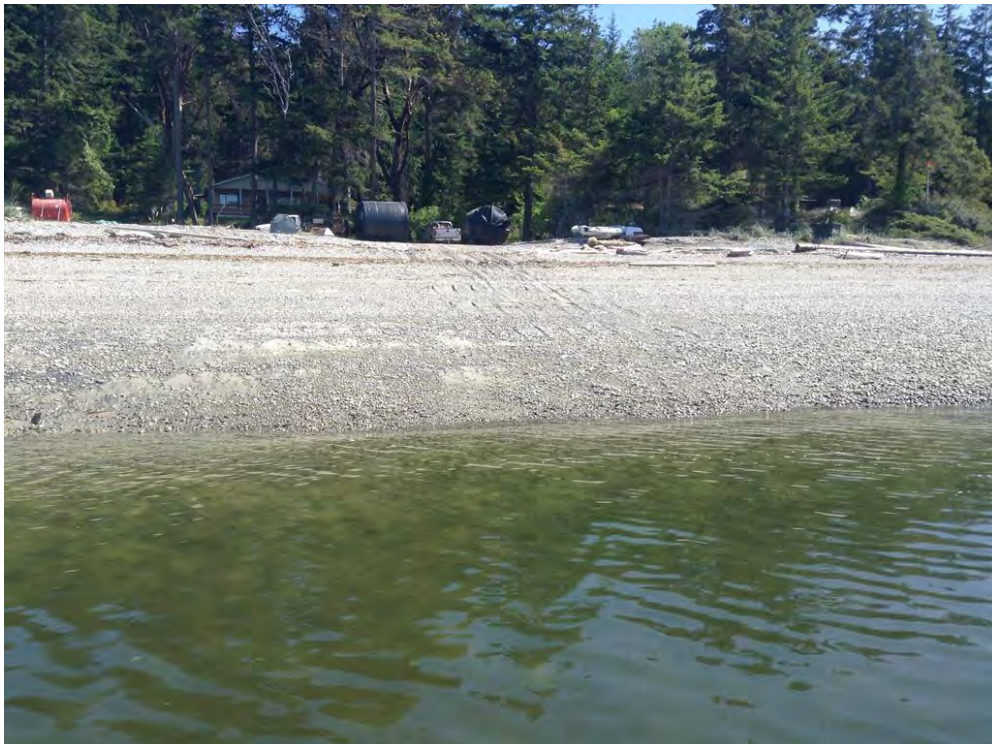
Photo: 18  
Barge ramp from the water at a 2.2m tide (chart datum).  
( Date Taken: May-12-16 3:09:45 PM, Latitude: 49°56'58.86", Longitude: -124°46'15.22" )

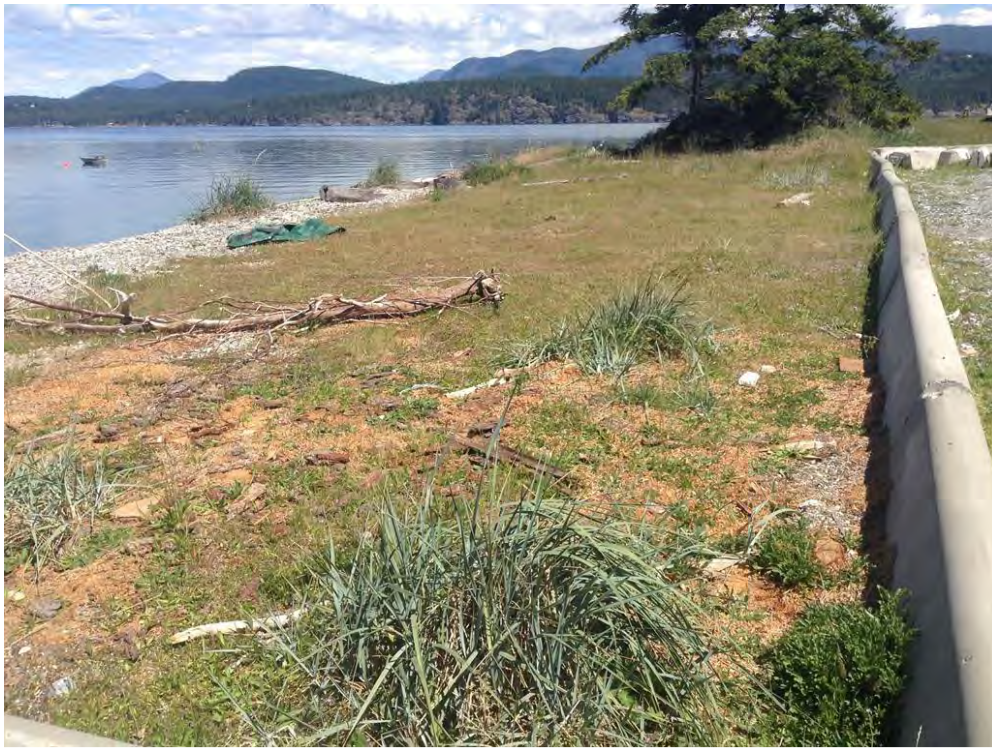
Photo: 19

Unused green space located southeast of the barge ramp. Note that this site could be explored for future restoration initiatives (i.e. the creation of additional dunegrass habitat).

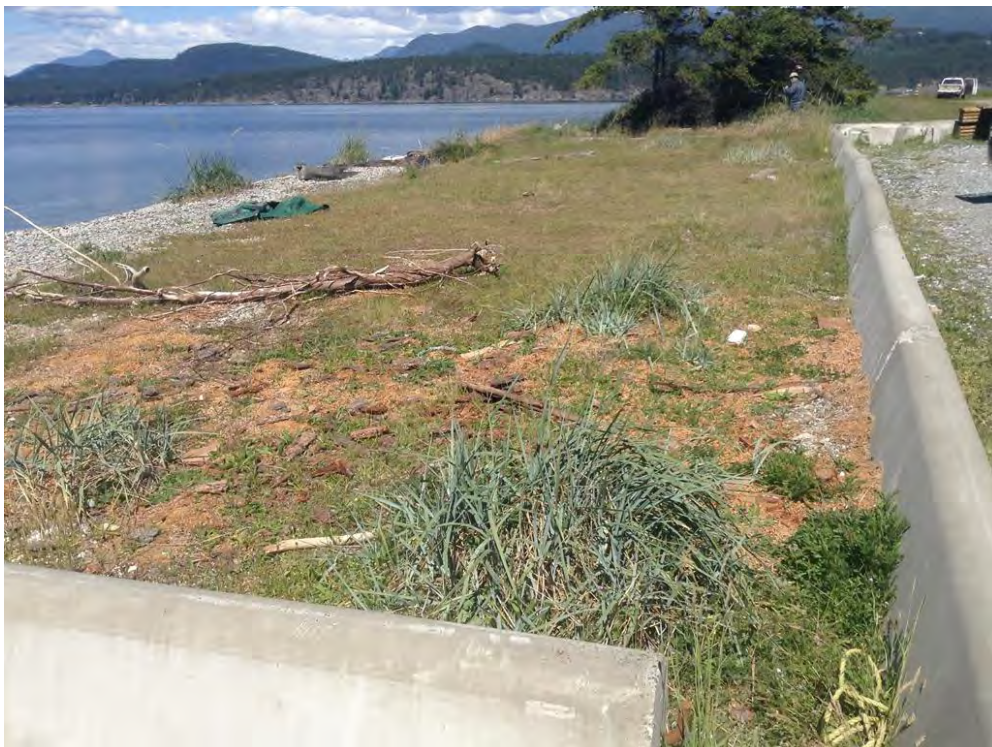
Photo: 20

Unused green space located southeast of the barge ramp. Note that this site could be explored for future restoration initiatives (i.e. the creation of additional dunegrass habitat).

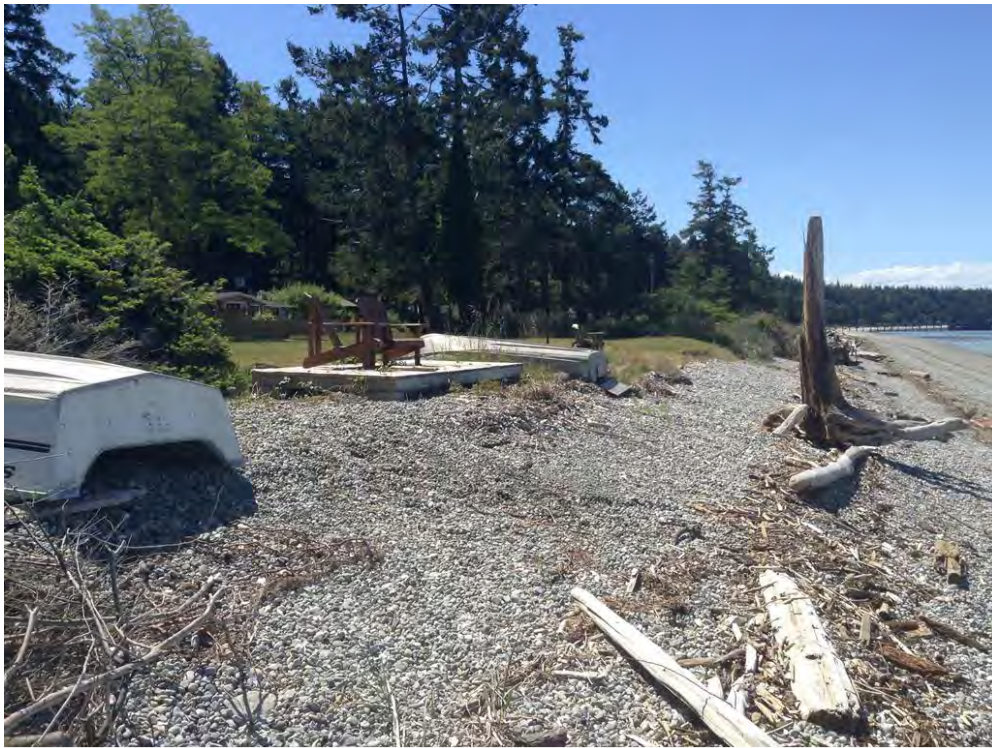
The historical loss of marine riparian habitat along the northern shoreline of Savary Island through residential development has resulted in a net loss of dune grass (*Leymus mollis*) habitat (Appendix 1, photos 21 - 22). Should habitat offsetting be required for the construction of a concrete ramp, restoration of a small green space identified adjacent to the barge ramp could be considered (Appendix 1, photos 19 - 20). This space could be contoured to an elevation that would support *L. mollis* and then transplanted with shoots from adjacent areas in an effort to re-establish lost marine riparian habitat.

Photo: 21  
 Example of loss of marine foreshore through residential development.  
 ( Date Taken: May-12-16 12:48:54 PM, Latitude: 49°56'57.42", Longitude: -124°46'15.76" )

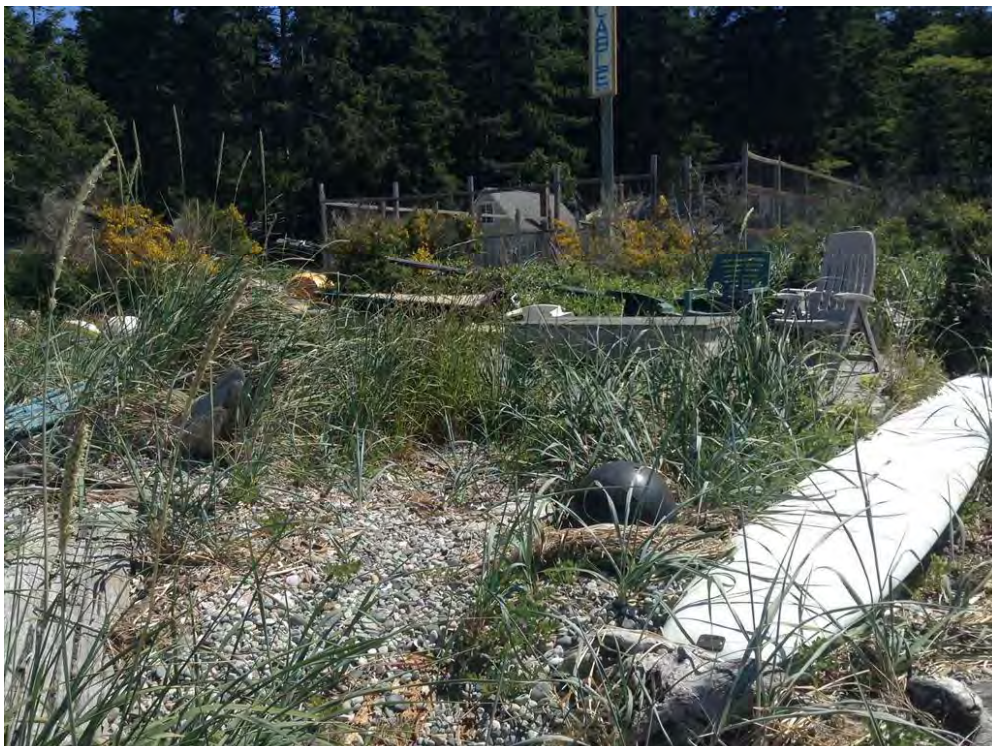
Photo: 22  
 Example of loss of marine foreshore through residential development.  
 ( Date Taken: May-12-16 12:54:54 PM, Latitude: 49°56'53.42", Longitude: -124°46'22.24" )

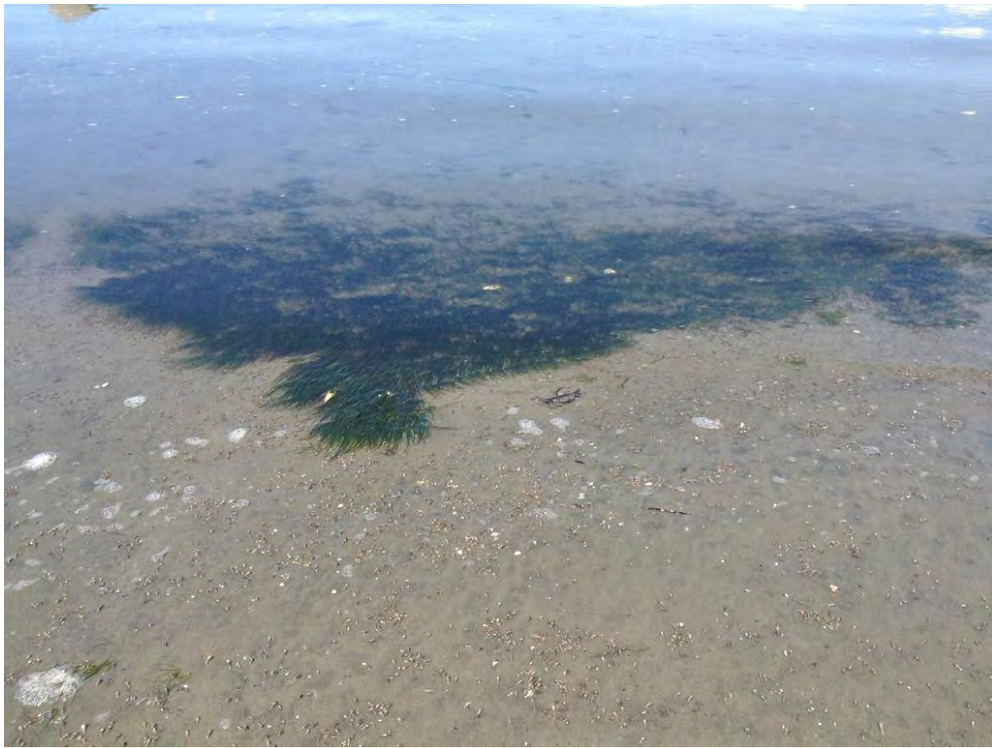
Photo: 25

Seagrass observed at the Mermaid Beach alternative barge ramp location, a location proposed by some Savary Island residents.  
( Date Taken: May-12-16 1:28:08 PM, Latitude: 49°56'25.44", Longitude: -124°49'54.23" )

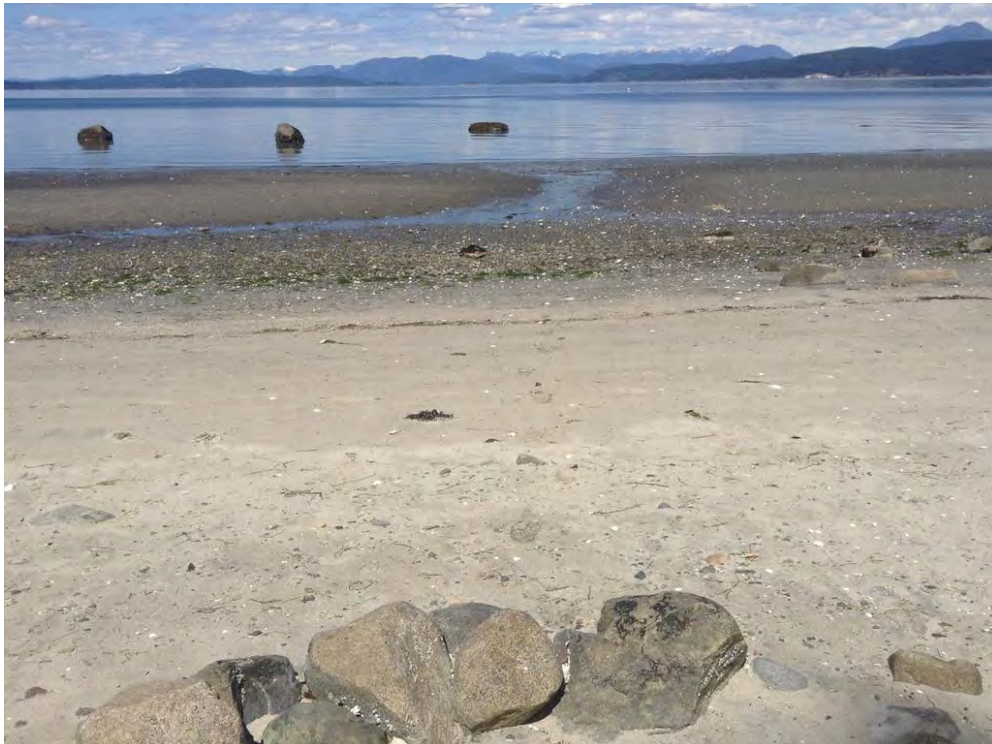
Photo: 28

Mermaid beach, location proposed as a potential alternative barge ramp location by some Savary Island residents. Note access to this site would require difficult road building down unstable slope with existing tension cracks, with additional road building required within the upper intertidal zone to access depths suitable for landing a barge.  
( Date Taken: May-12-16 1:29:53 PM, Latitude: 49°56'24.01", Longitude: -124°49'53.82" )

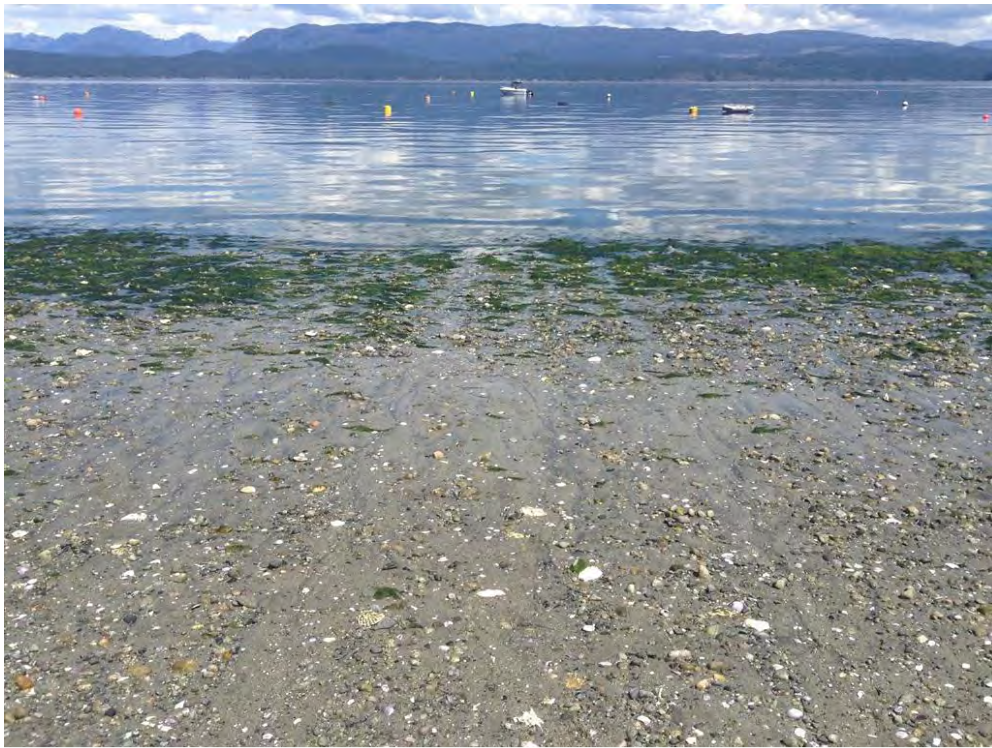
Photo: 33

Indian Point boat ramp, proposed as an alternative barge ramp location by some Savary Island residents. This site would require dredging, and additional survey work (i.e. intertidal clam assessment) would be required prior to applying for DFO approval.  
( Date Taken: May-12-16 1:52:38 PM, Latitude: 49°56'53.07", Longitude: -124°51'33.02" )

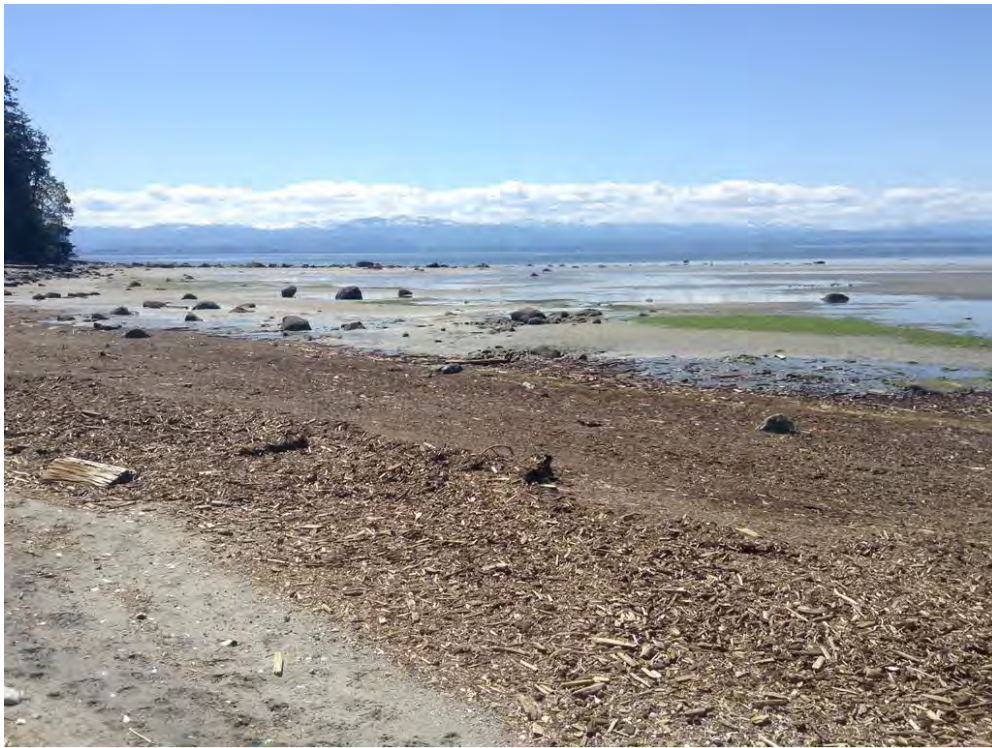
Photo: 37

Corner of sunset trail and Johnson's Lane, and location proposed as an alternative barge ramp site by some Savary Island residents. Note that shallow depths exist between Savary Island and Hernando Island and are not conducive to a barge ramp facility. ( Date Taken: May-12-16 2:05:18 PM, Latitude: 49°56'43.98", Longitude: -124°51'51.02" )

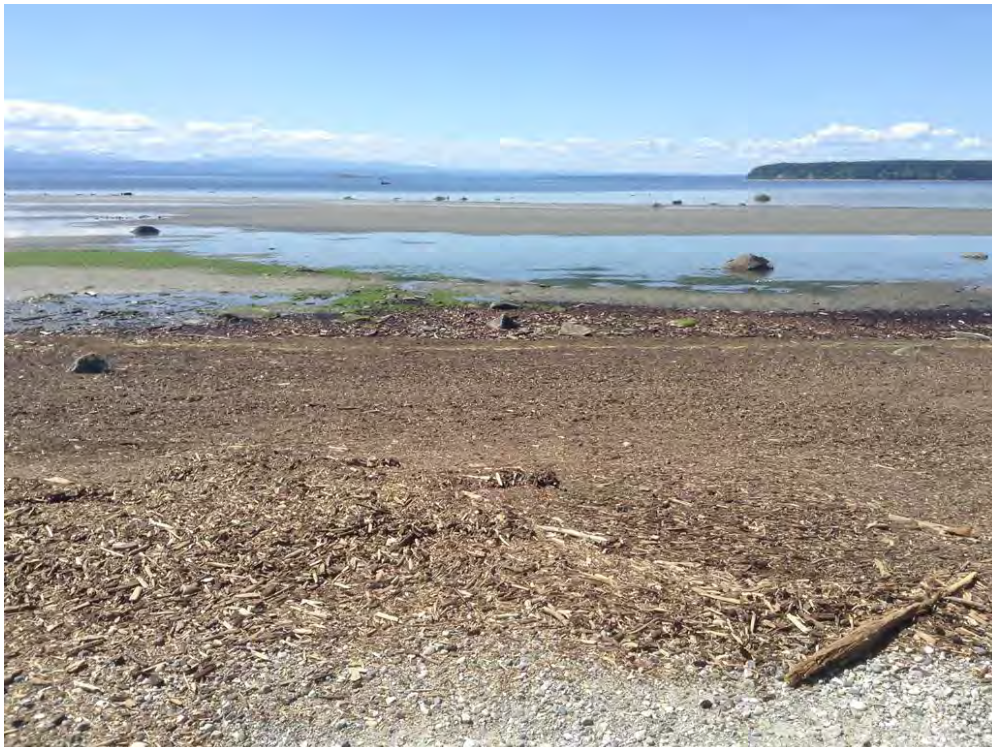
Photo: 38

Corner of sunset trail and Johnson's Lane, and location proposed as an alternative barge ramp site by some Savary Island residents. Note that shallow depths exist between Savary Island and Hernando Island and are not conducive to a barge ramp facility. ( Date Taken: May-12-16 2:05:36 PM, Latitude: 49°56'43.88", Longitude: -124°51'50.97" )

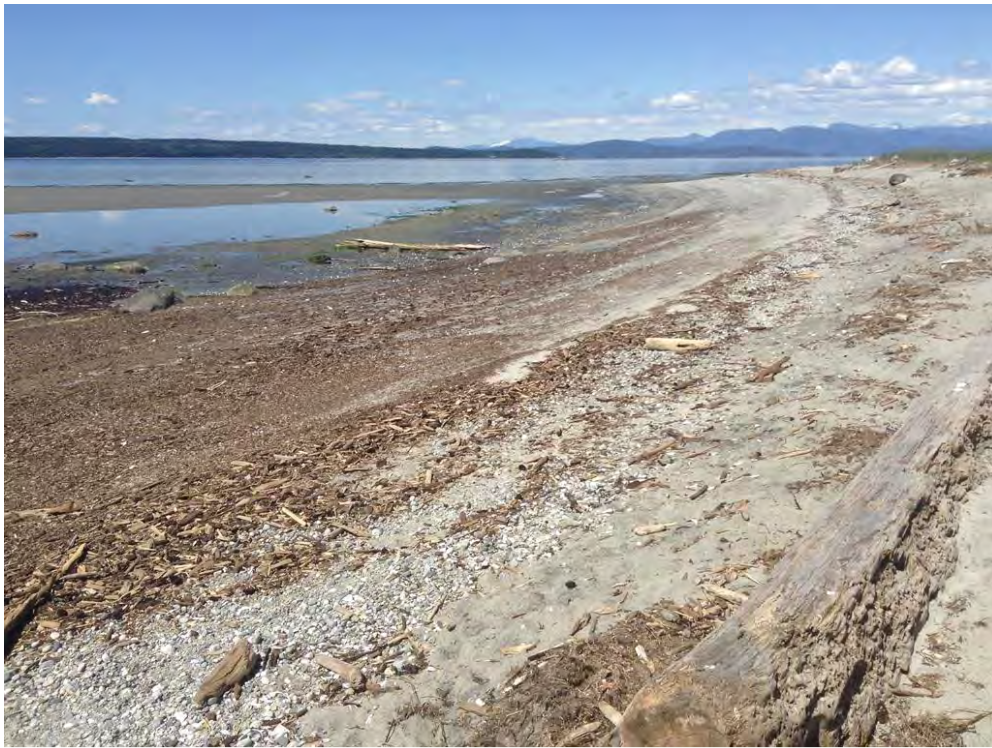
Photo: 39

Corner of sunset trail and Johnson's Lane, and location proposed as an alternative barge ramp site by some Savary Island residents. Note that shallow depths exist between Savary Island and Hernando Island and are not conducive to a barge ramp facility. ( Date Taken: May-12-16 2:06:47 PM, Latitude: 49°56'43.84", Longitude: -124°51'51.06" )
