July 12, 2016

**Subject: Intertidal Assessment for an Existing Barge Ramp  
Savary Island, B.C.**

Project: Savary Island Government Wharf and Barge Ramp

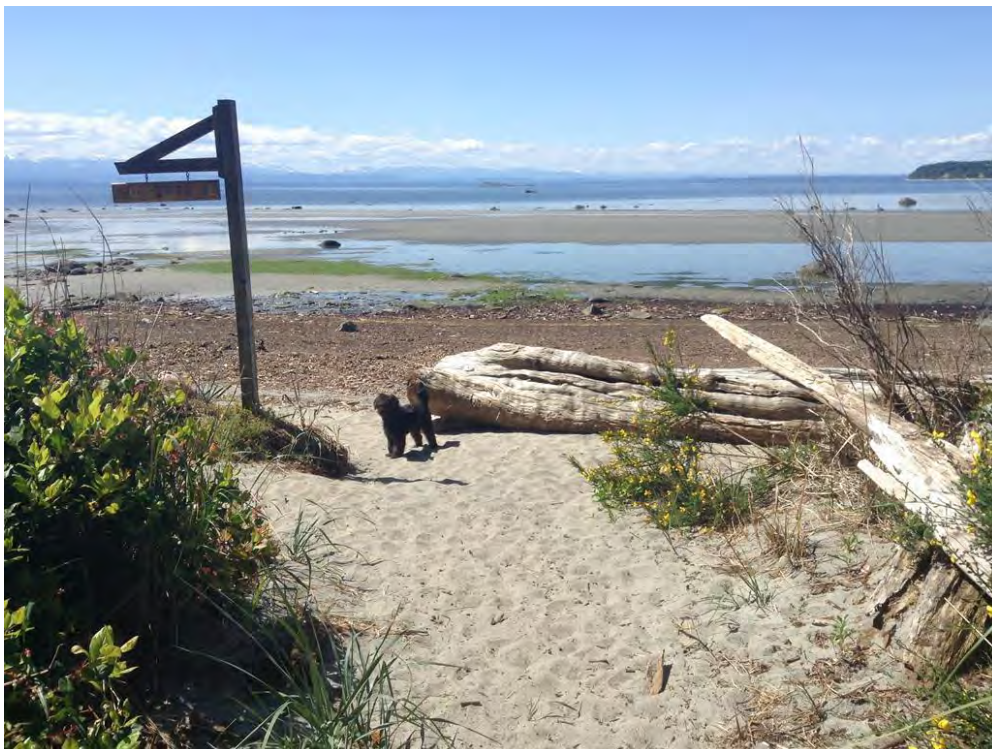
Photo: 40

Corner of sunset trail and Johnson's Lane, and location proposed as an alternative barge ramp site by some Savary Island residents. Note that shallow depths exist between Savary Island and Hernando Island and are not conducive to a barge ramp facility. ( Date Taken: May-12-16 2:07:11 PM, Latitude: 49°56'43.93", Longitude: -124°51'50.38" )
