**INSPECTION OF PILES AND
SUPERSTRUCTURE IN THE VAN ANDA DOCK
TEXADA ISLAND, BRITISH COLUMBIA**

JULY 27, 2017

FTI PROJECT NUMBER: P-3883

VAN ANDA DOCK & FLOAT INSPECTION SUMMARY REPORT

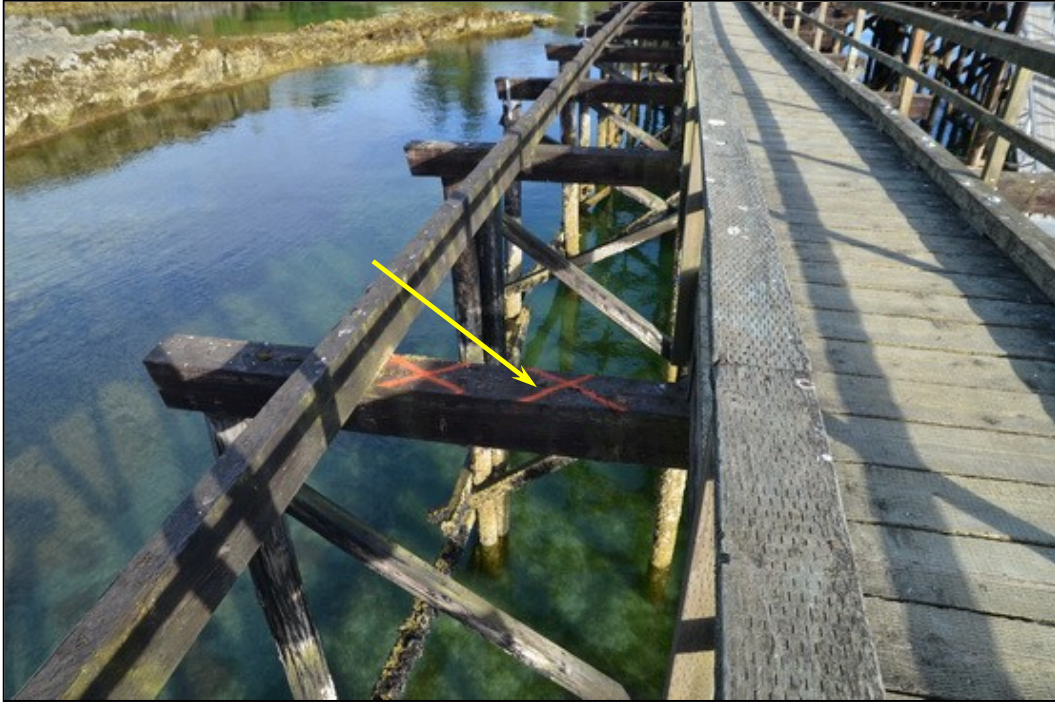
Caps: All caps were visually inspected, selectively hammer sounded and cored when suspected to have internal decay. The caps are generally in good condition with light weathering and checking. The caps in Bent 11 and Bent 16 have heavy fungal damage with the damage in Bent 11 located adjacent to the walkway and the damage in Bent 16 extending over the length of the cap; see Photographs 9 and 10. See Table 2 List of Damaged Sub-structure Timbers.

PHOTOGRAPH 9. Cap located at Bent 11 in the approach has heavy fungal damage from Row A (left) to Row B (middle).

MAINTENANCE /REPAIR WORK	Timing Estimations
APPROACH:	
Replace Caps (Bents 11 & 16)	2 – 5 Years
Replace Piles (Bent 5 – C, Bent 9 – A & B, Bent 10 – B)	2 – 5 Years
Multiple Piles. Plug and patch open bolt holes	2 – 5 Years
Replace Cross-braces (Bents 5, 12 & 15)	2 – 4 Years
Replace/Repair Walers (Row A (1), Row C (4))	2 – 4 Years
Replace brace spacer blocks (Bents 14 & 16)	2 – 4 Years
Tighten bolts securing handrail post (Bent 5.2 – Row B)	2 – 5 Years
WHARFHEAD:	
Tighten bolts securing curb along Bent 19	2 – 5 Years
Tighten bolts securing handrail posts along Bent 24	2 – 5 Years
Replace section of deck at top of gangway	1 – 2 Years
Replace Bearing Piles (Bent 20 – G, Bent 22 – E & Bent 24 – H)	2 – 5 Years
Replace Brace Pile (Bent 29 – H Br (S))	2 – 5 Years
Replace four Cross-braces (Bents 20, 22 & 24)	2 – 5 Years
Replace three brace spacer blocks (Bent 20)	2 – 5 Years
Replace Fender Piles (Bent 19 – H Fr 4, Bent 20 – H Fr 1, Bent 23 – H Fr 1 & 2, & Bent 24 – H Fr 3)	2 – 5 Years

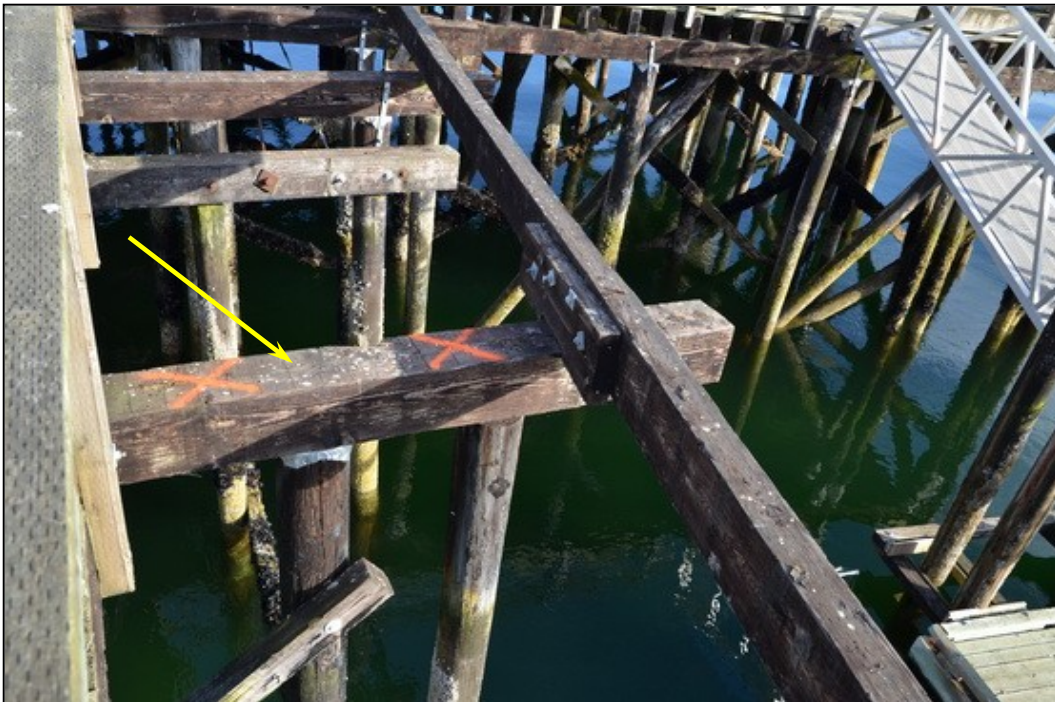
PHOTOGRAPH 10. Cap located at Bent 16 in the approach has heavy fungal damage from Row A to Row C (right).

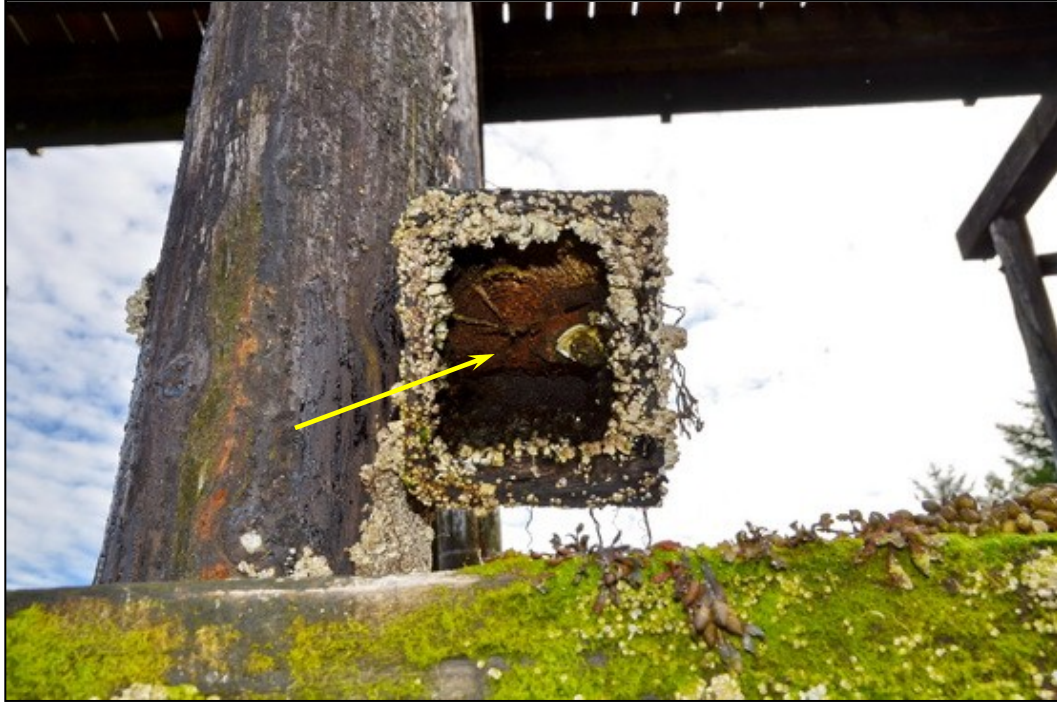
Cross-Bracing and Spacer Blocks: Creosote treated cross-bracing is present throughout the approach. Cross-bracing runs between the piles in each Bent. Three braces have significant marine borer damage at their lower ends (Bents 5, 12 and 15); see Photograph 11. Two spacer blocks (used to take up space between the cross-brace and the pile) have heavy marine borer damage in Bents 14 and 16; see Photograph 12. Light damage is present in five braces.

PHOTOGRAPH 11. Marine borer damage in the lower end of a cross-brace in the approach. Damage extends up to the attachment bolt.

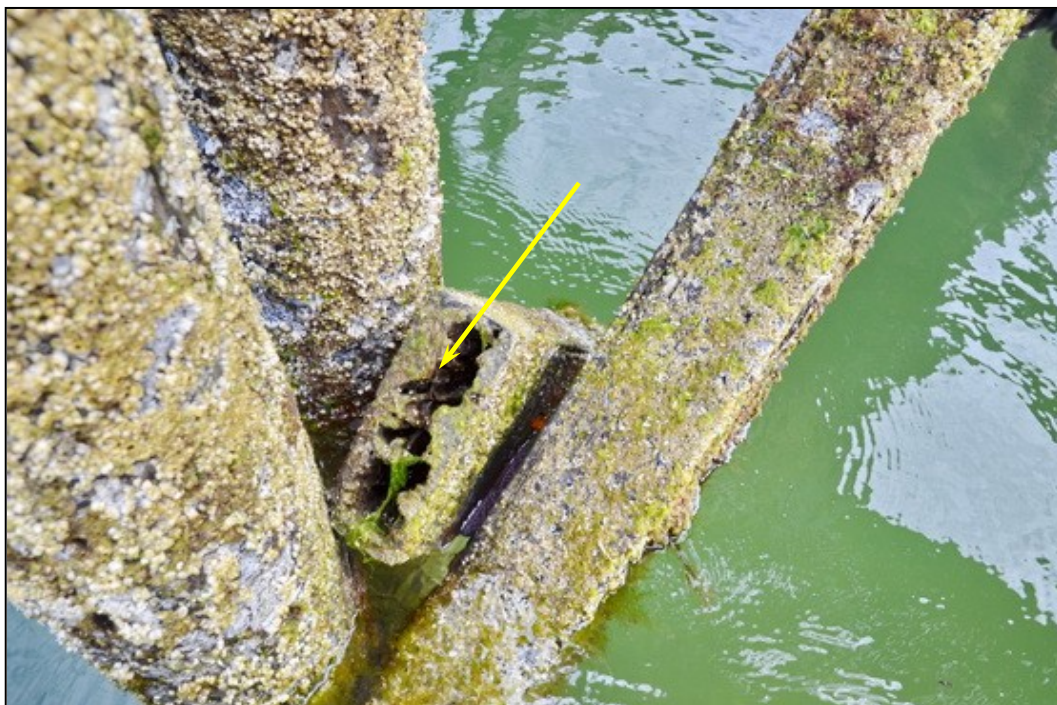
PHOTOGRAPH 12. Heavy marine borer damage to a spacer block between the cross-brace and the pile in the approach.

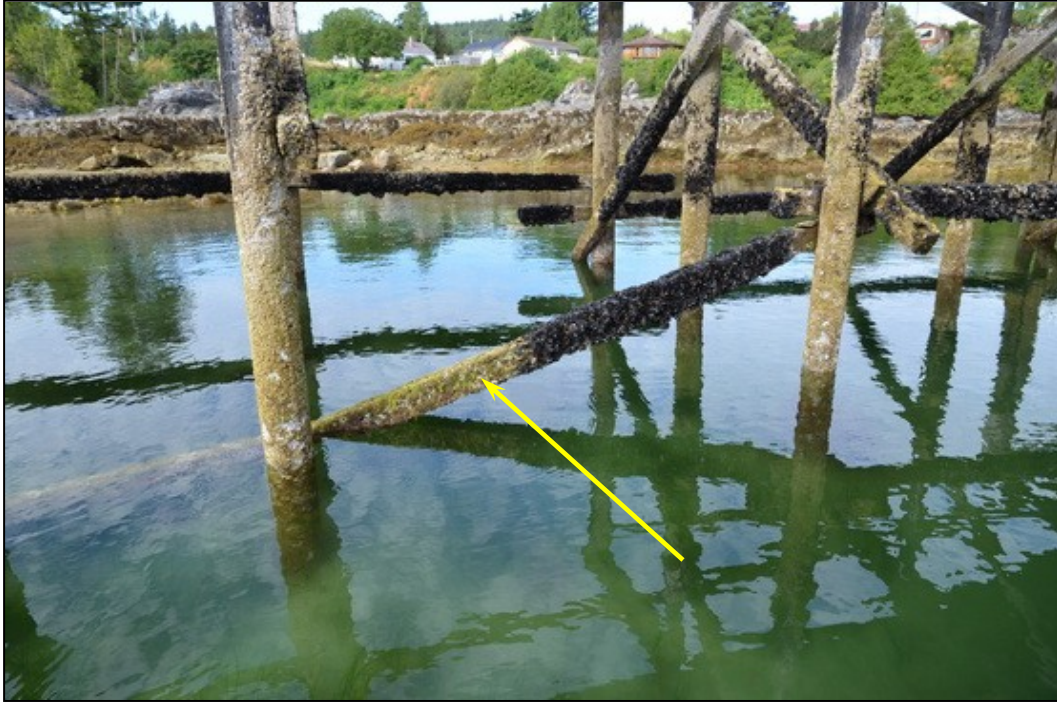
Walers: Creosote treated horizontal walers are present throughout the approach. Walers extend between piles in successive bents along the same pile row. Significant marine borer and mechanical damage was found in five walers mostly along Row C; see Photograph 13. One of these walers is not attached to its pile (Bent 16 to 17 at Bent 16 - Row A).

PHOTOGRAPH 13. Failed horizontal waler along Row C in the approach.

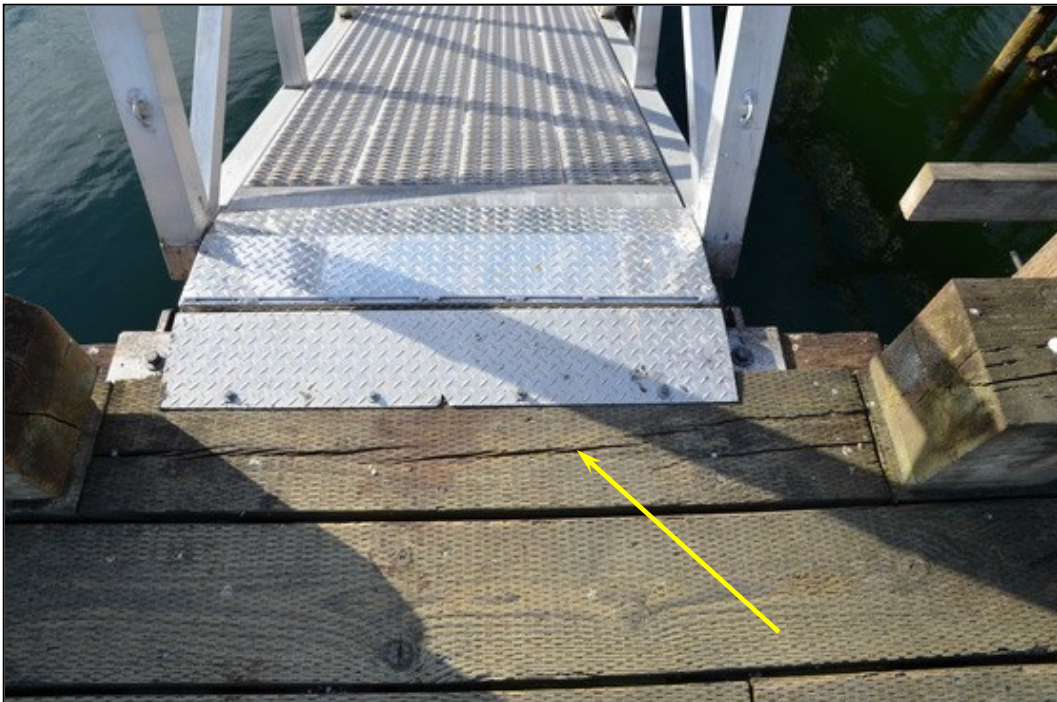
Decking: Decking was visually inspected. The decking is in good condition with light weathering and checking. One section of decking at the top of the gangway is badly split, see Photograph 14.

Upper Transition: The hinged aluminum tread plate is in good condition, one of the securing lag-bolts is loose; see Photograph 19. The deck timber that supports the upper transition plate is badly split; see Photograph 14.

PHOTOGRAPH 14. Deck at the top of the gangway is badly split and is recommended for replacement.

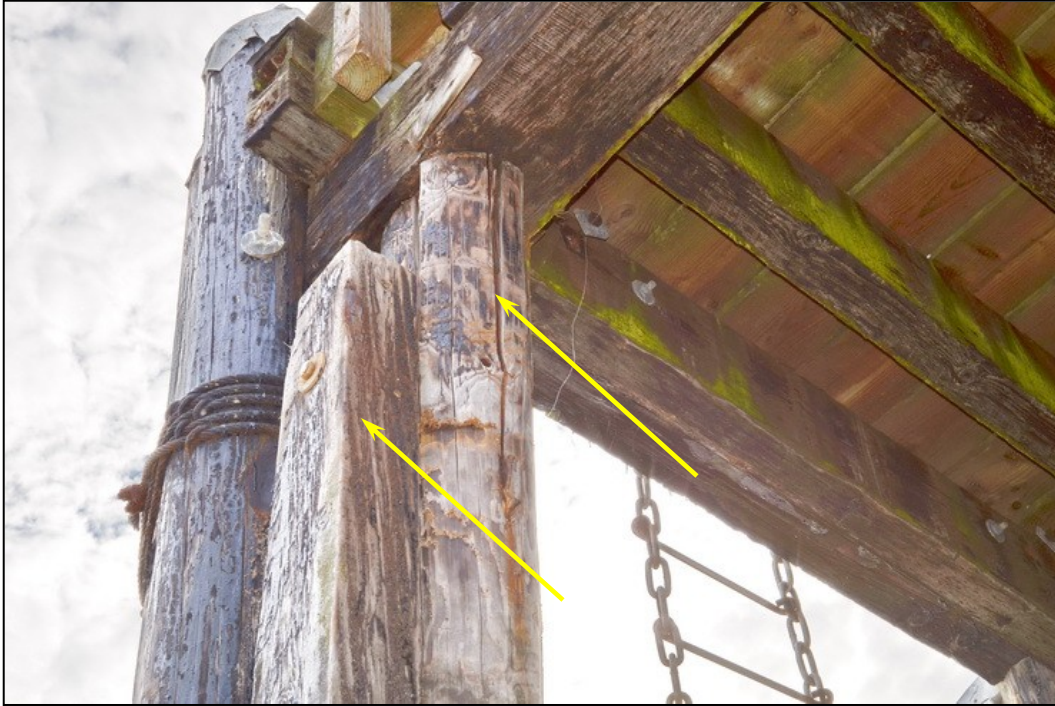
Bearing and Brace Piles: The creosote-treated bearing and brace piles were visually inspected both above and underwater, and probed where accessible; See Table 1 Approach, Wharfhead and Float Piles for detailed results. Four piles (three bearing and one brace) were found to have significant marine borer and mechanical damage; see Photograph 15.

PHOTOGRAPH 15. Mechanical impact damage to Pile 24 – H in the wharfhead. The pile is badly split, and the associated cross-brace has failed.

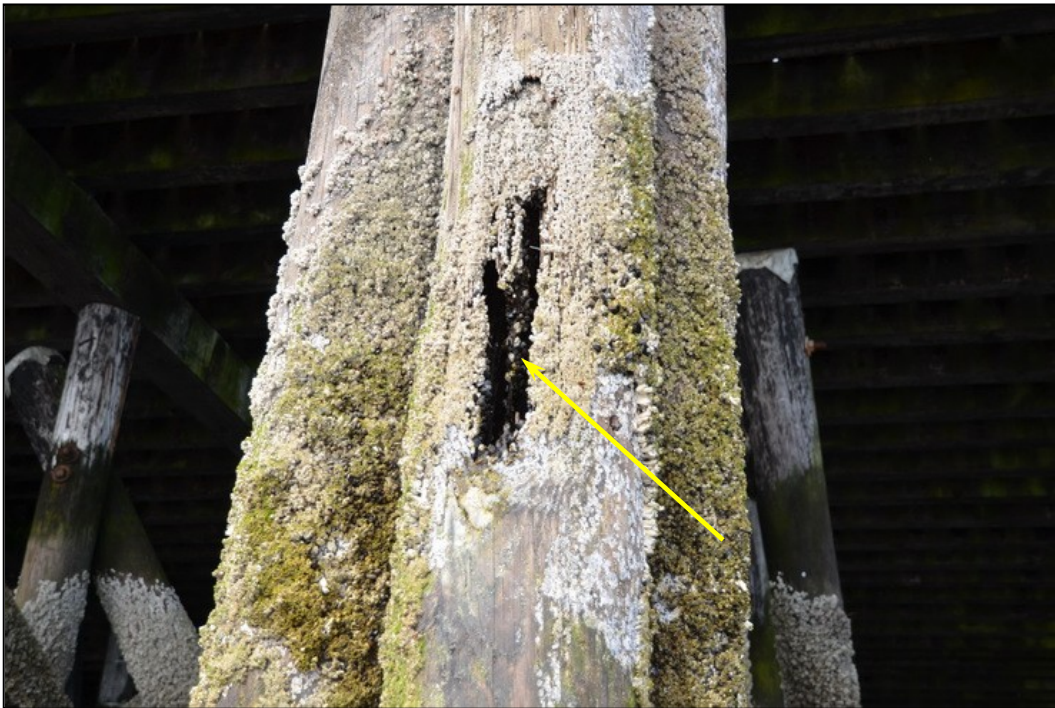
Fender Piles: The creosote-treated fender piles are located along the north side of the wharfhead. They are grouped in clusters of three piles except at the north end of Bent 19 which has five piles. Five of the fender piles have significant marine borer damage. This damage is generally located in the intertidal zone and has occurred as a result of abrasion damage to the pile surface combined with marine borer attack; see Photograph 16.

PHOTOGRAPH 16. Heavy marine borer damage to one of the fender piles along the north side of the wharfhead.

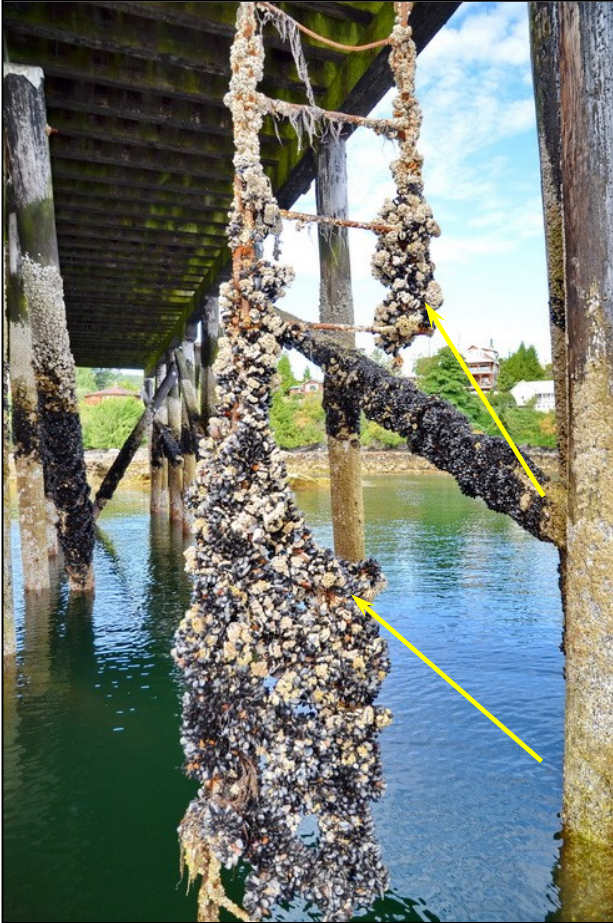
PHOTOGRAPH 17.

Ladder: There is one ladder on the north side of the wharfhead. It is in poor condition as one side has failed; see Photograph 17.

Failure of the only ladder between Bents 23 and 24 at Row G, that provides access to the wharfhead.

Replace Ladder	1 – 2 Years
Tighten Tie-off bollard bolts.	2 – 5 Years
GANGWAY:	
Lower Transfer Plate	Monitor
Gangway Sliders abrasion	Monitor
Install safety chains between handrail and top of gangway	1 – 2 Years
FLOAT & FLOAT ANCHOR PILES:	
Pile Cluster Well Liners. Install strips on piles & replace well liners as required	1 – 2 Years
Replace Float Anchor Pile (East Cluster – Pile 2 SW Pile)	2 – 5 Years
Tighten bull-rail bolts as required	1 – 2 Years
Replace northeast bull-rail	1 – 2 Years
UPLAND FORESHORE:	
Install armour rock to protect bank from further erosion	1 – 2 Years

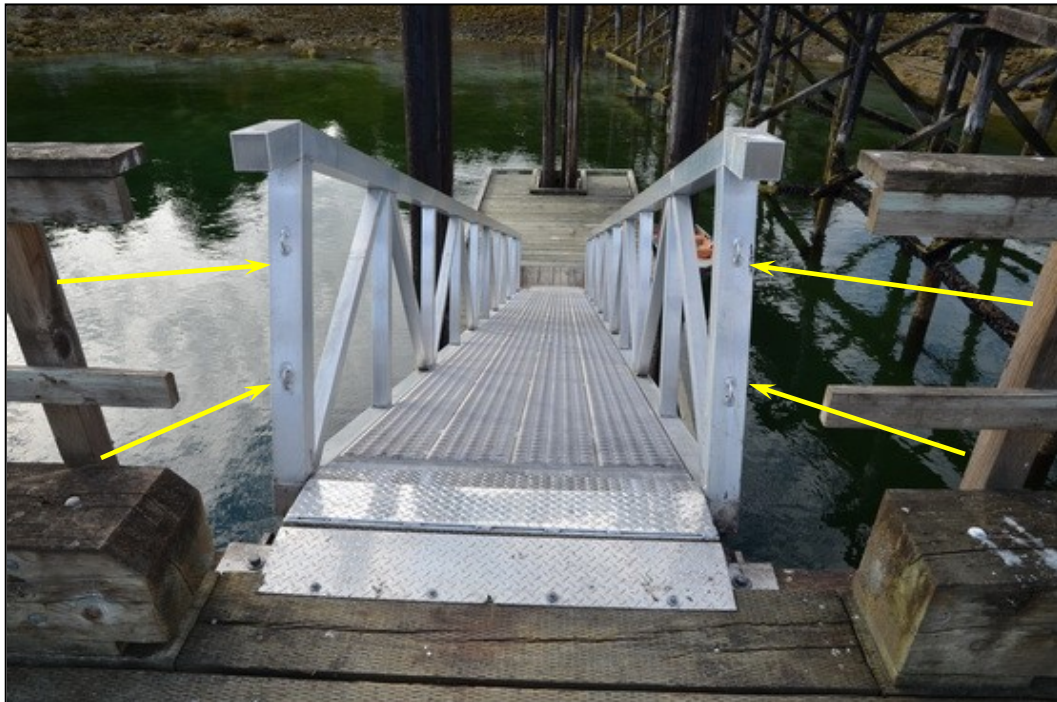
Body: The aluminum gangway is in good condition; see Photograph 7. There are no safety chains between the top of the gangway and the wharfhead railing leaving a gap; see Photograph 18.

PHOTOGRAPH 18. Eyes are present on the gangway to secure safety chains to the posts around the wharfhead. Chains are missing.

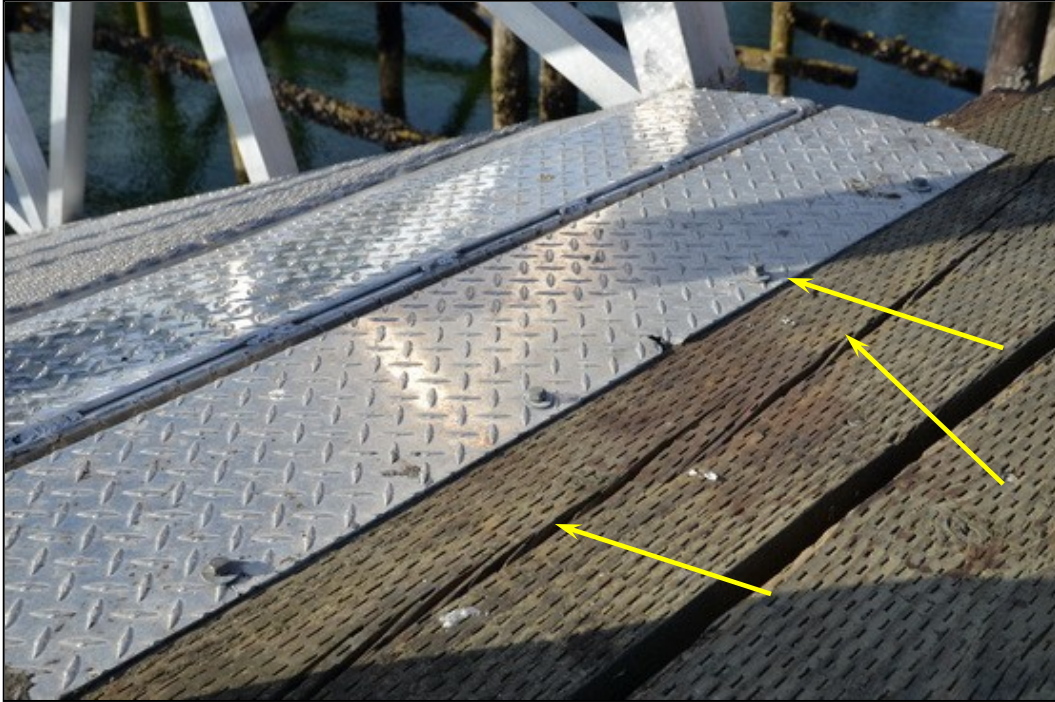
PHOTOGRAPH 19. Bolts securing part of the upper transition plate are loose. Mounting timber is also split.

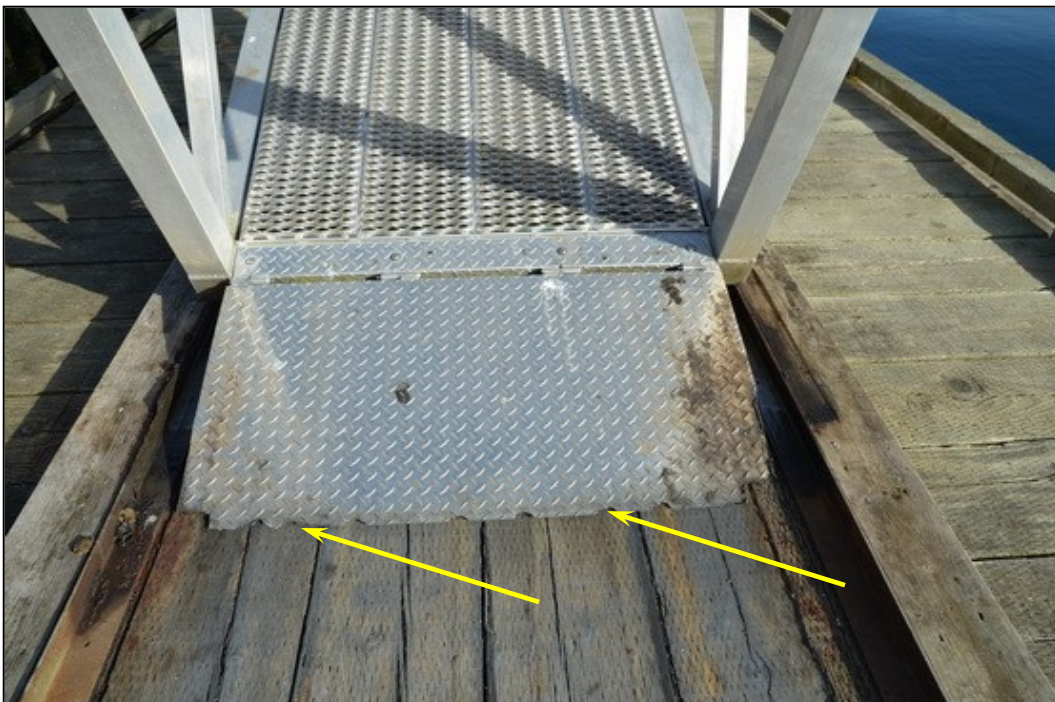
Lower Transition: The lower transition is in fair to good condition. The leading edge abrades with the gangway pad and the nails that secure the gangway pad timbers; see Photograph 20. The lower transition remains functional.

PHOTOGRAPH 20. The lower edge of the lower transfer plate abrades with the pad that supports the sliders and ramp guides. It remains functional.

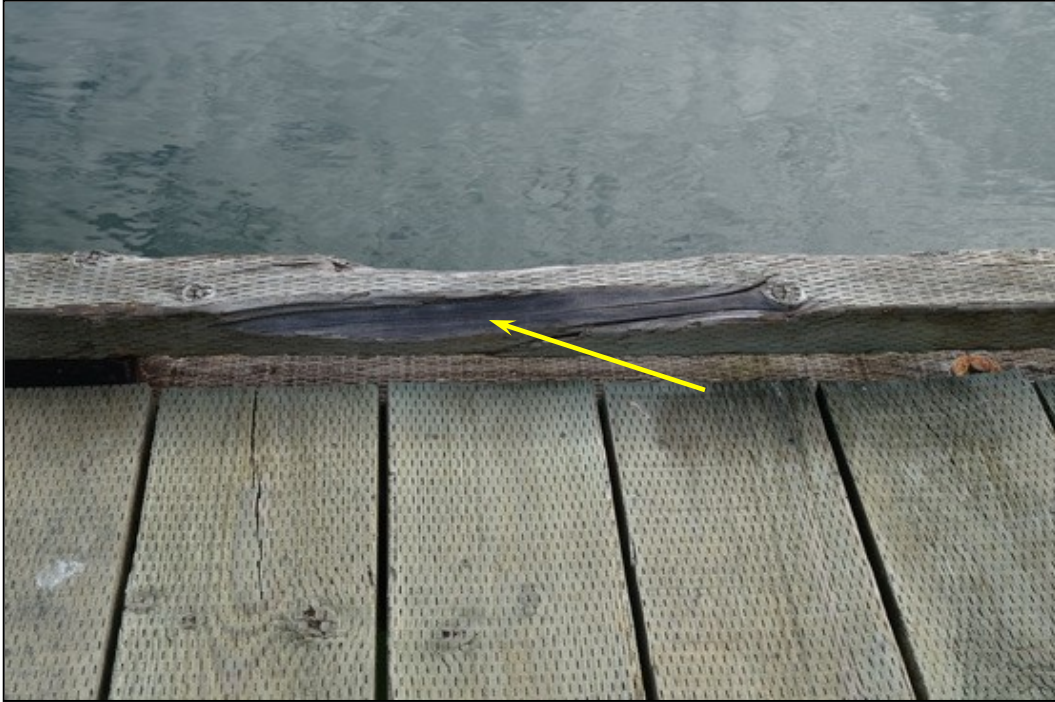
Bull-Rails and Risers: Bull-rails were visually inspected. Rails are located on all four sides of the float. The north rail has moderate mechanical damage with up to 40% cross-section loss; see Photograph 21. A bull-rail securing bolt is loose at the southwest corner of the float, allowing for some play in the rail. The risers are in good condition with light weathering and abrasion.

PHOTOGRAPH 21. Mechanical damage to the rail along the north side of the float. The rail is recommended for replacement.

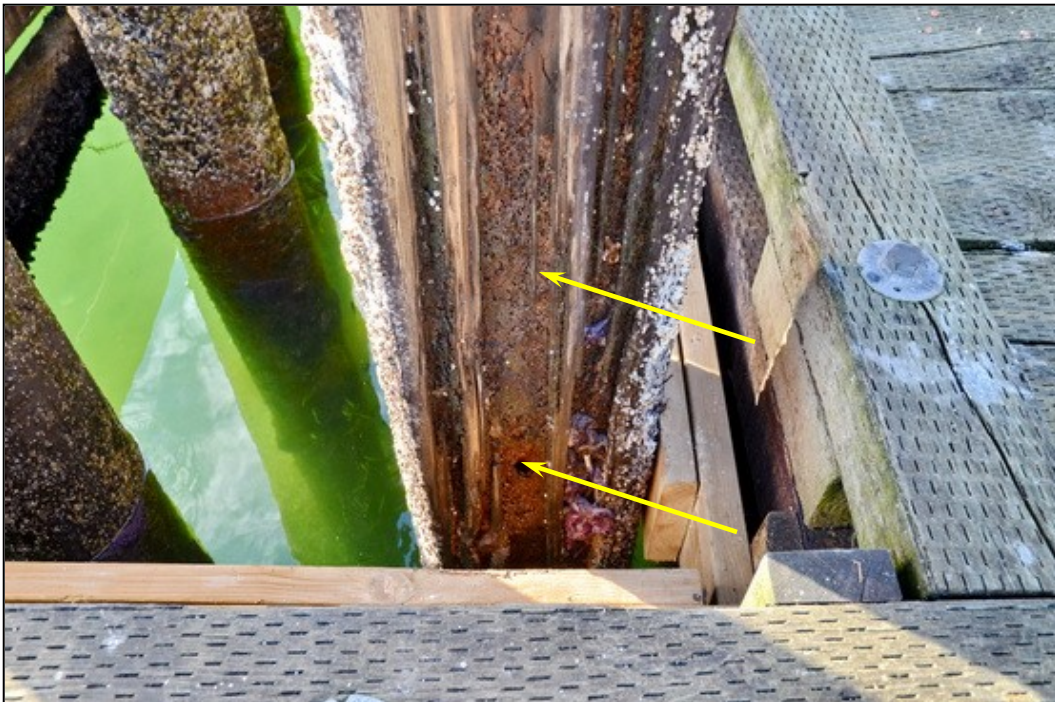
Abrasion damage has taken place to seven of the 10 piles. Generally this has resulted in a cross-section loss of 10% or less to the piles. One pile (East Cluster SW corner) has more significant damage with marine borers creating additional internal damage to the pile; see Photograph 22.

PHOTOGRAPH 22. Float anchor pile (East Cluster SW corner) has a combination of abrasion and marine borer damage. This pile will likely require replacement within the next 3 to 5 years

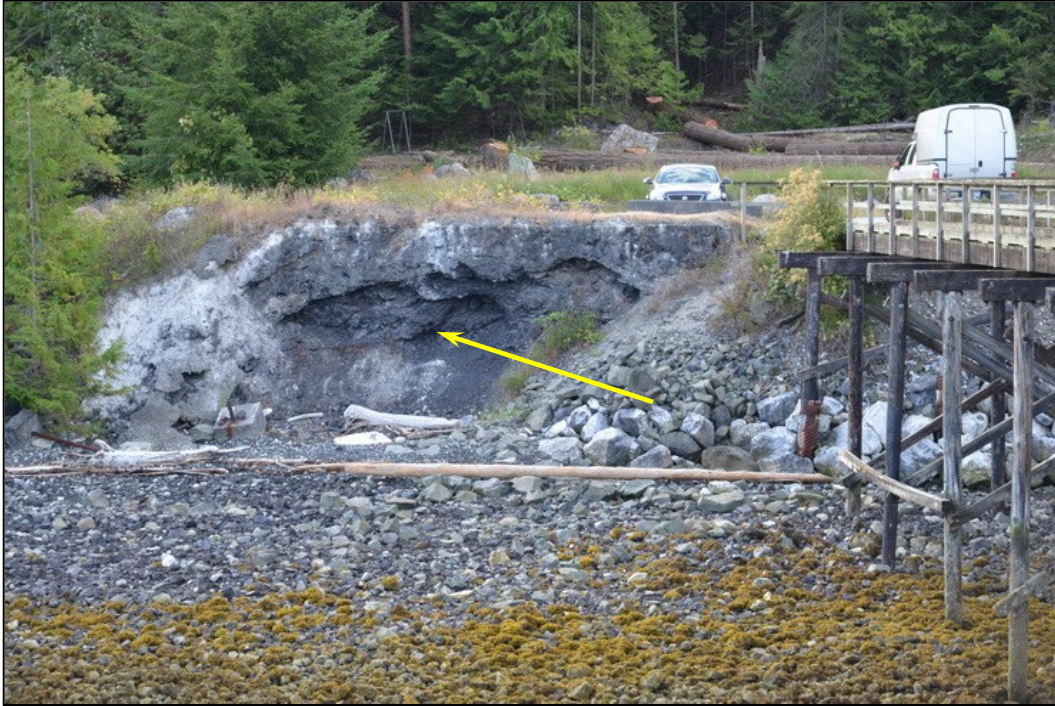
PHOTOGRAPH 23. Erosion of the bank along the north side of the approach creates the potential for a slope failure.

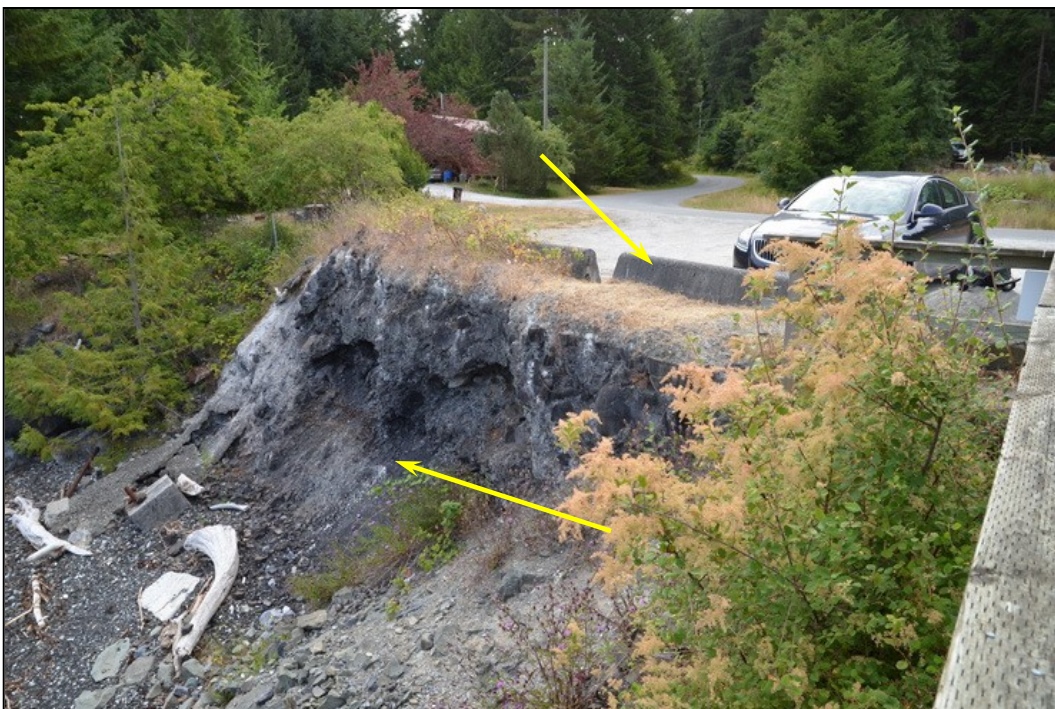
PHOTOGRAPH 24. Erosion of the bank along the north side of the approach creates the potential for a slope failure. Concrete barriers are located along the top of the slope. The area should be armoured with rip-rap to prevent further erosion.
