Ministry of  
Transportation  
and Infrastructure

# Texada Island Drainage Study

Final Report

January 2024

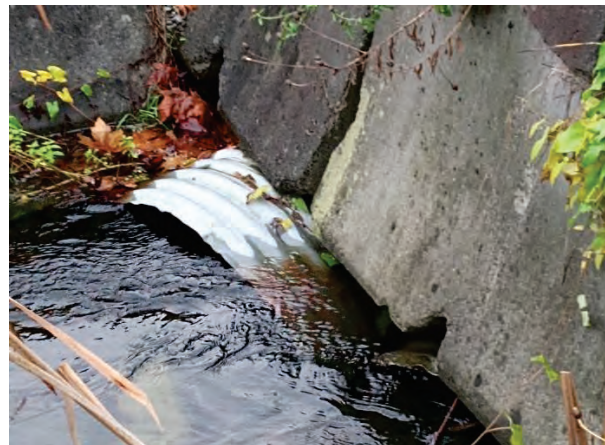
**PHOTO 2: AREA 1- FULL FLOW (VID, NOVEMBER 2023)**

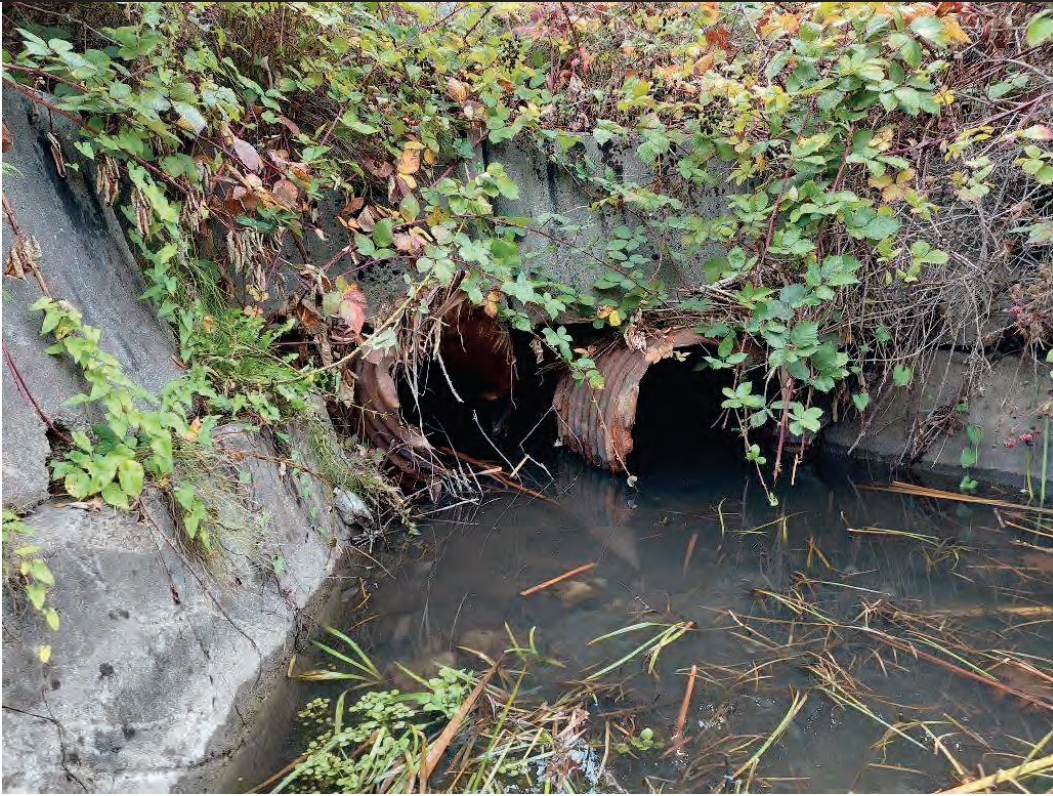
- Twin 900 mm CSP culvert (CHRIS: 2257630 & 2257631, “Culvert 2”) with improvised headwalls and wingwalls at the inlet and outlet from concrete roadside barriers (CRBs).
- Both culvert pipes appeared to be heavily corroded with damaged inlets.
- The lack of a proper headwall led to scour at the inlet between both pipes with the potential for piping.
- The CRBs were placed directly on top of the unprotected pipes creating an uneven load.
- Sediment and vegetation at the outlet blocked about 25% of the overgrown downstream channel.
- Tension cracks are visible on the pavement above along both sides of the culvert crossing indicating settlement and potential piping.
- The culvert pipes appeared to be overall in poor condition and are recommended to be replaced.
- The culvert crossing is signed as fish-bearing.

Culvert Inlet: Inlet damaged and corroded, CRB headwall & wingwalls

2	<b>Culvert Replacement - Van Anda Creek @ Van Anda Avenue</b> (Priority Area 1)	2257630, 2257631	<ul style="list-style-type: none"> <li>Existing twin 900 mm CSP culvert pipes are in poor condition and undersized for the design storm requiring a replacement.</li> <li>The critical condition of the culvert is highlighted, as a previous maintenance attempt had to be halted, due to concerns that the culvert could potentially fail during the works.</li> <li>The replacement culvert was conceptually sized to be a 4,800 x 1,600 mm open-bottom arch culvert with fish gravels for fish passage. The replacement includes headwalls and wingwalls. <ul style="list-style-type: none"> <li>The replacement culvert requires a regrading and raise of the Van Anda Avenue crossing.</li> </ul> </li> </ul>
3	<b>Erosion Protection of Staaf Creek @ Bell Road</b> (Priority Area 6)	NA	<ul style="list-style-type: none"> <li>Install Class 100kg Riprap along the right bank of Staaf Creek next to Bell Road just upstream of the ex. culvert crossing (2254782) and regrade the creek embankment to 2:1 on a length of 50 metres.</li> </ul>

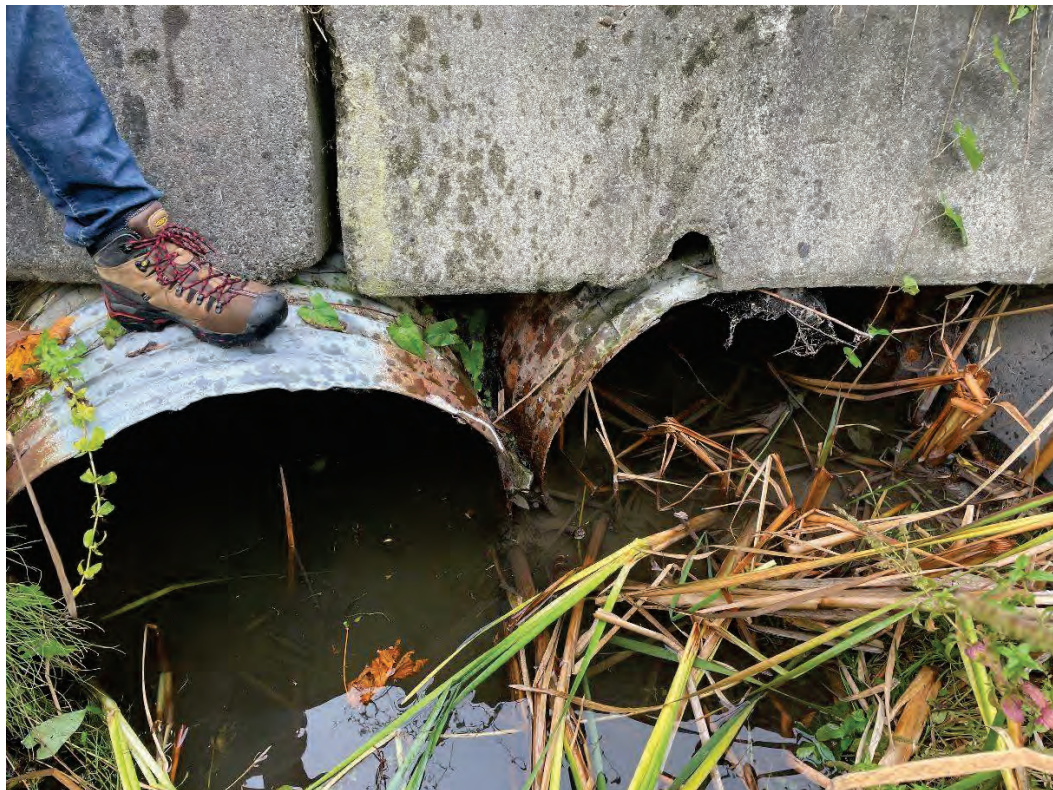
Culvert Outlet: Sediment Accumulation on right bank

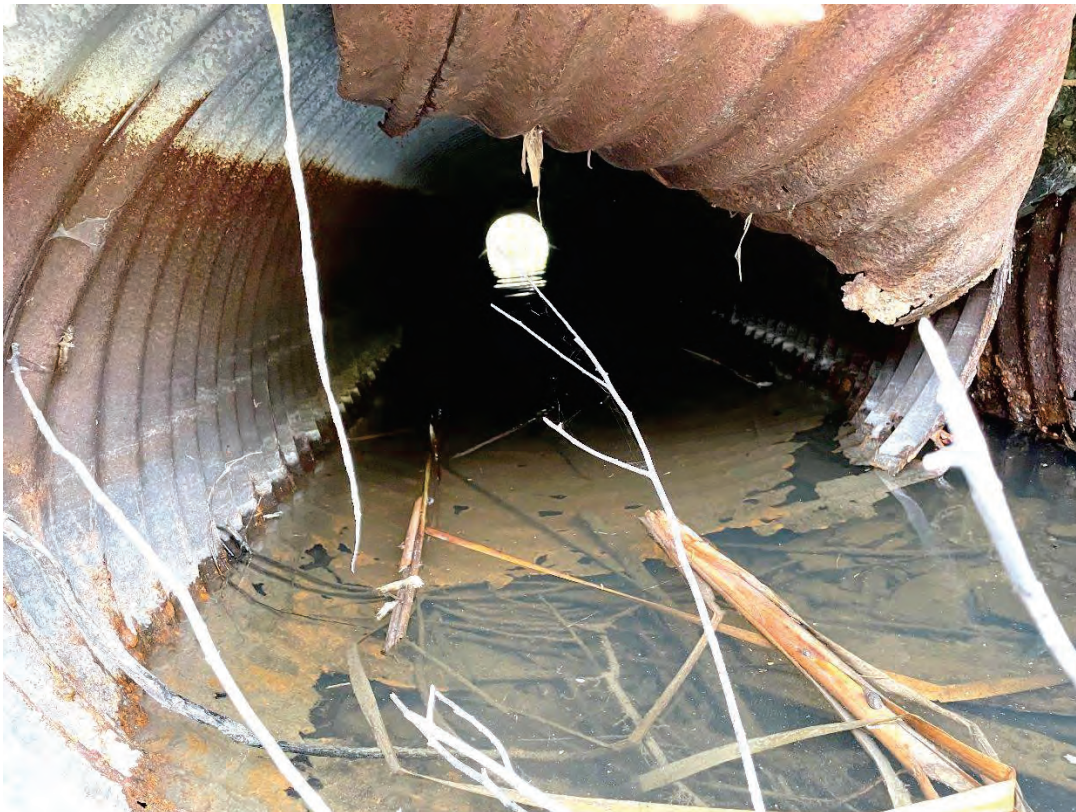
Pipe Interior (western pipe) facing DS: Visible damage of inlet and heavy corrosion of invert

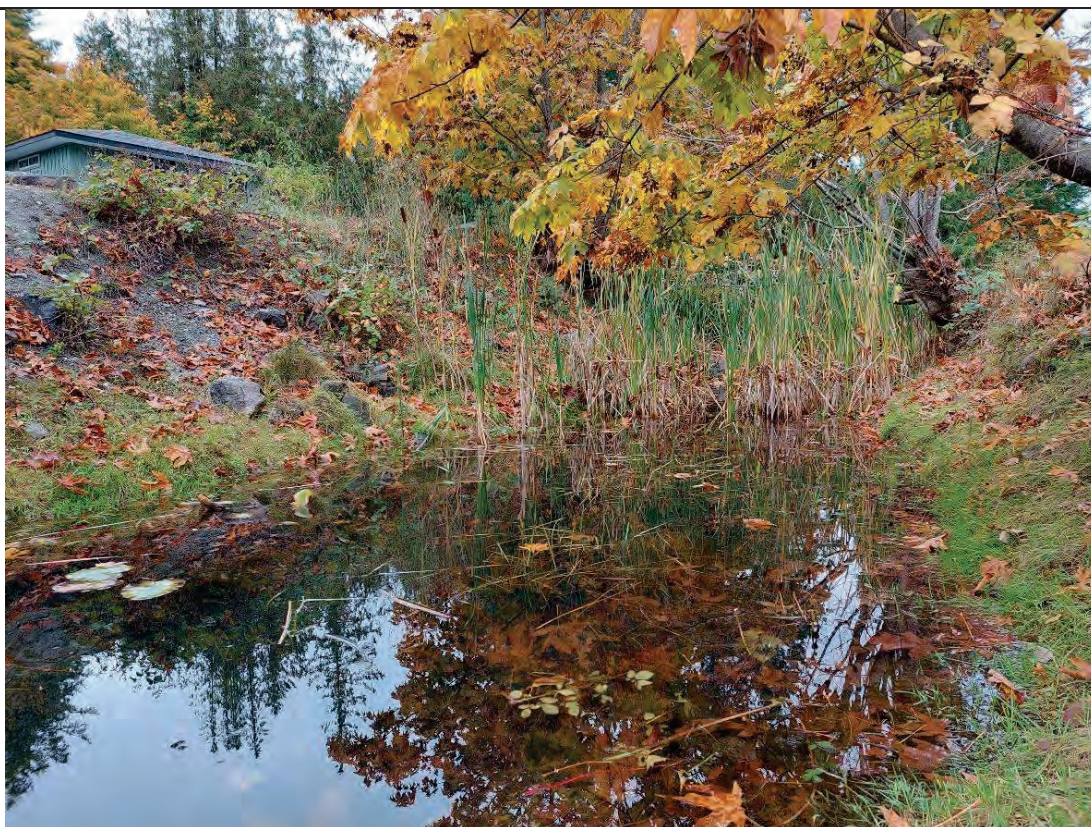
Upstream Channel facing US: Bank erosion visible on the left side

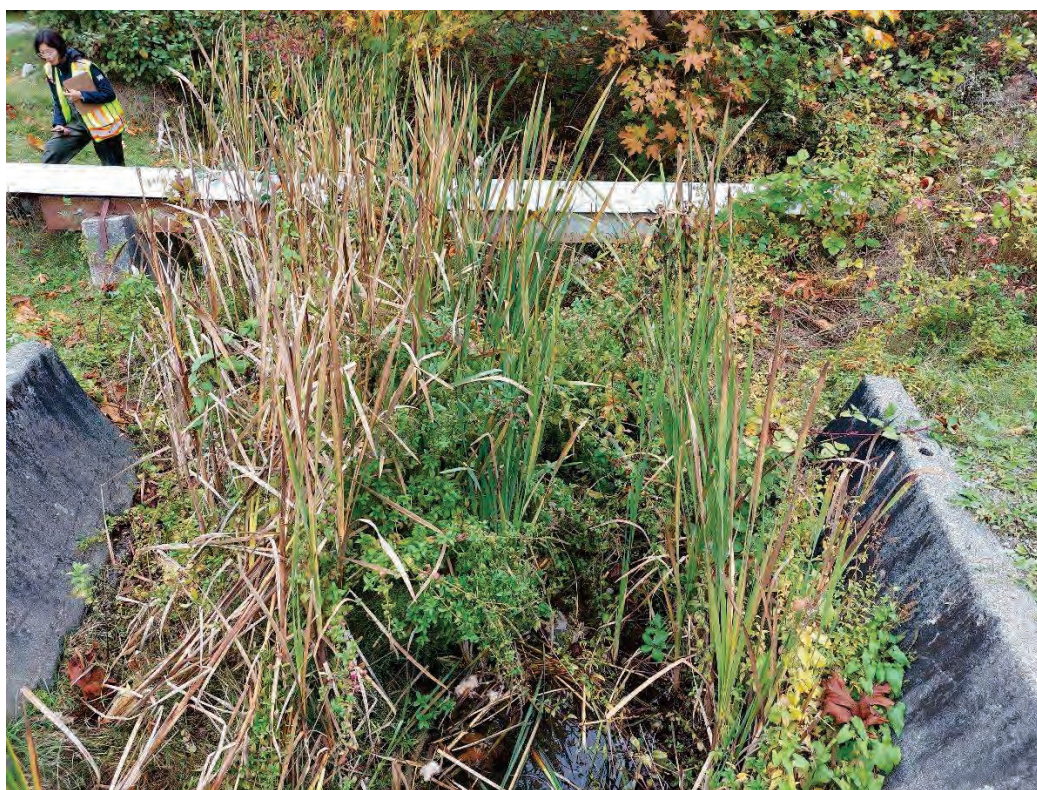
Downstream Channel facing DS: Sediment accumulation and vegetation visible & CRB wingwalls

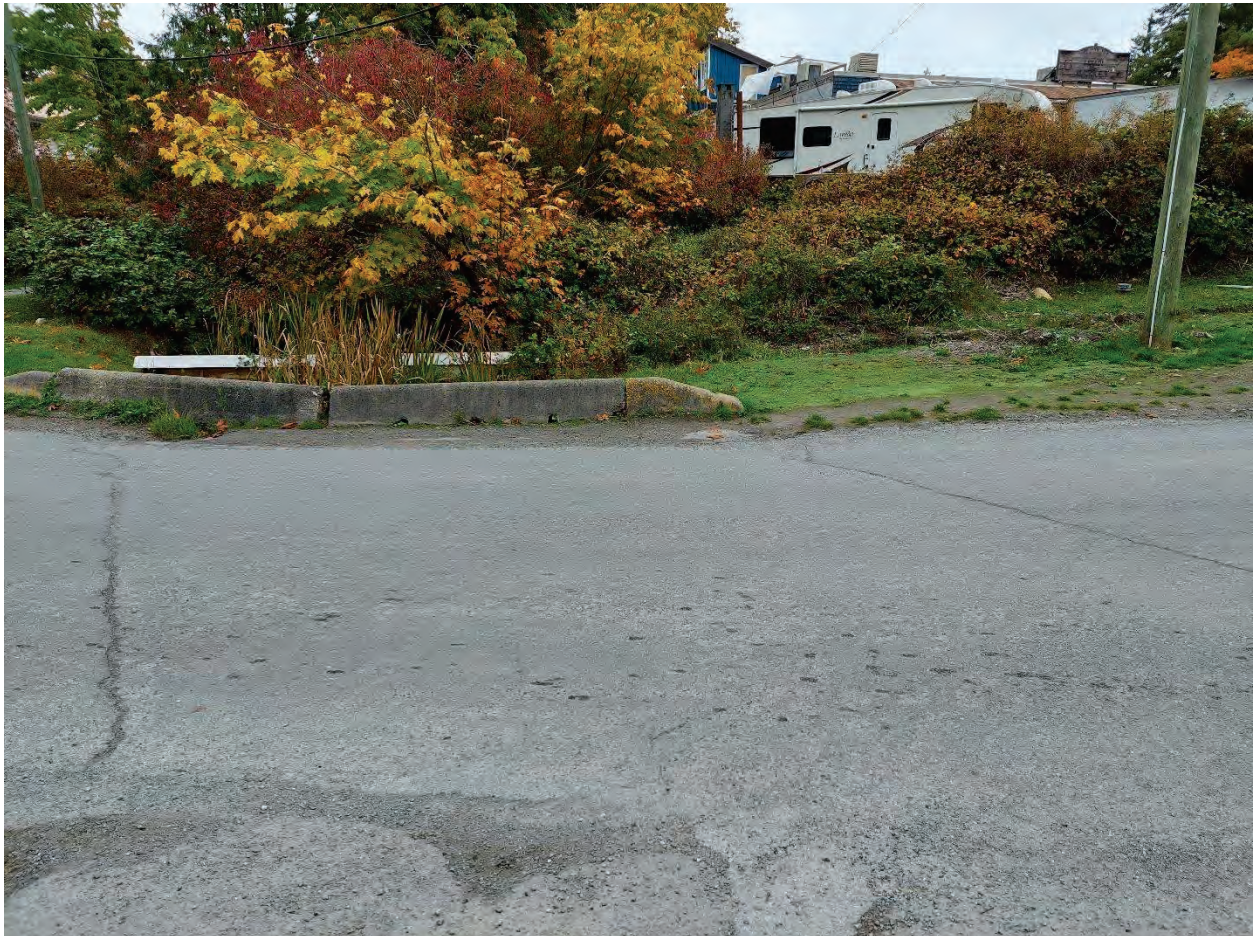
Pavement Surface: Tension cracks visible on the left and the right from the culvert crossing

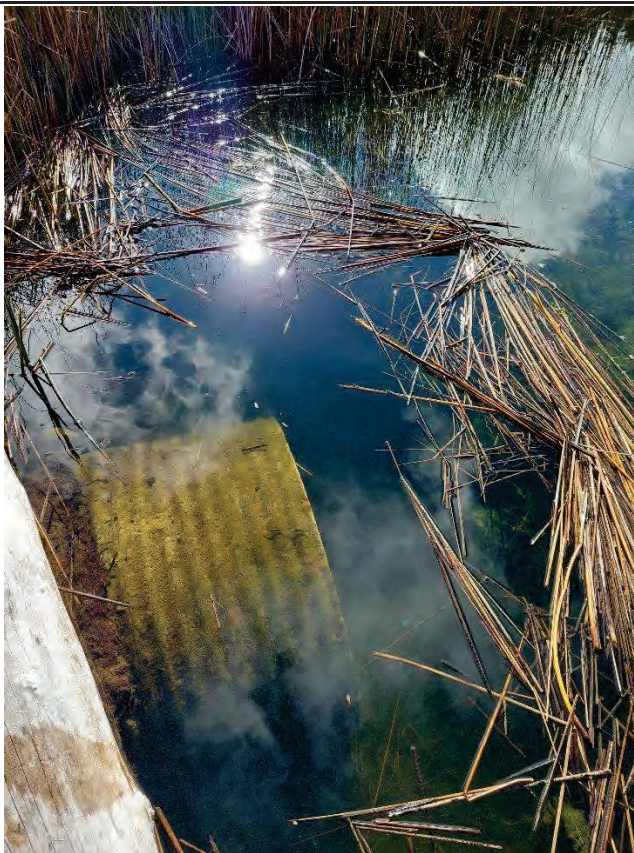
Culvert Inlet: Inlet fully submerged, log and reeds debris present above pipe

#	RECOMMENDATION	CHRIS ID	RECOMMENDATION NOTES
<b>SHORT-TERM RECOMMENDATIONS (within next 2 years)</b>			
1	<b>Maintenance, Inspection &amp; Blockage Removal at Priest Lake</b> (Priority Area 3)	344936	<ul style="list-style-type: none"> <li>Existing 1,200 mm CSP culvert is likely blocked and has no relief structure with risk of overflowing and flooding of Gillies Bay Road.</li> <li>Based on observations from site assessment and Van Anda Improvement District comments that the downstream water level is lower than the upstream water level without apparent flow indicating a potential blockage of the culvert.</li> <li>Similar to previous maintenance, a specialized maintenance crew will be required as the culvert will likely be submerged due to the high downstream water level from the Priest Lake weir downstream of the pond.</li> <li>Note that Priest Lake is an active water reservoir, and the downstream pond is a sensitive habitat.</li> </ul>

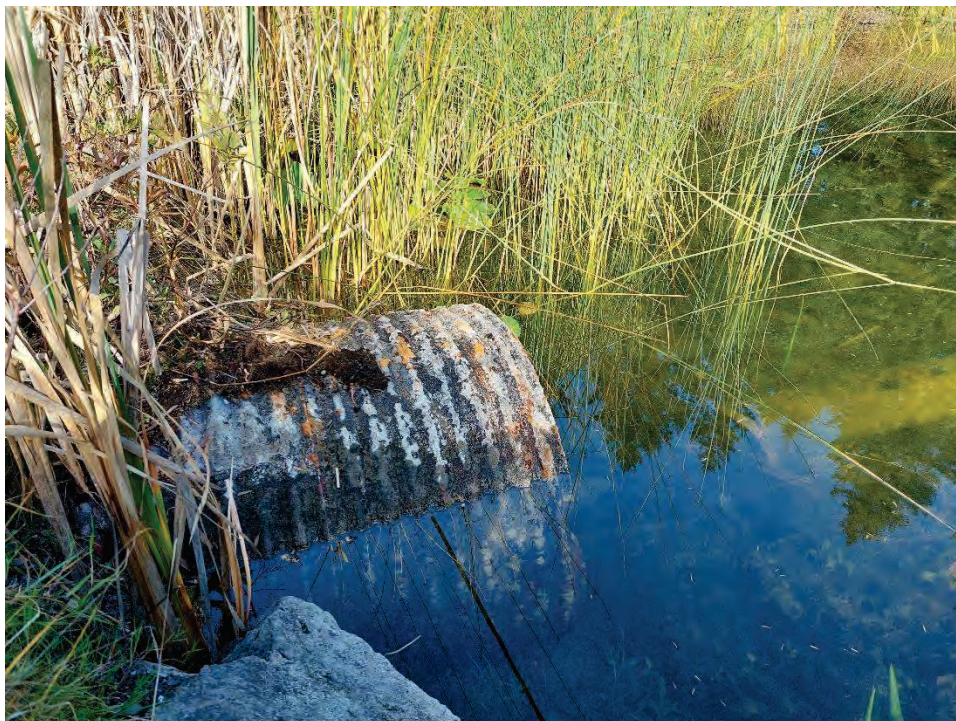
- The visible portion of the culvert outlet appeared to be corroded with damaged coating. The overall culvert condition was not assessed due to the limited inspection.
- The downstream water level appeared to be steady and high, indicating that the culvert does not operate under free flow condition but with backwater from the downstream.

Culvert Outlet: Outlet about 75% submerged and visibly corroded on the outside

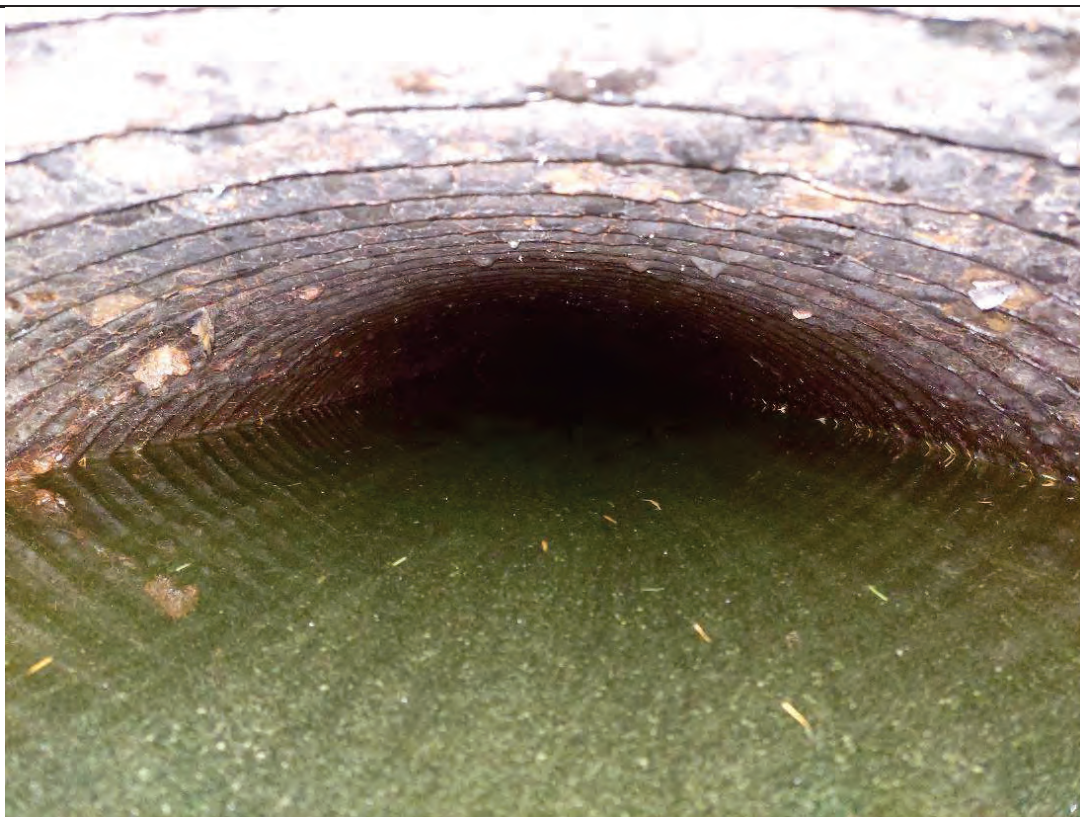
Pipe Interior facing US: Pipe lining visibly damaged with corrosion visible

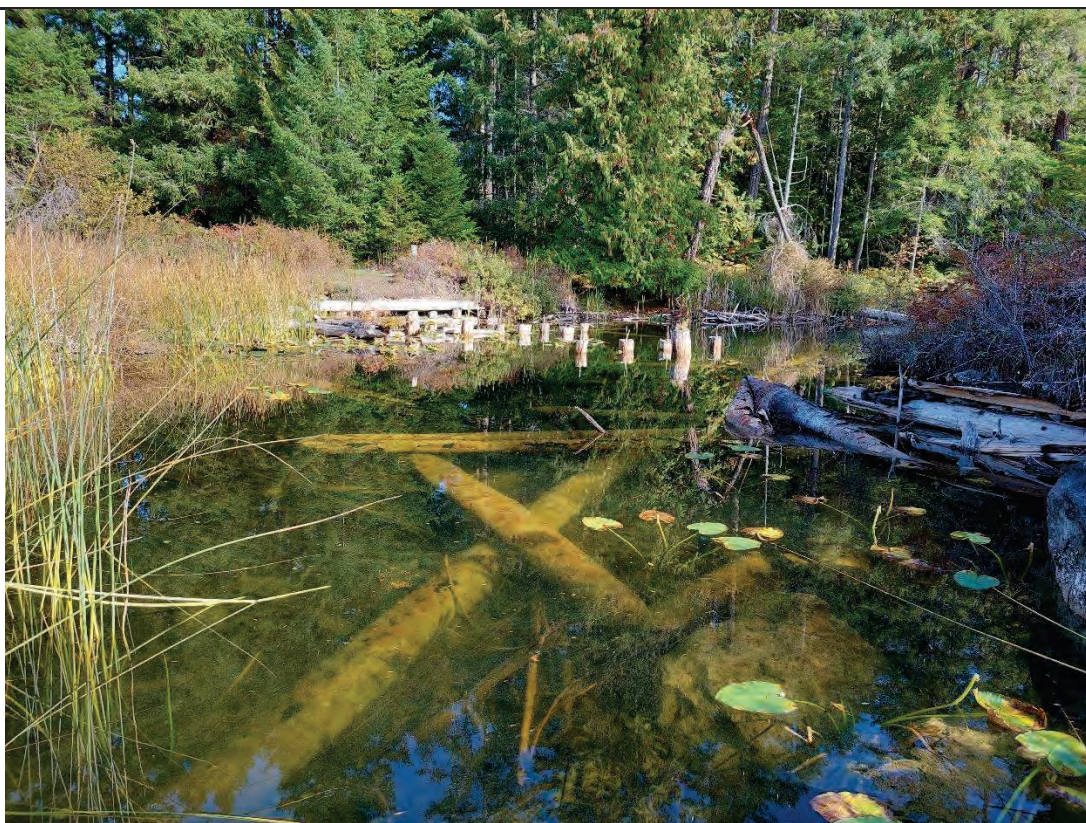
Downstream Channel facing DS: Woody debris and old CSP pipe visible, sensitive habitat for painted turtle

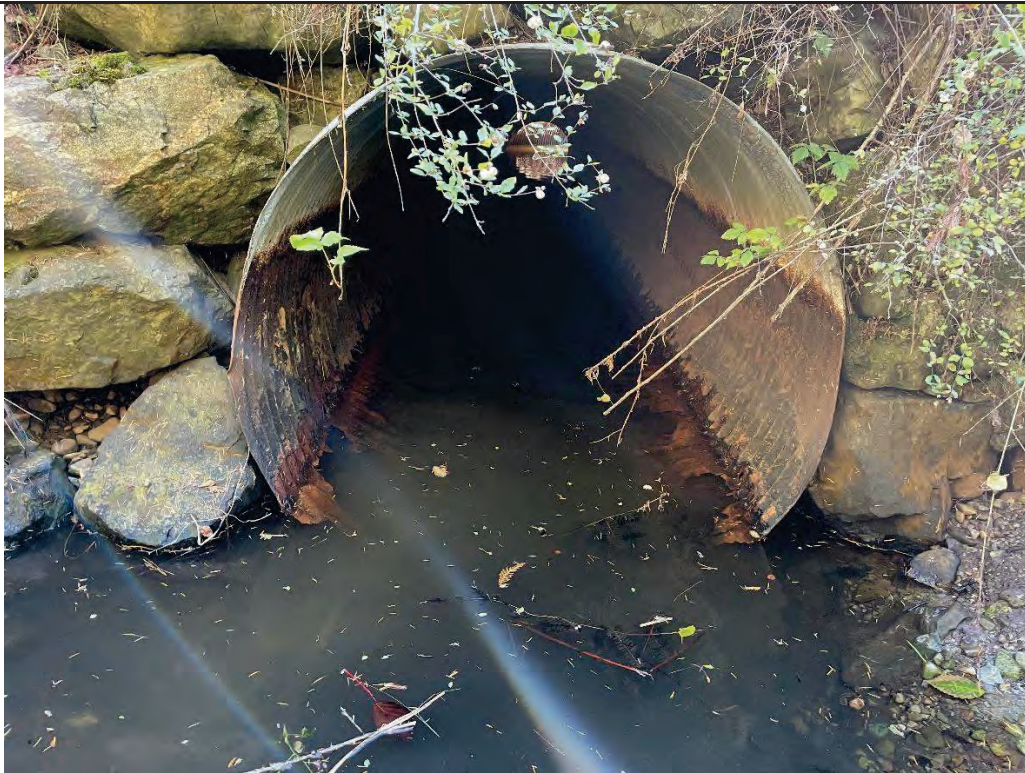
- The culvert invert was visibly corroded with localized significant material loss.
- The culvert appeared to be overall in poor condition and is recommended to be replaced.
- The culvert outlet is next to the confluence of Trout Creek coming from the east and close to the estuary of Cranby Creek.

Culvert Inlet: Heavily corrosion at pipe invert with large section of missing material

<b>MEDIUM-TERM RECOMMENDATIONS (within next 5 years)</b>			
4	<b>Culvert Replacement - Cranby Creek @ Gillies Bay Road</b> (Priority Area 2)	2256032	<ul style="list-style-type: none"> <li>Existing 1,500/1,200 mm CSP culvert is in poor condition and greatly undersized for its large catchment and flows.</li> <li>The replacement culvert was conceptually sized to be a 2,700 x 2,400 mm box culvert, embedded by 480 mm into fish gravel to improve fish-passage. The replacement includes headwalls and wingwalls. <ul style="list-style-type: none"> <li>An alternative culvert was conceptually sized to be a 3,400 x 1,800 mm open-arch culvert.</li> <li>The conceptual size considered a High-Water Level at the downstream of 1.65 m CGVD13, but future sea level rise should be considered during future design stages as well.</li> </ul> </li> </ul>
5	<b>Culvert Replacement - Priest Lake @ Gillies Bay Road</b> (Priority Area 3)	3442936	<ul style="list-style-type: none"> <li>Existing 1,200 mm CSP culvert is greatly undersized without a relief structure and has a history of blockages.</li> <li>The replacement culvert was conceptually sized to be twin 2,100 x 1,800 mm box culverts with wingwalls and headwalls reducing the likelihood of a blockage. <ul style="list-style-type: none"> <li>Priest Lake is an active water reservoir of the Van Anda Improvement District, the downstream pond is a sensitive habitat.</li> <li>A large diameter gas pipeline is located between Priest Lake Road and Gillies Bay Road and would need to be protected or relocated.</li> </ul> </li> </ul>

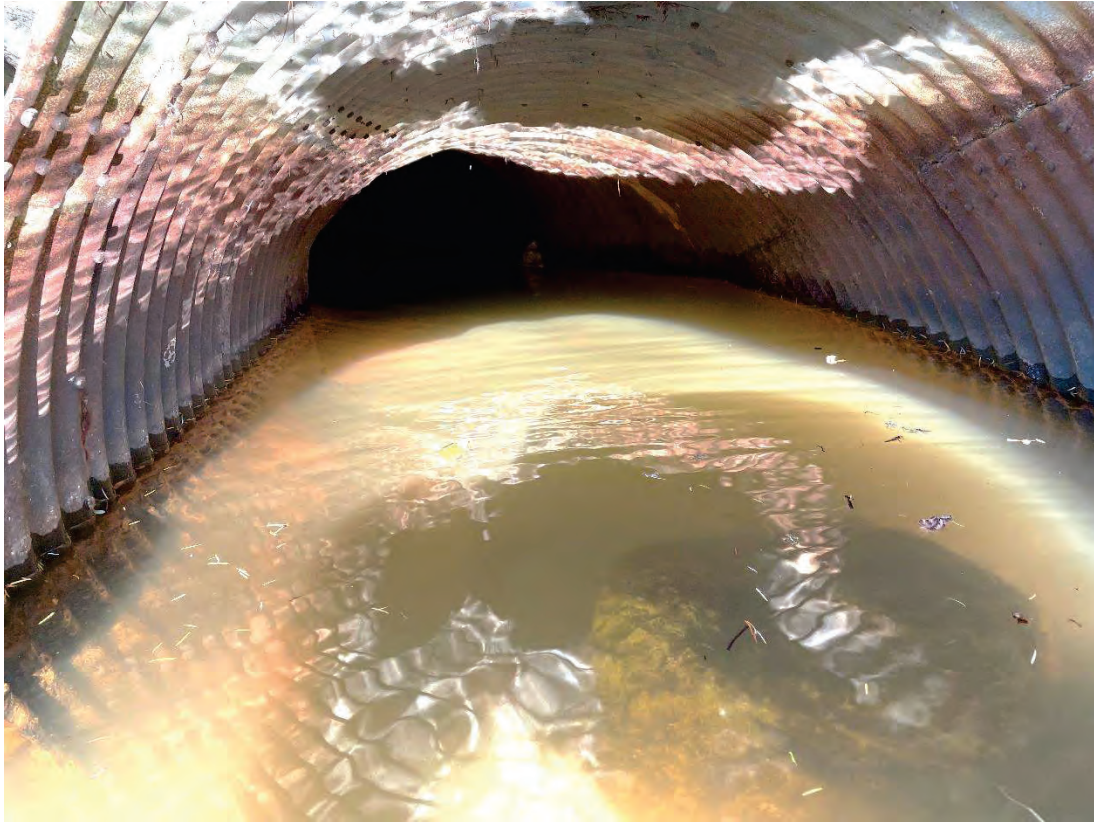
Culvert Interior facing US: Visible pipe joint separation with visible rock on the right side

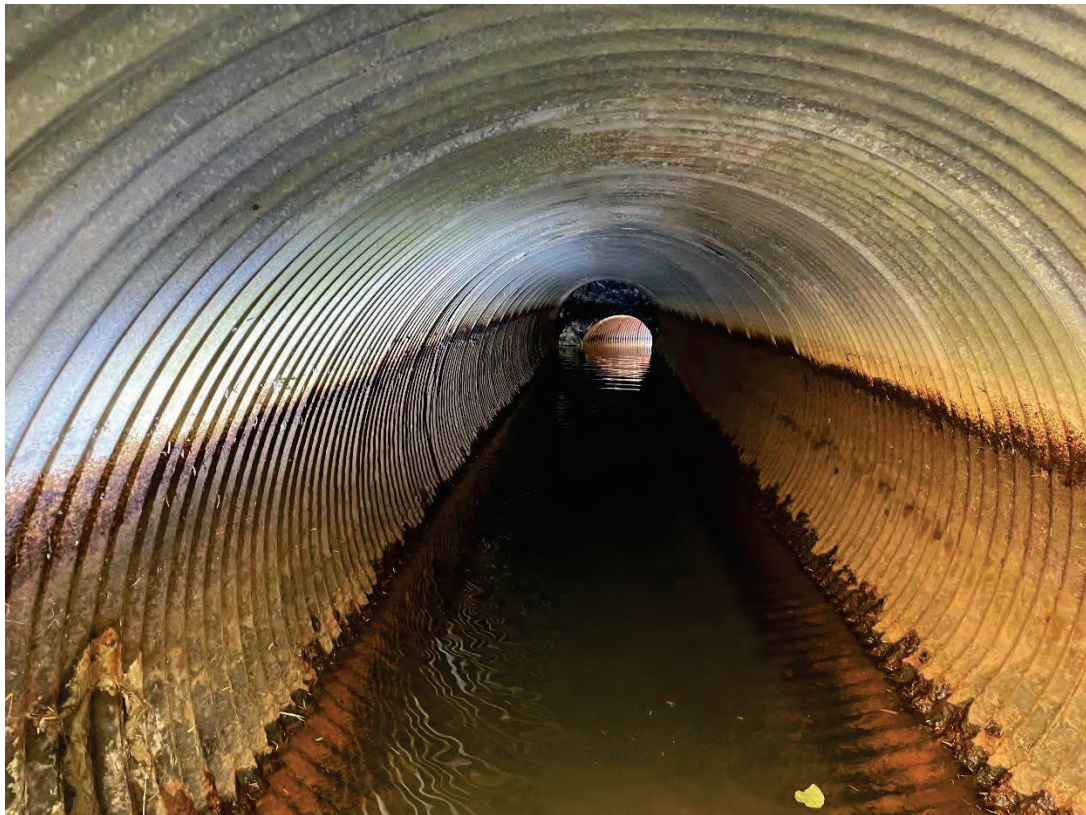
Pipe Interior facing DS: Pipe joint separation visible with skewed outlet pipe and visible rock

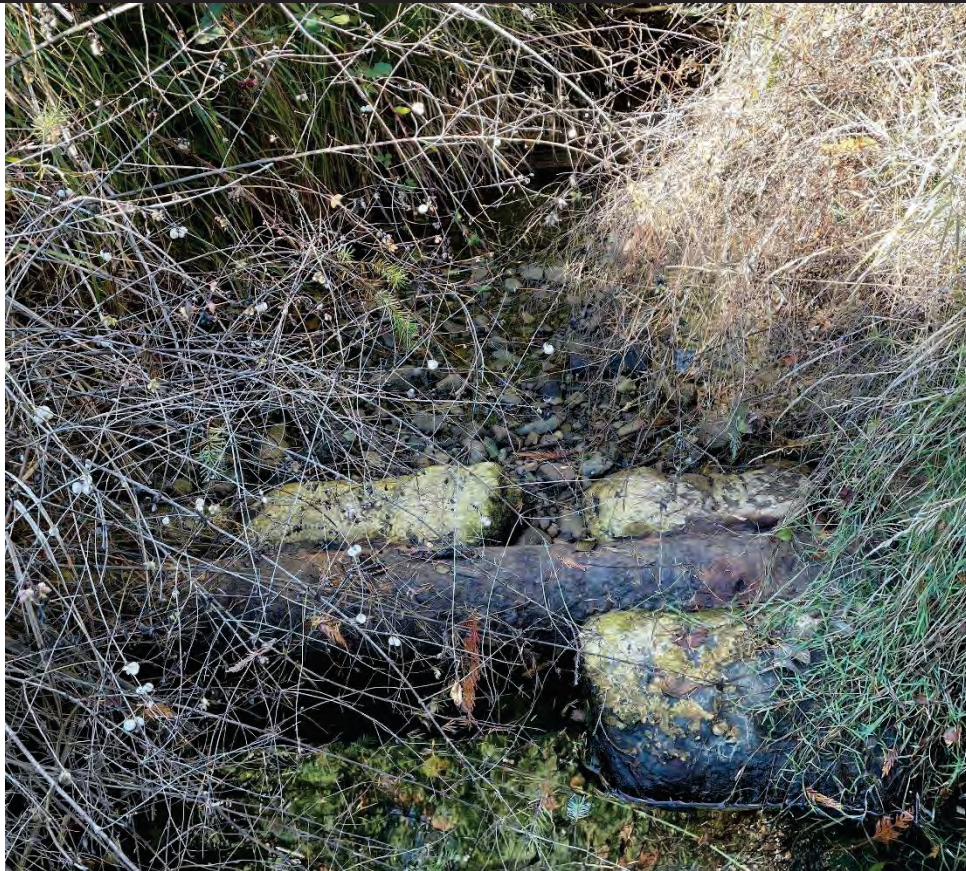
Upstream Channel facing US: DI utility service line visible in the upstream channel 3m from inlet

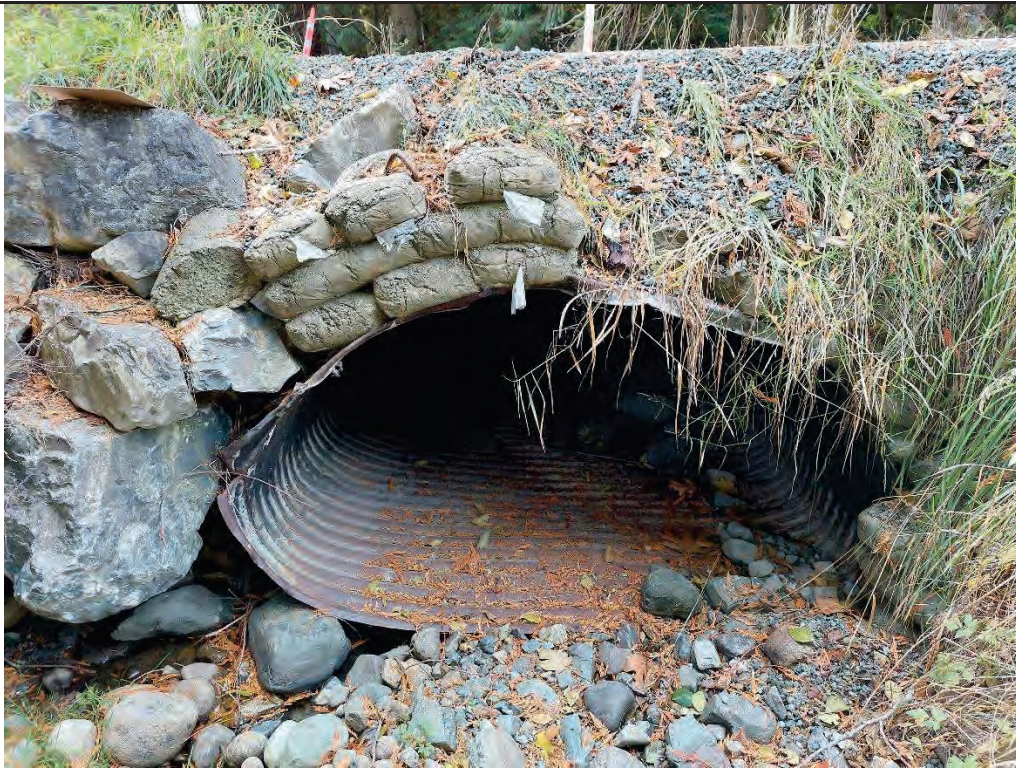
- The outlet road embankment appeared steep and unstable with the road gravel eroding into the channel.
  - The headwall concrete bags had mostly failed, showing cavities around the inlet.

Culvert Inlet: Failed concrete bag headwall, culvert pipe visibly corroded, flow below gravel

6	<b>Culvert Replacement - Staaf Creek @ Bell Road</b> (Priority Area 6)	2254782	<ul style="list-style-type: none"> <li>Existing 1,800 x 1,200 mm CSP arch-pipe culvert is in poor condition and undersized with signs of piping at the crossing.</li> <li>The replacement culvert was conceptually sized to be a 2,800 x 1,500 mm box culvert, embedded by about 300 mm in fish gravel to improve fish passage. The replacement includes headwalls and wingwalls. <ul style="list-style-type: none"> <li>Bell Road might be potentially regraded and raised for the culvert replacement.</li> </ul> </li> </ul>

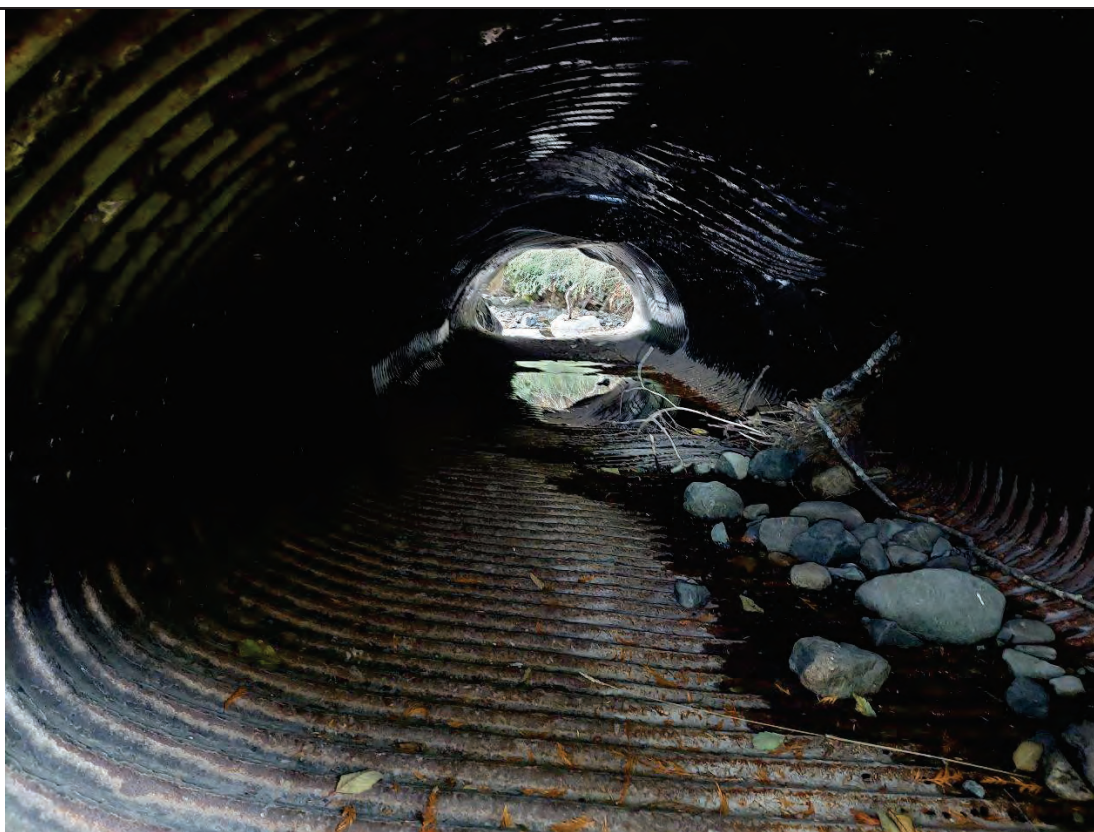
- A single 1,800 x 1,000 mm CSP arch-pipe culvert (2254782) was found at the crossing of Staaf Creek and Bell Road.
  - The culvert showed major buckling and significant corrosion of the pipe invert.

Culvert Interior facing DS: Buckling visible at 2 o'clock, flowing water visible in the middle of the culvert

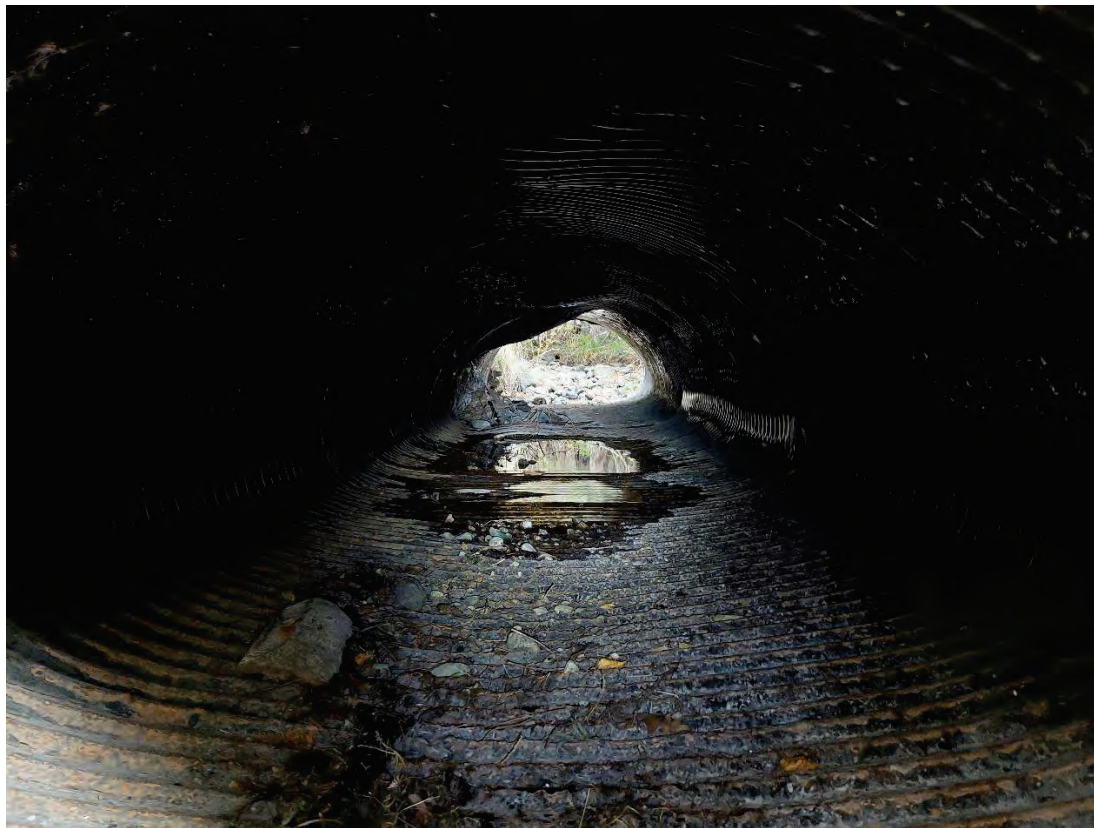
Culvert Inlet facing US: Buckling visible at multiple locations, flow disappearing at pipe invert

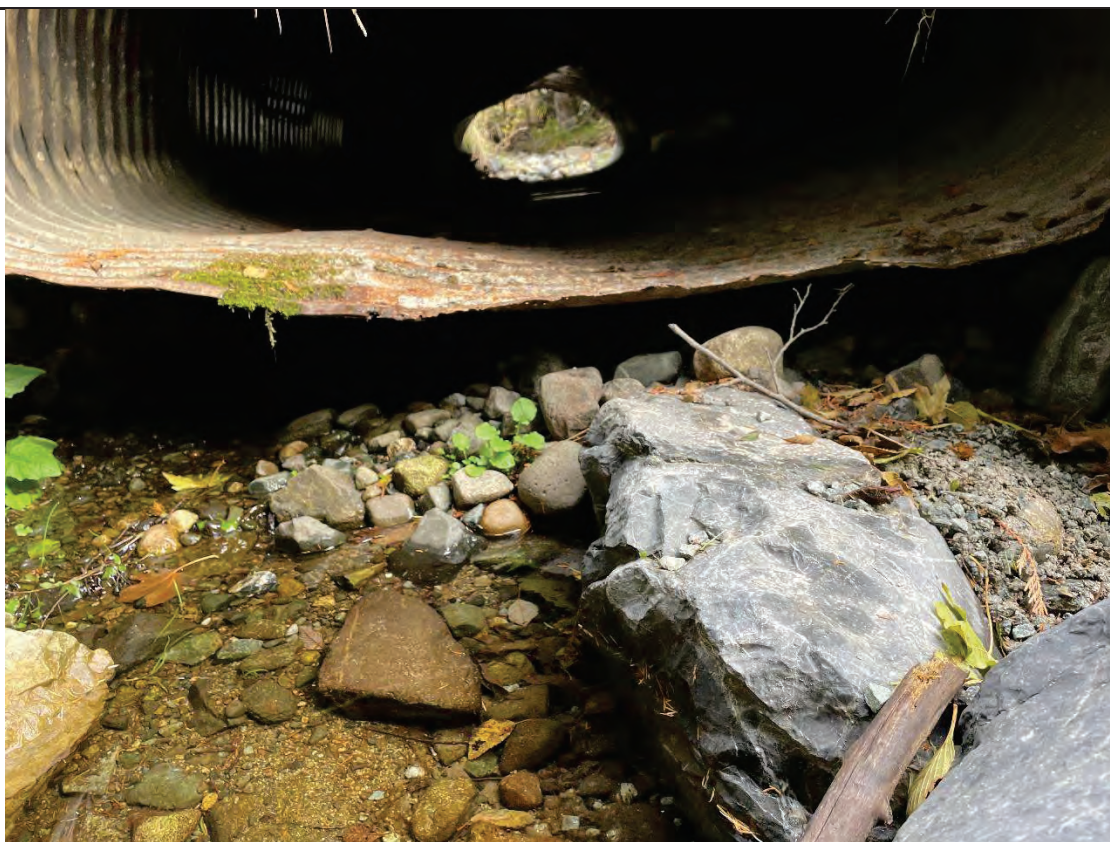
Culvert Outlet: Visible undermining of culvert pipe with visible stream flowing under pipe

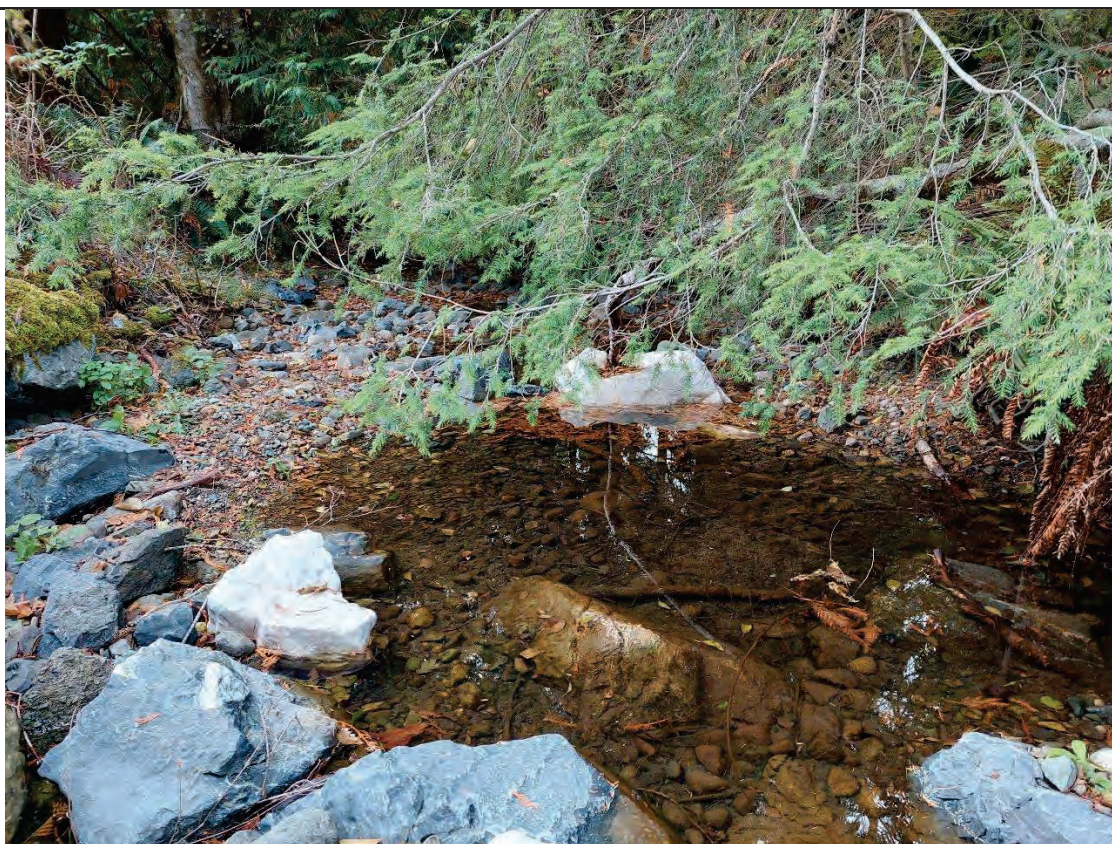
Downstream Channel facing DS: Downstream pool with erosion of banks on both sides

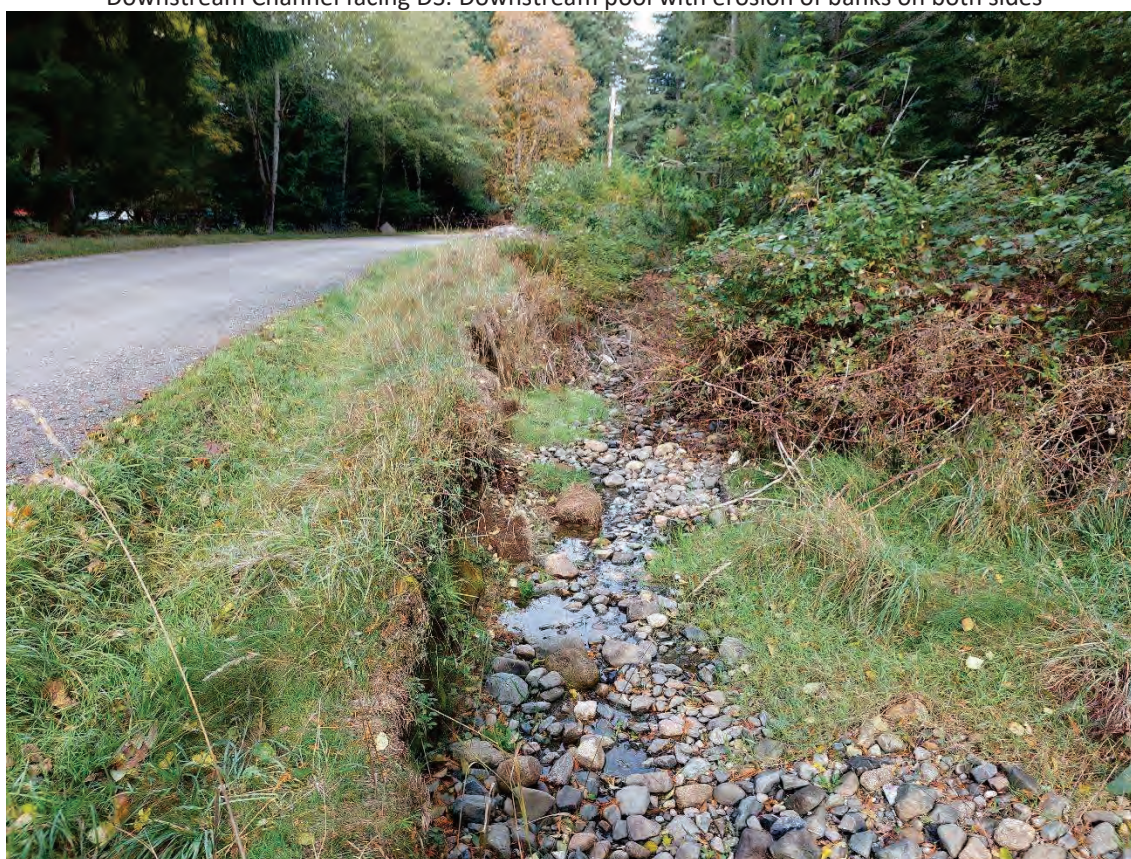
- The culvert appeared to be overall in poor condition.
- Major erosion and active undermining were visible at the south bank of Staaf Creek next to Bell Road along two sections, estimated together at around 25 m. Signs of recently placed fill, rocks and riprap were visible.

Upstream Channel at Bell Rd: Undermining of roadside ditch along 10m stretch

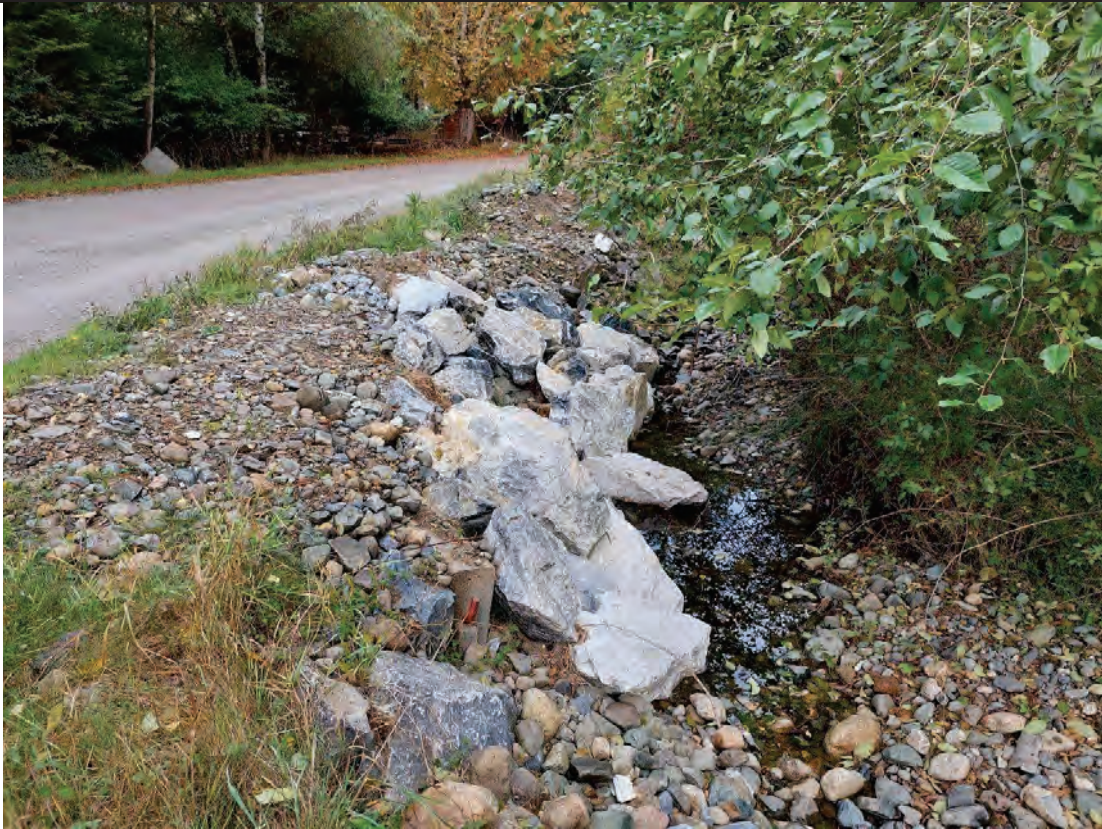
Upstream Channel at Bell Rd: Undermining of embankment along 14m stretch, dumped riprap visible

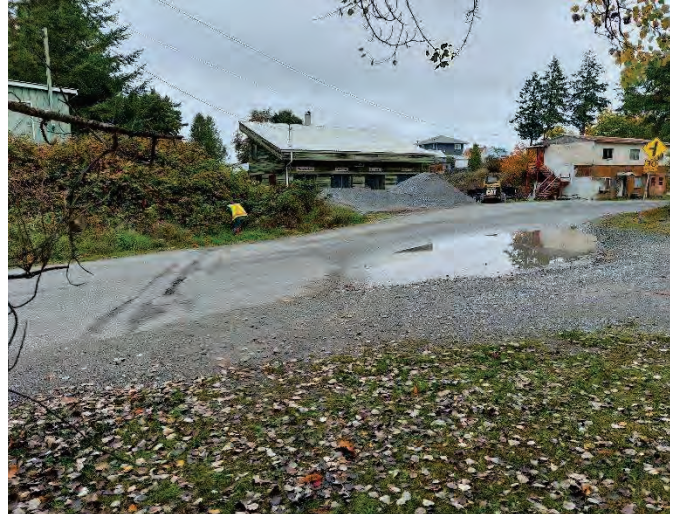
AREA 2 MARBLE RD: CROSS CULVERT UNDER PAVEMENT CRACK LINES

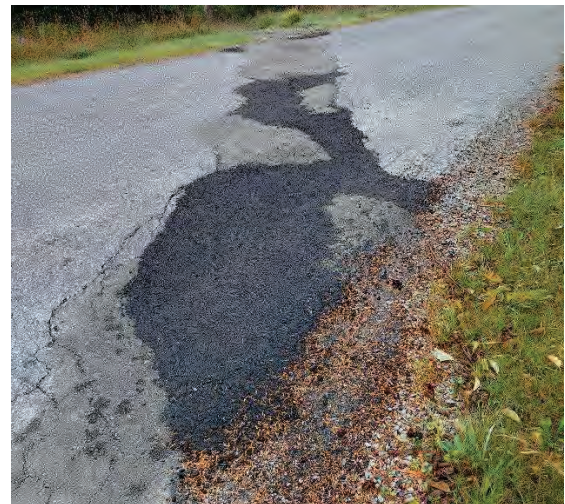
- The culvert appeared to have insufficient cover of less than 15 cm and a very poorly constructed pavement restoration with potholes, cracks, and settlement around the pipe.

**AREA 4 AIRPORT RD: NEW CULVERT, POOR PAVEMENT INSTALLATION WITH TENSION CRACKS AND SETTLEMENT**

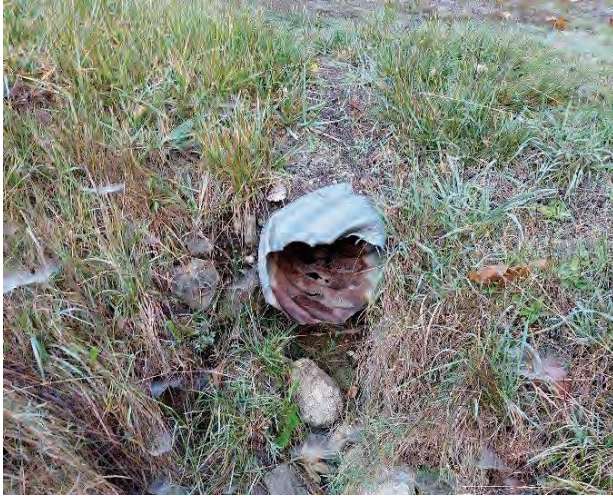
**AREA 4 AIRPORT RD: 300MM CSP CULVERT (2258675) OUTLET,  
CORRODED INVERT**

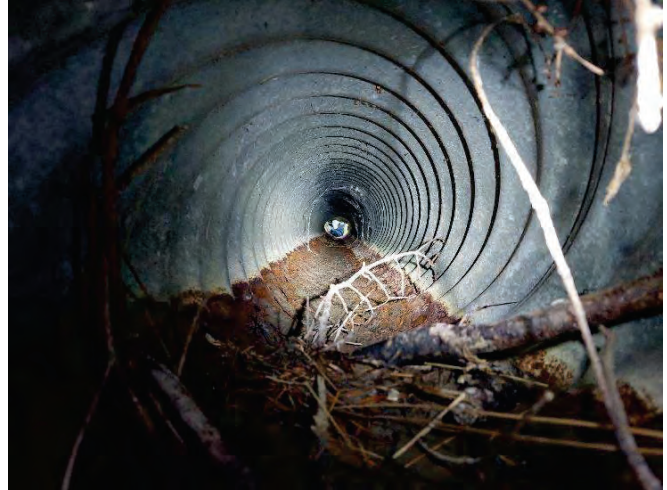
- The culvert pipe alignment is bent with minor pipe joint separation visible. The overall culvert condition appeared to be fair.
- A 300 mm CSP culvert (CHRIS: 2258675) was inspected at the water tank driveway with a heavily corroded pipe invert and in poor condition.

**AREA 4 AIRPORT RD: 300MM CSP CULVERT (2258675), HEAVILY  
CORRODED INVERT**

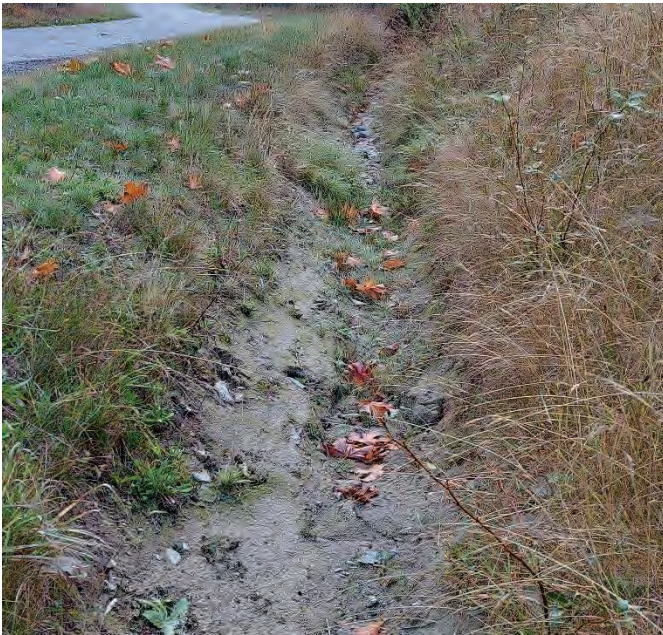
- A 450mm DI culvert was inspected south of the water tank with only surficial corrosion and in overall fair condition (49.682369°N, 124.490133°W).
- The western roadside ditch along Airport Road showed multiple locations with visible erosion and scour, likely from the high flows in the ditch due to the high slope between the water tank and Pine Street.

**AREA 4 AIRPORT RD: EROSION OF ROADSIDE DITCH**

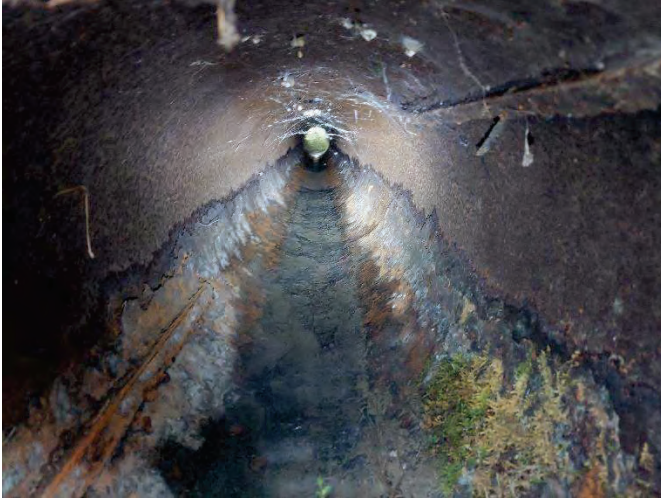
AREA 4 AIRPORT RD: 450MM DI CULVERT INTERIOR, SURFICAL CORROSION
