Ministry of  
Transportation  
and Infrastructure

# Texada Island Drainage Study

Final Report

January 2024

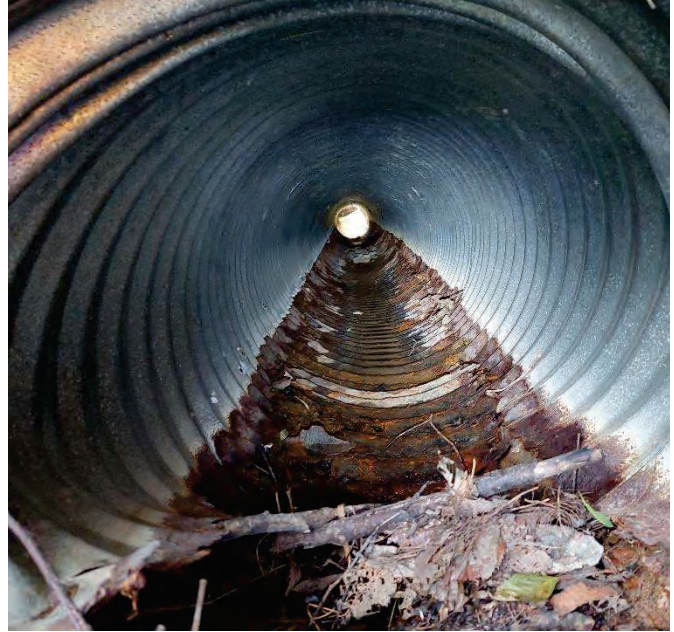
- The western pipe appeared to be recently installed and in good condition. The pipe appeared not be fully aligned with the ditch.
  - The eastern pipe appeared to be older with significant corrosion and loss of material and in poor condition.

AREA 4 GILLIES BAY RD: OLD EASTERN 600MM CSP CULVERT, MAJOR CORROSION OF PIPE INVERT

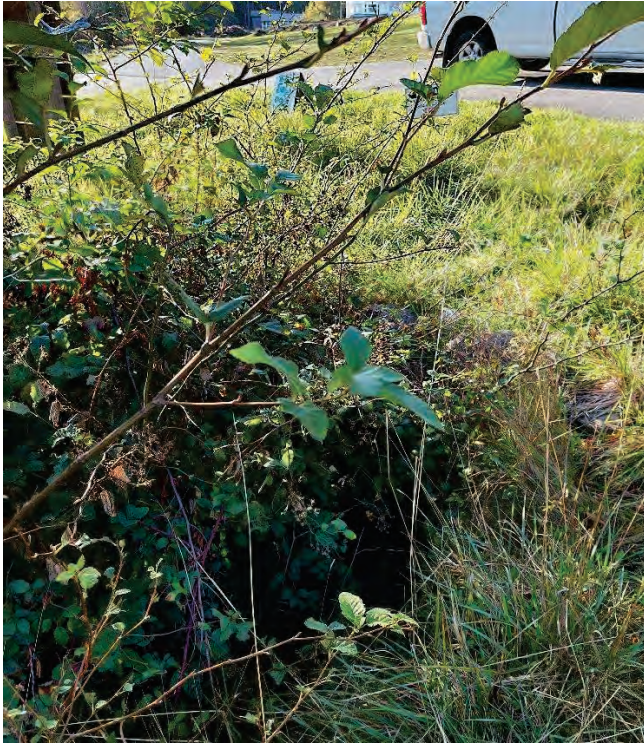
AREA 4 SANDERSON RD: OVERGROWN ROADSIDE DITCH

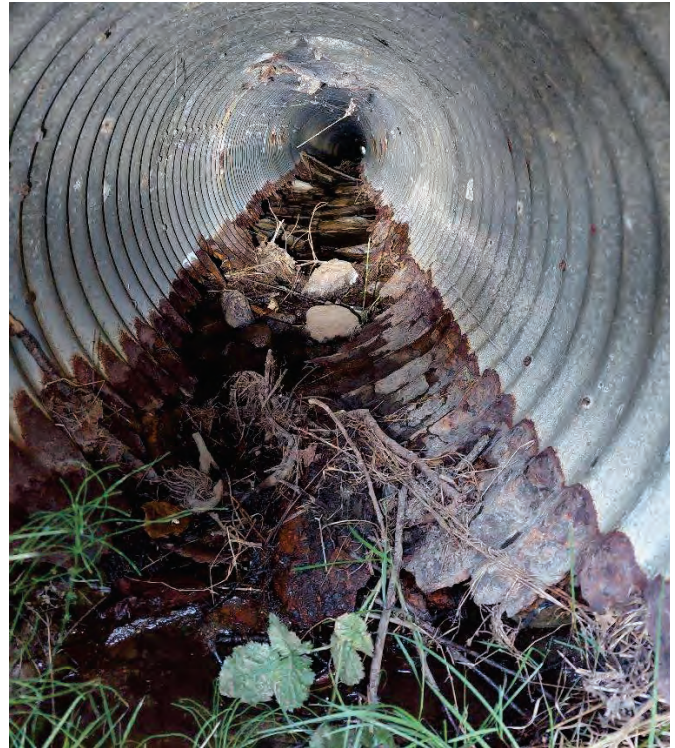
- The culvert had significant corrosion of the pipe invert with complete loss of material. It appeared to be in poor condition.
  - The location of the culvert just downstream of the twin 600 mm CSP appears significant for its compared small conveyance capacity and may indicate that the culvert is undersized.

AREA 4 SANDERSON RD: CULVERT (2258625) PIPE INVERT CORRODED AWAY LOOKING DOWNSTREAM

9	<b>Culvert Replacement - Sanderson Road @ Gillies Bay Road</b> (Priority Area 3)	2258625	<ul style="list-style-type: none"> <li>Existing 525 mm CSP culvert is in poor condition and greatly undersized.</li> <li>The replacement culvert was conceptually sized to be a 1,800 x 900 mm box culvert with headwalls and wingwalls.</li> <li>The site assessment did not find another flow route downstream of the ex. twin 600 mm CSP culvert at the Tennis Court, but future design should review the flow path in detail.</li> </ul>
10	<b>Culvert Replacement - Tennis Court @ Gillies Bay Road</b> (Priority Area 3)	UNK	<ul style="list-style-type: none"> <li>Existing twin 600 mm CSP culvert is partially in poor condition and greatly undersized.</li> <li>The replacement culvert was conceptually sized to be a twin 1,200 x 900 mm box culvert with headwalls and wingwalls.</li> </ul>
11	<b>Culvert Replacement - Airport Road</b> (Priority Area 3)	UNK	<ul style="list-style-type: none"> <li>Existing recently installed 600 mm CSP culvert is poorly installed with insufficient cover and a lack of proper riprap apron at the outlet.</li> <li>The replacement culvert recommended is a 600 mm HDPE pipe with sufficient min. 450 mm cover with a potential sump at the inlet and a riprap apron at the outlet.</li> </ul>

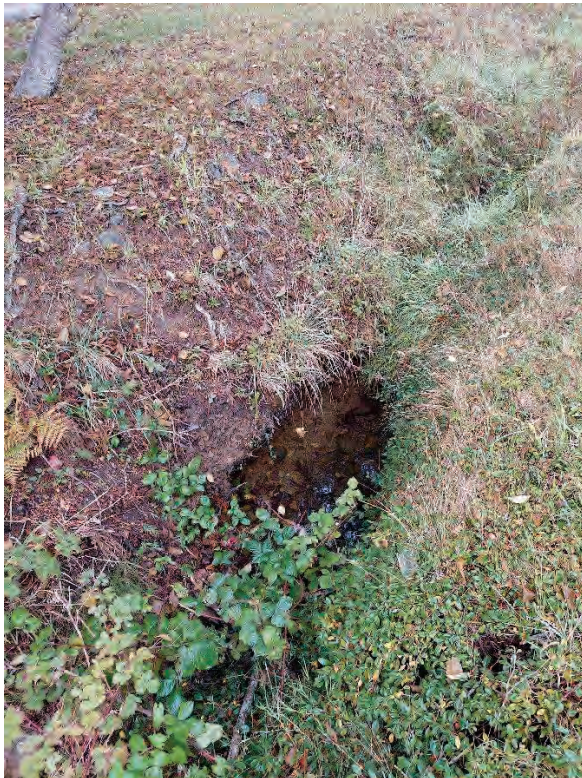
AREA 4 GILLIES BAY RD: BANK EROSION OF ROADSIDE DITCH

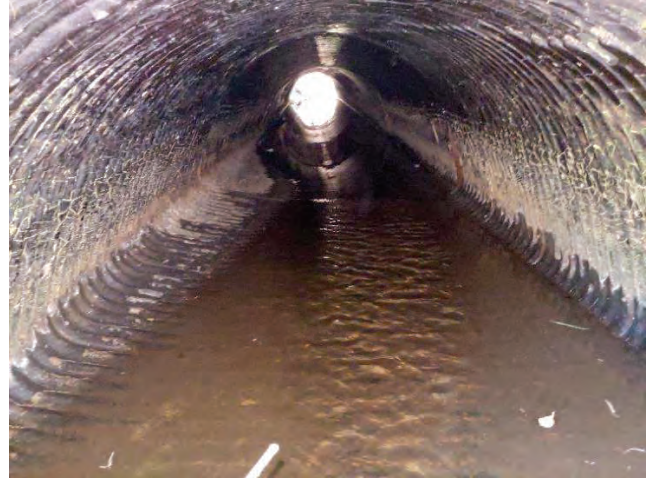
AREA 5 GILLIES BAY: ARCH PIPE (2256032) WITH LOCAL CORROSION

7	<b>Culvert Replacement - Trout Creek @ Gillies Bay Road</b> (Priority Area 5)	2256032	<ul style="list-style-type: none"> <li>Existing 1,800 x 1,100 mm CSP arch-pipe culvert is in fair condition but greatly undersized and known for seasonal floodings around Gillies Bay Road.</li> <li>The replacement culvert was conceptually sized to be a 4,300 x 1,500 mm open bottom arch culvert with headwalls and wingwalls. Note that the culvert for the conceptual size appeared to be outlet controlled and a headloss of 0.3 m has not been achieved. The culvert should be analyzed in detail at a later stage.</li> </ul>
8	<b>Culvert Replacement &amp; Valley Curb Installation - Marble Road</b>	2257259	<ul style="list-style-type: none"> <li>Existing 450 mm CSP culvert is in fair condition but greatly undersized.</li> <li>The replacement culvert recommended is a 1,200 x 600 mm box culvert.</li> <li>A new valley curb is recommended to be installed along the southside of Marble Road towards the small creek in the west on an approx. length of 18 metres.</li> </ul>

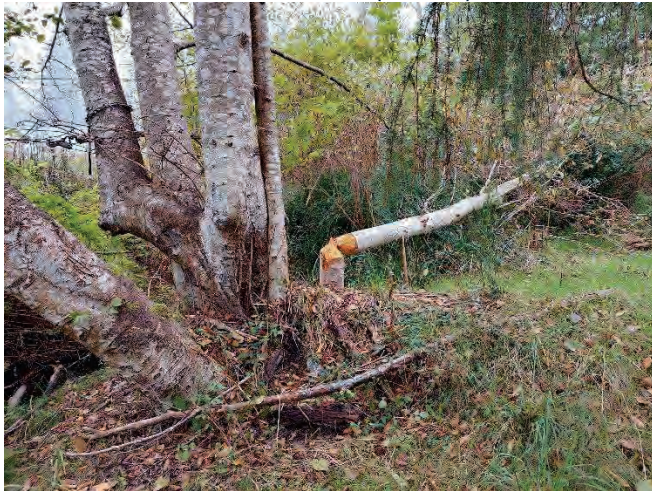
AREA 5 GILLIES BAY: SIGNS OF BEAVERS UPSTREAM OF CULVERT

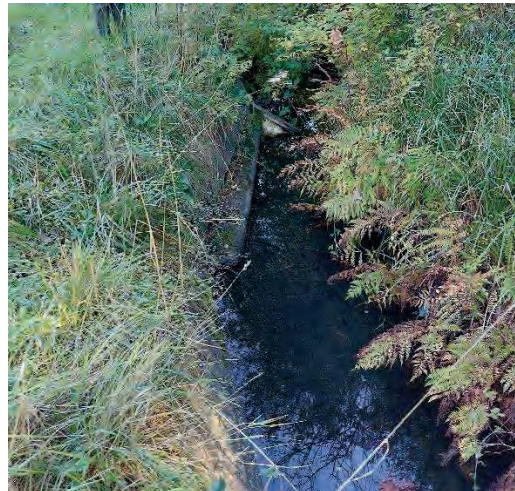
AREA 5 GILLIES BAY: SIGNS OF FAILED CONCRETE EMBANKMENT

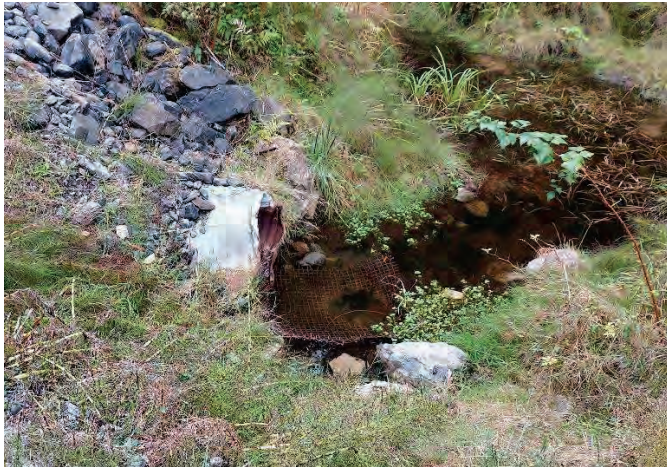
CULVERT	NOTES
Culvert 1 – Blubber Bay Road (CHRIS ID: 2254949)	<ul style="list-style-type: none"> <li>900mm CSP culvert, appears overall in <u>fair condition</u>.</li> <li>Inlet damaged, pipe invert corroded and most of pipe coating is lost.</li> <li>Inlet grate damaged and not attached to the inlet.</li> <li>Pipe transitions from galvanized heavily corroded CSP at the inlet to coated CSP with minor corrosion.</li> </ul>
Culvert 4 – Gillies Bay Road (CHRIS ID: 2256045)	<ul style="list-style-type: none"> <li>1050mm CSP culvert, appears overall in <u>fair condition</u>.</li> <li>Lower half of the culvert corroded with woody debris in the pipe.</li> <li>Culvert outlet not inspected as heavily overgrown.</li> </ul>
Culvert 5 – Gillies Bay Road (CHRIS ID: 2256047)	<ul style="list-style-type: none"> <li>1200mm CSP culvert, appears overall in <u>fair condition</u>.</li> <li>Pipe coating mostly intact but starting to fail on both sides.</li> <li>Minor pipe joint separation and debris within pipe.</li> <li>Road embankment erosion at the outlet.</li> </ul>

**CULVERT 1 (2254949) INLET: DAMAGED INLET AND GRATE**

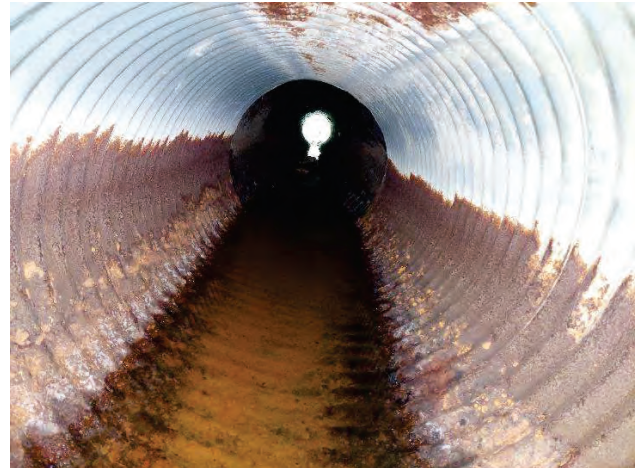
**CULVERT 1 (2254949) INTERIOR: MATERIAL CHANGE AND HEAVY CORROSION**

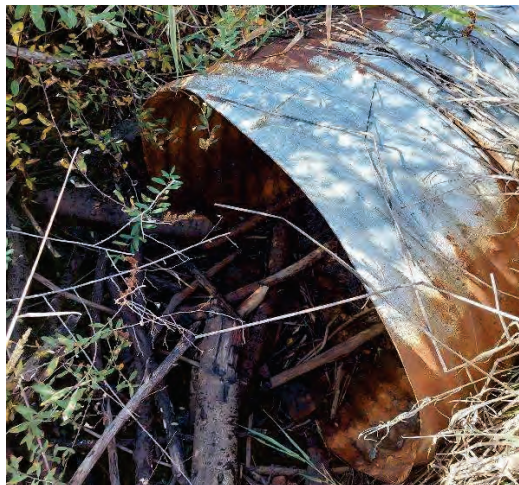
**CULVERT 4 (2256045) INLET: MINOR WOODY DEBRIS**

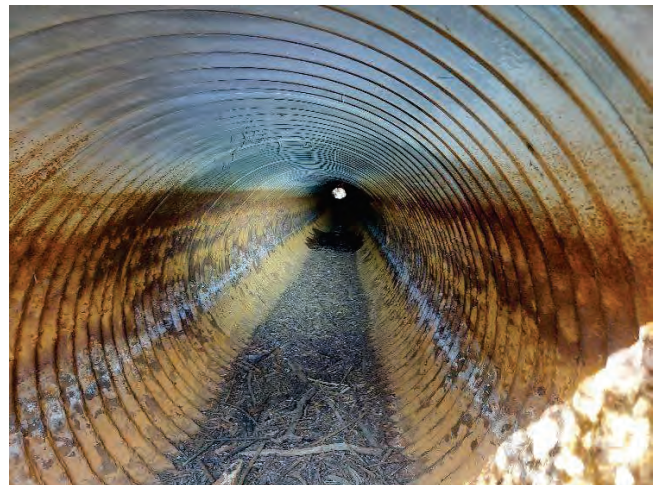
**CULVERT 4 (2256045) INTERIOR: MAJOR CORROSION & MINOR DEBRIS**

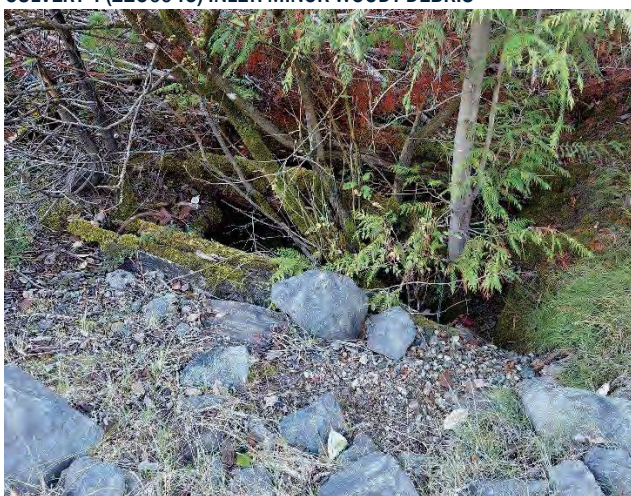
**CULVERT 5 (2256047) INLET: VEGETATION PRESENT AT INLET**

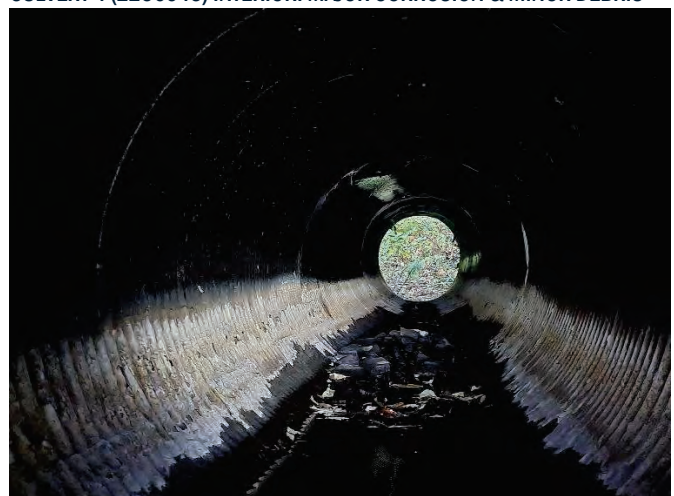
**CULVERT 5 (2256047) INTERIOR: DAMAGED COATING AND MINOR ROCK**

DEBRIS

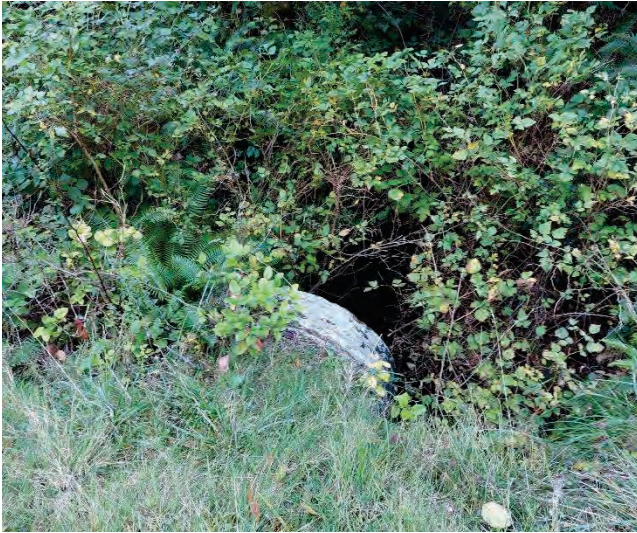
CULVERT 6 (2256019) INLET: OVERGROWN INLET

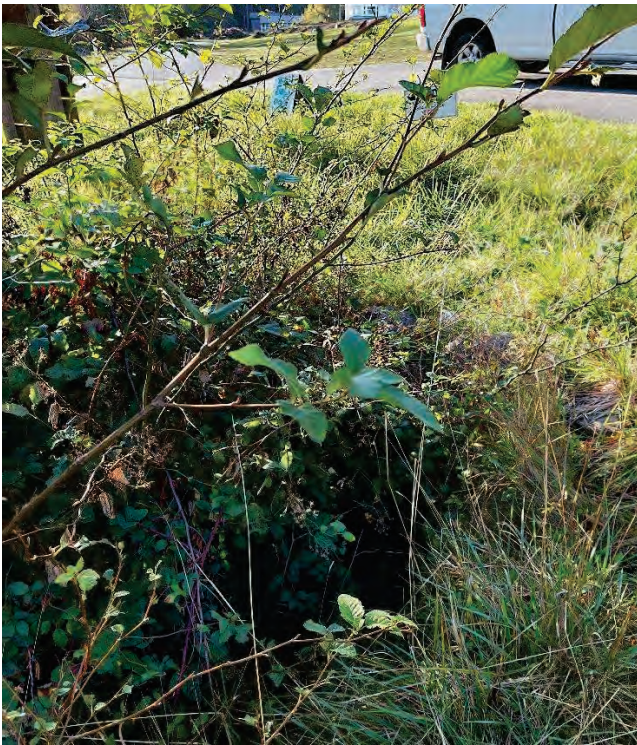
CULVERT 7 (2258625) OUTLET: OVERGROWN ROADSIDE DITCH

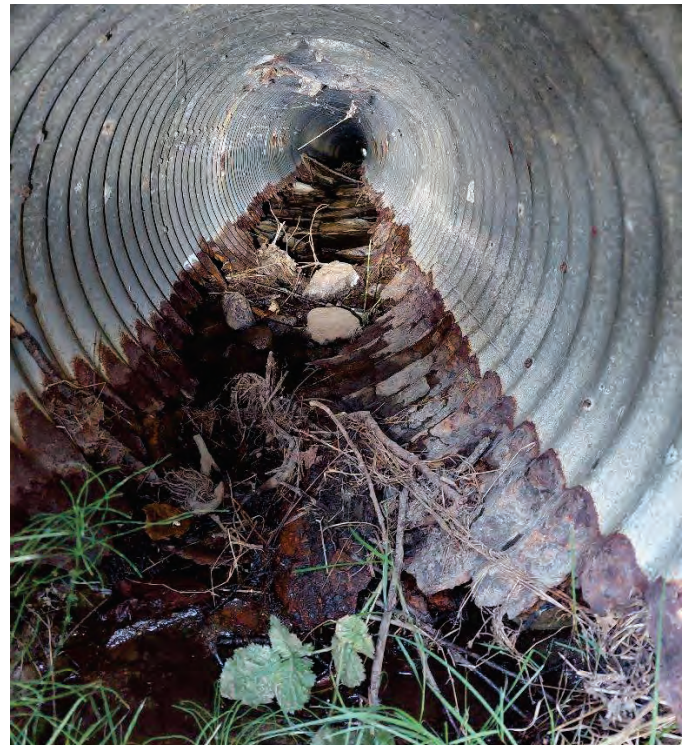
CULVERT 7 (2258625) INTERIOR: PIPE INVERT CORRODED AWAY

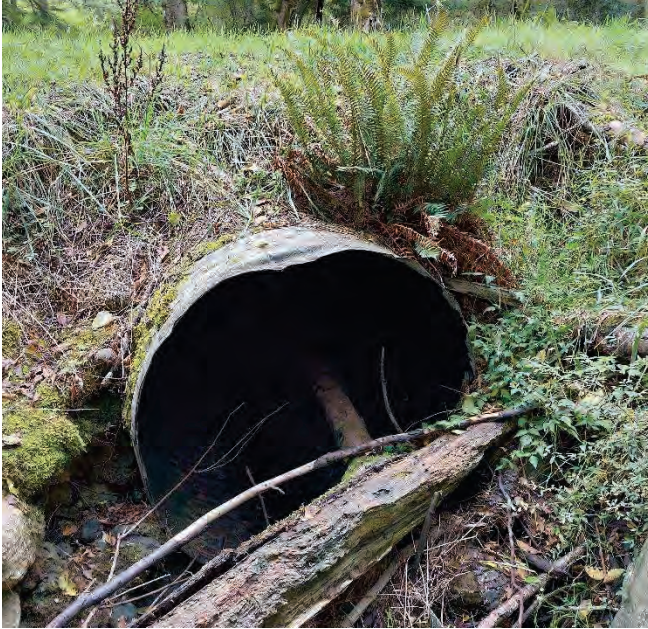
**CULVERT 9 (2256424) INLET: WOODY DEBRIS AT INLET**

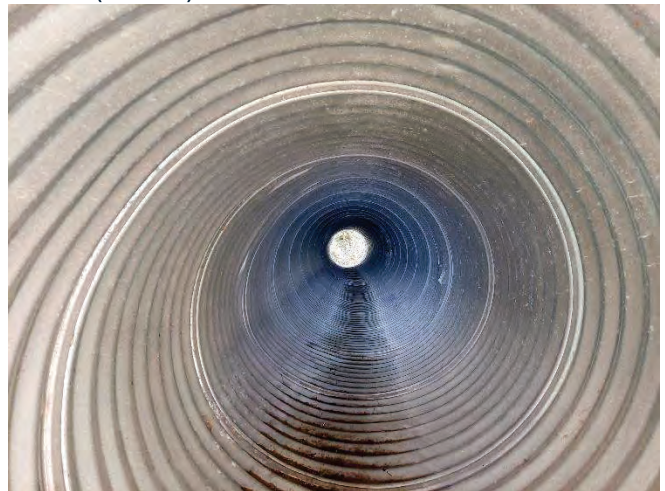
**CULVERT 11 (2254788) INTERIOR: GOOD PIPE CONDITION**

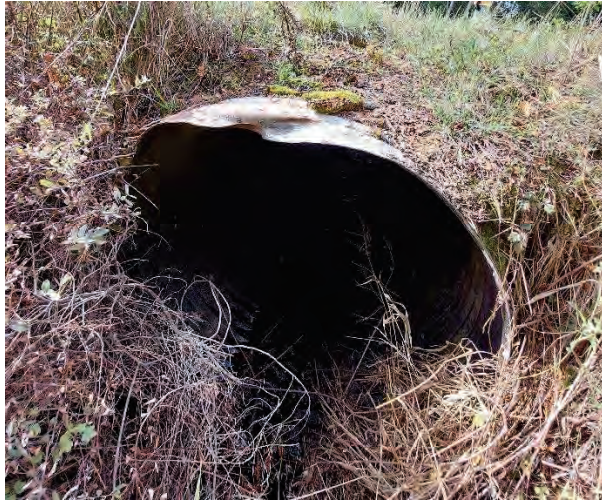
Culvert 12 – Central Road (CHRIS ID: 2255061)	<ul style="list-style-type: none"> <li>1200mm CSP, appears overall in <u>poor condition</u>.</li> <li>Major buckling at 12 o'clock and significant pipe joint separation in the pipe middle.</li> <li>Pipe coating mostly intact.</li> </ul>
Culvert 13 – Central Road (CHRIS ID: 3442926)	<ul style="list-style-type: none"> <li>1050mm CSP, appears overall in <u>good condition</u>.</li> <li>Active flow present during inspection.</li> <li>Pipe coating mostly intact with only minor corrosion.</li> </ul>
Culvert 14 – Central Road (CHRIS ID: 3442927)	<ul style="list-style-type: none"> <li>1050mm CSP, appears overall in <u>fair condition</u>.</li> <li>Minor pipe joint separation.</li> <li>Pipe coating mostly intact</li> </ul>
Culvert 15 – Central Road (CHRIS ID: 2255027)	<ul style="list-style-type: none"> <li>2200 x 1350mm CSP arch-pipe, appears overall in <u>fair condition</u>.</li> <li>Notable corrosion and abrasion of the pipe invert with notable local material loss.</li> <li>Bank erosion downstream of the culvert.</li> <li>Gravel potholes present on top of the culvert.</li> </ul>

**CULVERT 12 (2255061) INLET: INLET BEND**

<b>LONG-TERM AND GENERAL RECOMMENDATIONS</b>			
12	<b>Culvert Replacement - Central Road</b> (Additional Area)	2255061	<ul style="list-style-type: none"> <li>Existing 1200 mm CSP culvert is in poor condition with major pipe joint separation and buckling.</li> <li>A replacement culvert has not been conceptually sized as part of the study but should be sized in the future.</li> </ul>
13	<b>Regular Culvert Inspections</b> (-)	NA	<ul style="list-style-type: none"> <li>Regular culvert inspections are recommended to be conducted every 5 years to monitor the culvert conditions.</li> <li>Culverts which were assessed to be in poor condition should be visually assessed every 2 years before being replaced and after every major storm event.</li> </ul>
