## **Powell River Regional District Landslide and Fluvial Hazards Study Electoral Area D – Texada Island**

**POWELL RIVER  
REGIONAL DISTRICT**

DECEMBER 21, 2016  
ISSUED FOR USE  
FILE: 704-V13103482-01.002

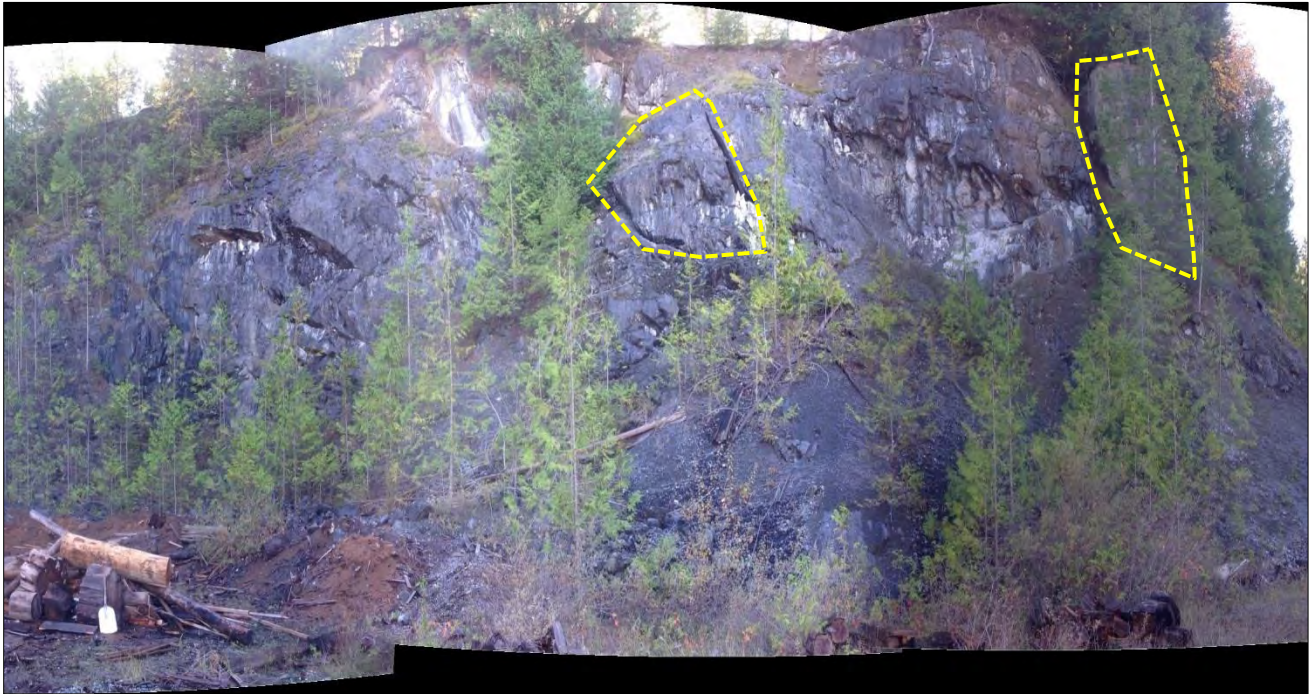
**Photo 1:** View of bedrock escarpment located north of Blubber Bay Road, west of Van Anda town site. Yellow dashed lines show loose and potentially unstable rock wedges on the slope. Note shovel in bottom-left corner for scale. (Photo taken October 2016).

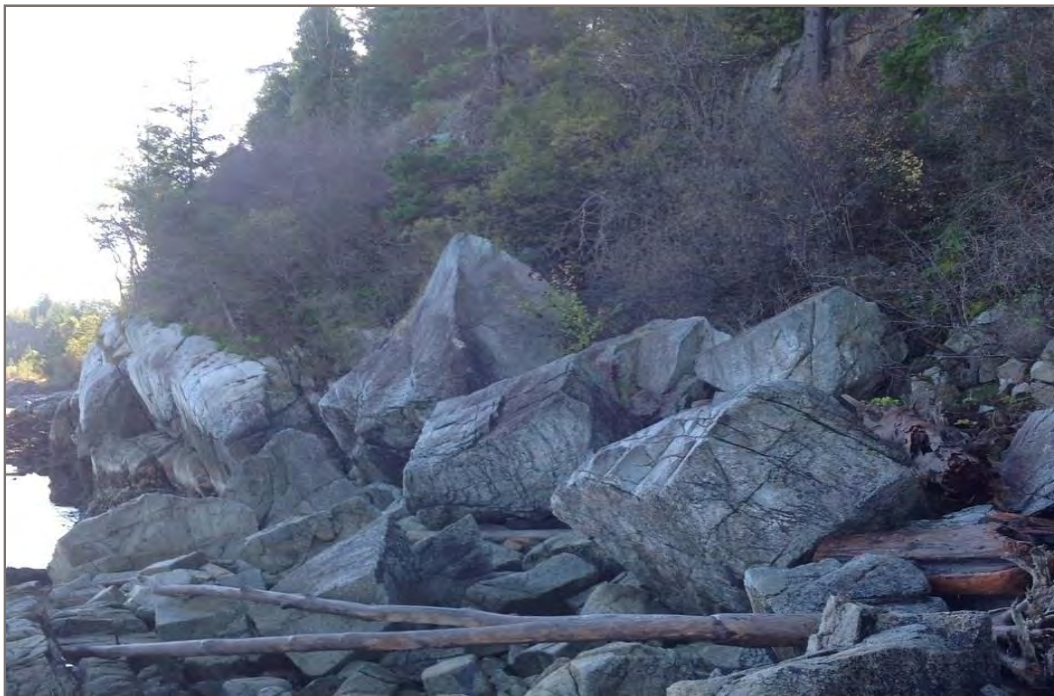
**Photo 2:** View of coarse talus (rock fall debris) comprised of large angular boulders up to 4 m in diameter. Photo taken east of Van Anda along a section of coastline near Van Anda point. (Photo taken October 2016).

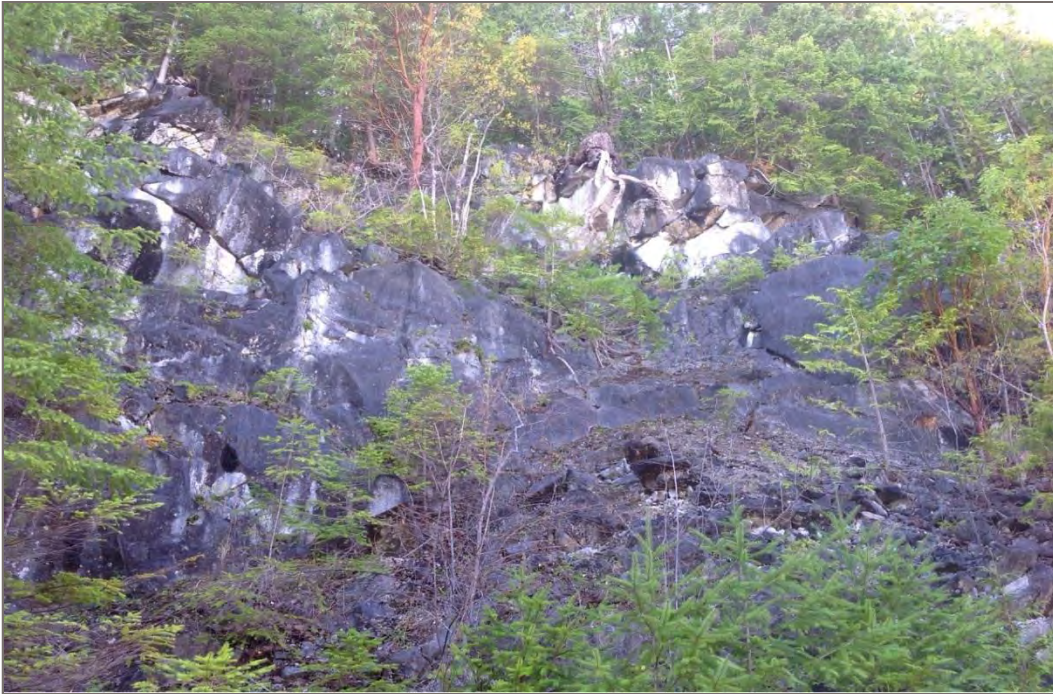
**Photo 3:** View of steep bedrock bluffs upslope of Smelter Avenue, east of Van Anda. Note areas of loose, fractured rock near the crest. Lighter shaded areas on the bluff indicate where more recent rock fall activity has occurred. (Photo taken October 2016).

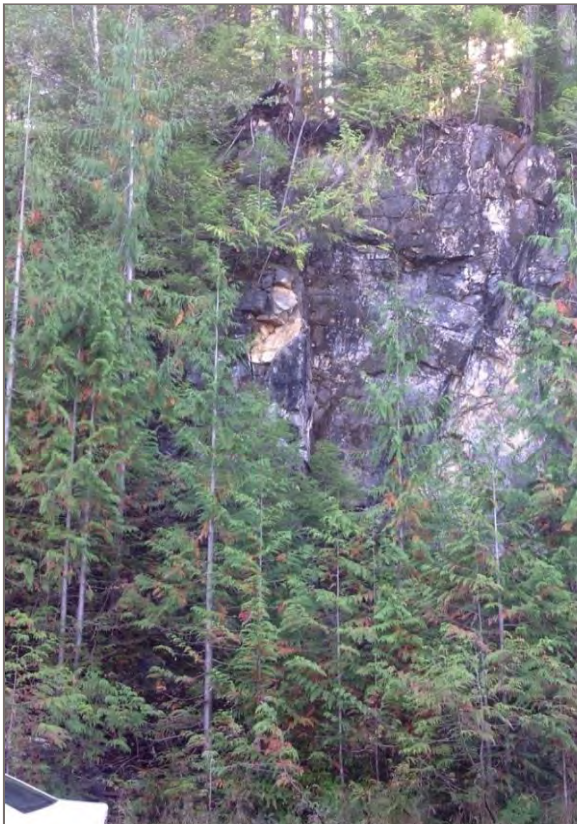
**Photo 4:** View of steep bedrock bluffs along Kirk Lake Road near intersection with Gillies Bay Road. Lighter shaded areas on the bluff indicate where more recent rock fall activity has occurred. (Photo taken October 2016).

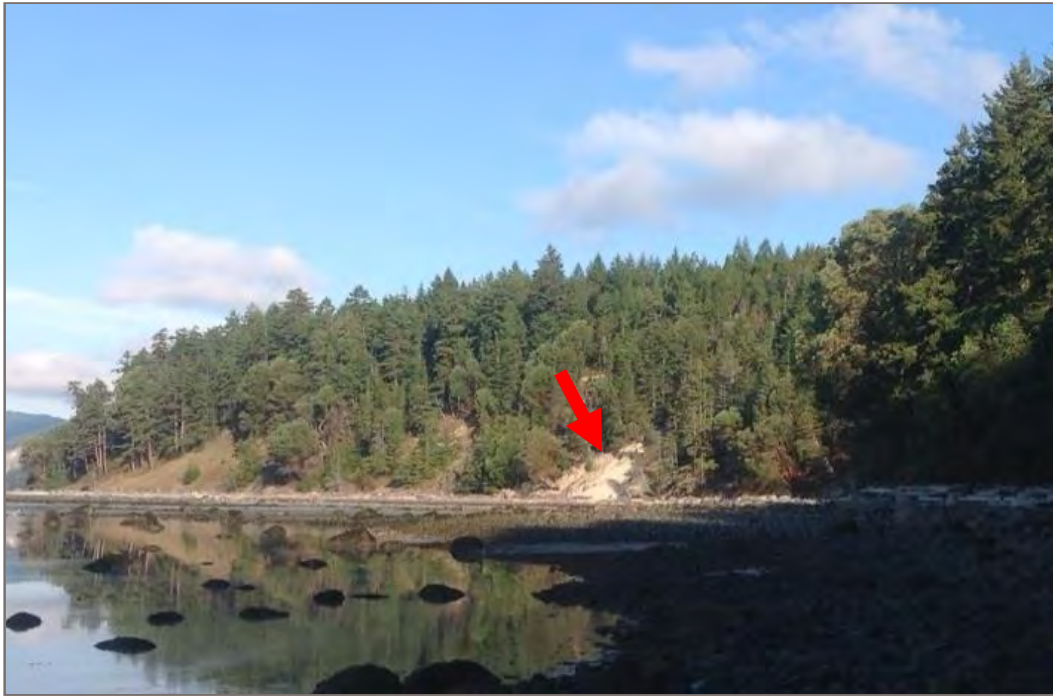
**Photo 5:** View of coastal escarpment west of Gillies Bay looking towards the area known locally as the “Sand Banks”. Lighter shaded area (red arrow) indicates where active erosion and landslide activity are occurring. (Photo taken October 2016).

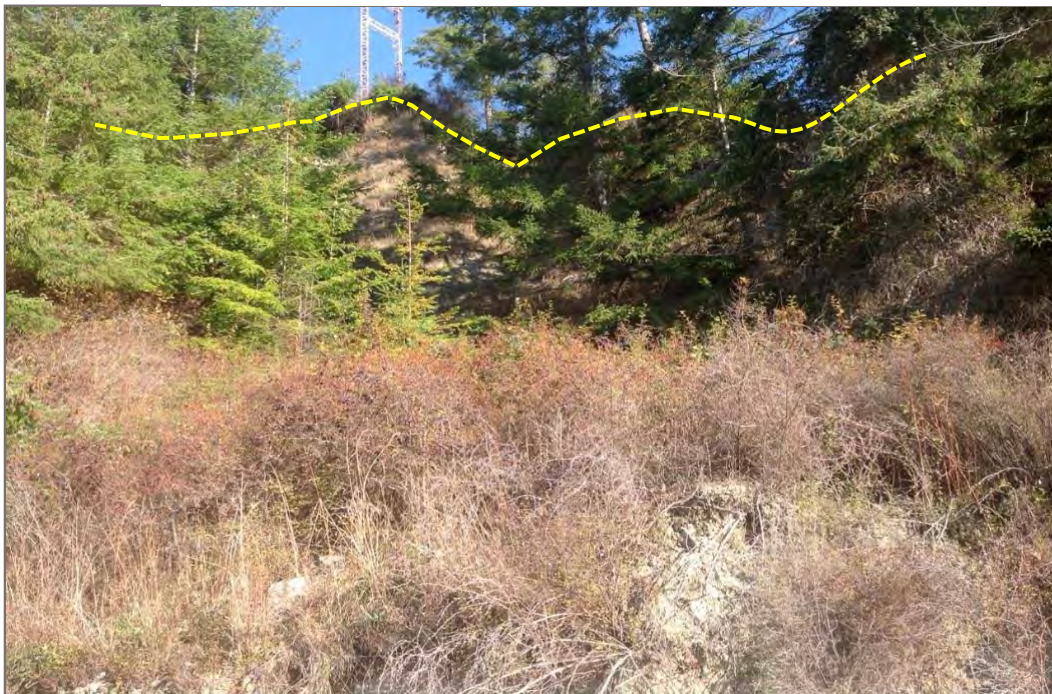
**Photo 6:** View of coastal escarpment looking up at cable TV tower at the west end of Gillies Bay. Yellow dashed line delineates approximate crest of slope; note v-shaped gully and exposed soil near the crest. (Photo taken October 2016).

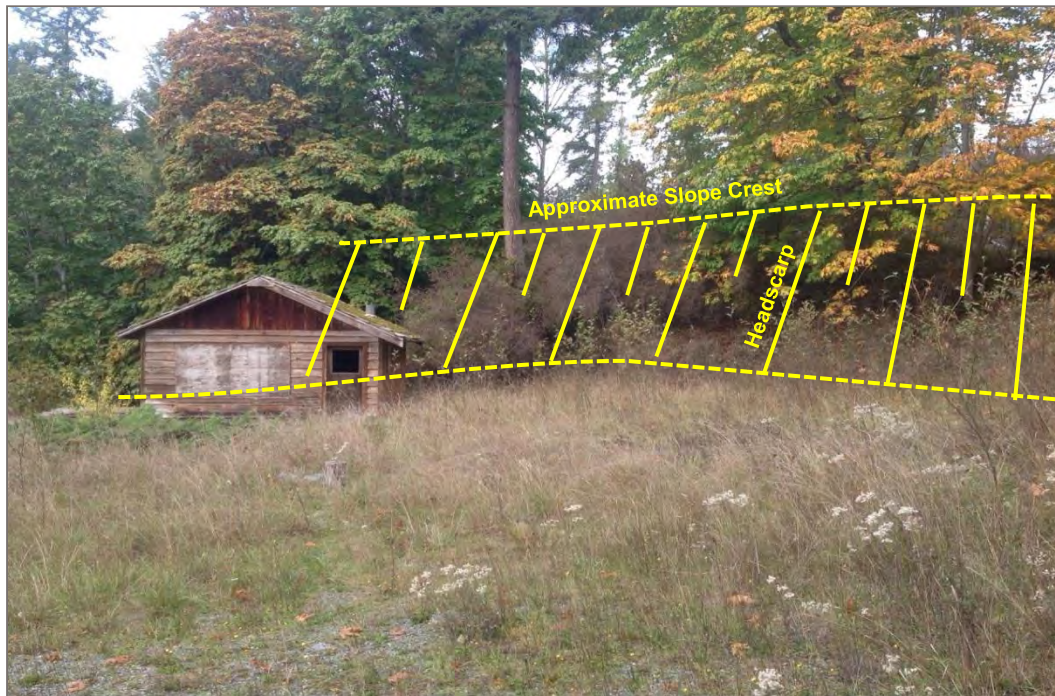
**Photo 7:** View of ground surface within the ancient (?) landslide (slump) located along the east side of Gillies Bay. Yellow dashed lines delineate approximate crest of slope and the height of the exposed headscarp. (Photo taken October 2016).

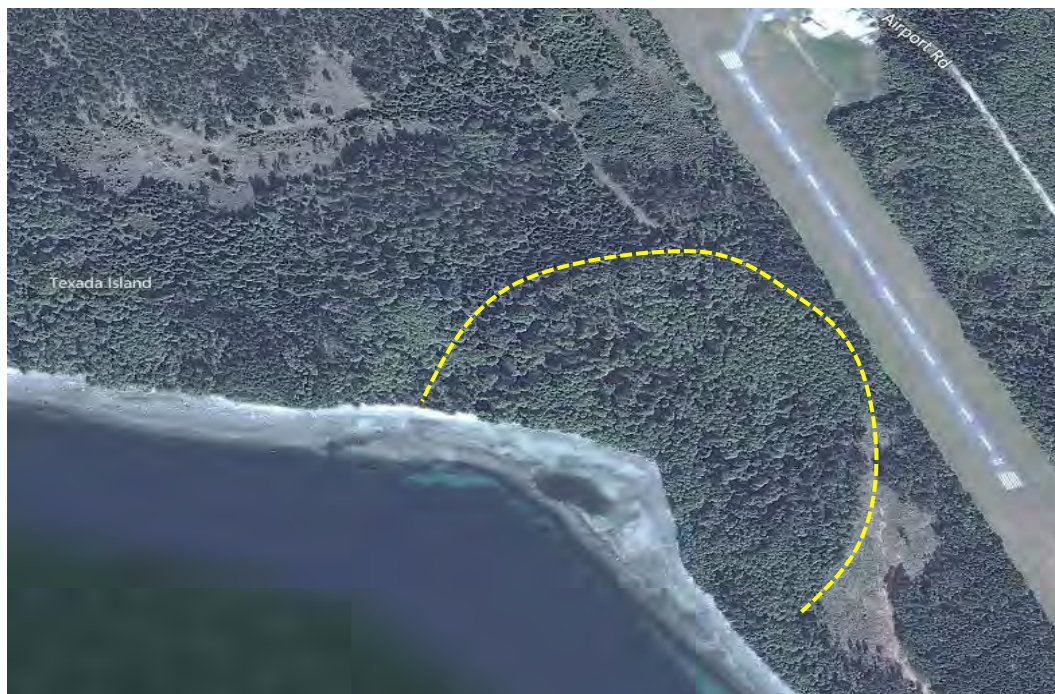
**Photo 8:** Aerial view of ancient (?) landslide (slump) located near the runway at Texada/Gillies Bay Airport. Yellow dashed line delineates approximate location of the headscarp. (Image from Bing Maps; date of image unknown).

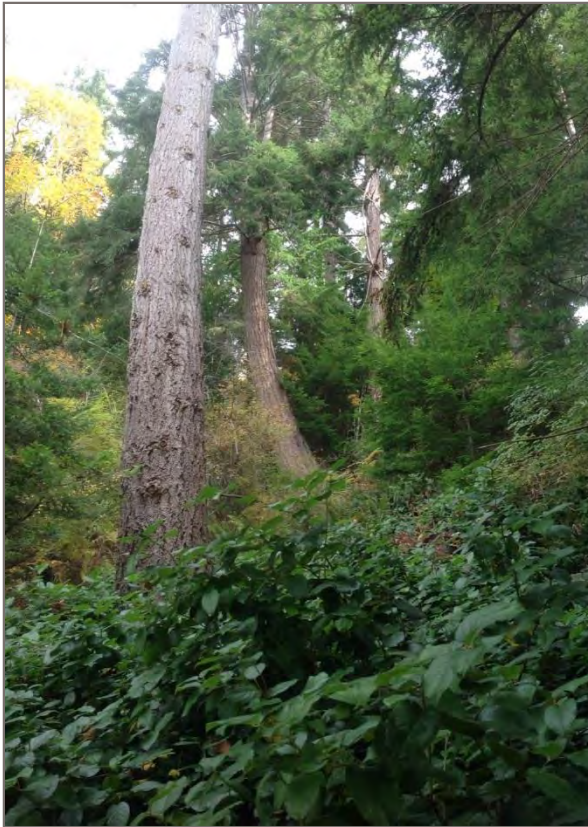
**Photo 9:** View of coastal escarpment along east side of Gillies Bay. Curved tree trunks indicative of slope creep and potential slope instability. (Photo taken October 2016).

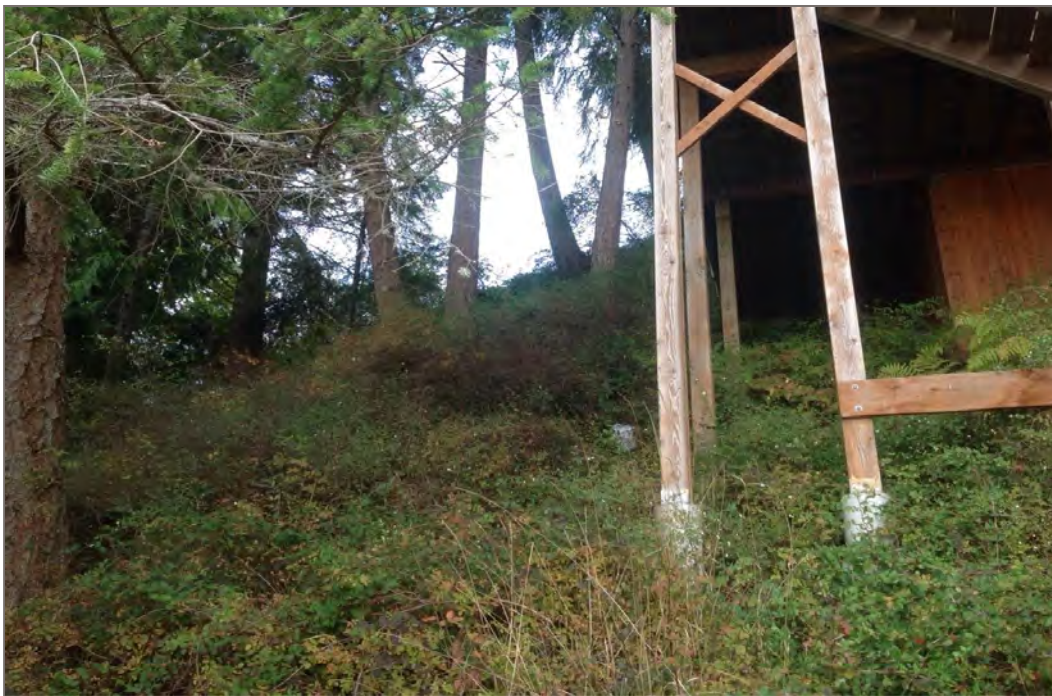
**Photo 10:** View of coastal escarpment along east side of Gillies Bay. Curved / tilted tree trunks indicative of slope creep and potential slope instability. (Photo taken October 2016).

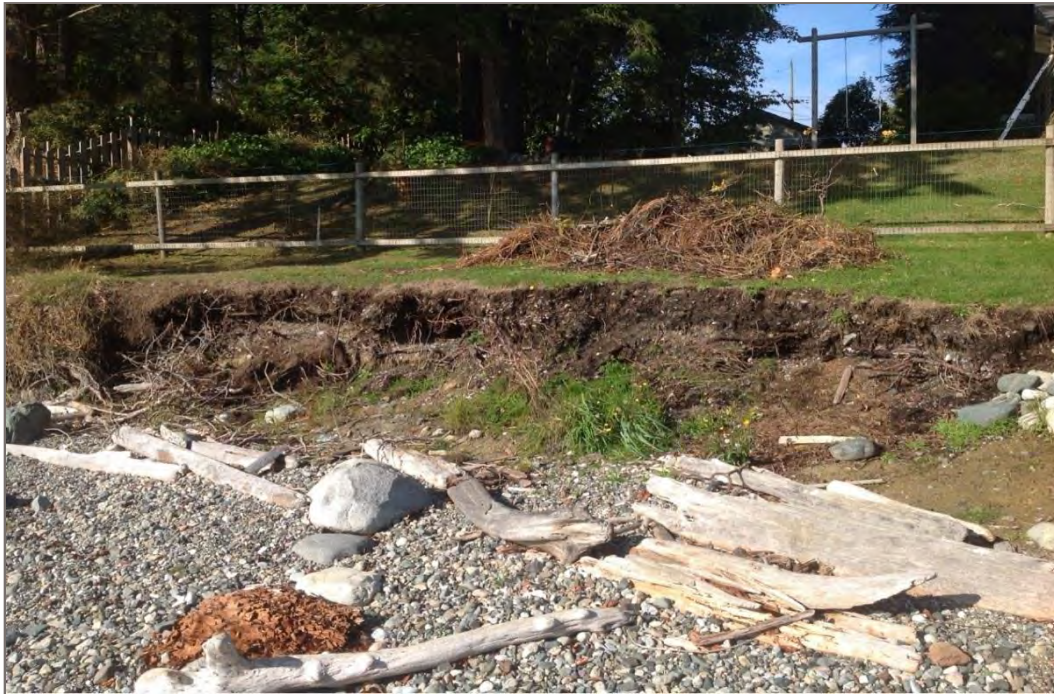
**Photo 11:** View of coastline erosion along the west side of Gillies Bay. (Photo taken October 2016).

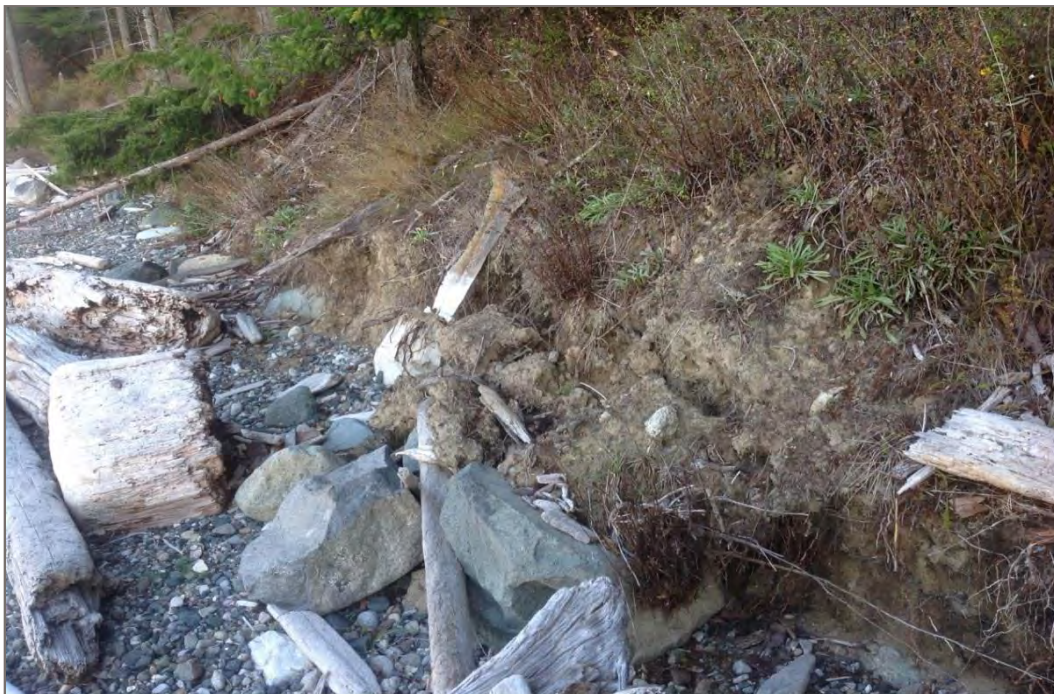
**Photo 12:** View of coastline erosion to the west of Gillies Bay, along the section of coastline between the cable TV tower and the "Sand Banks" area. (Photo taken October 2016).
