# **Detailed Structural Inspection**

Van Anda dock Texada Island, British Columbia

Inspection Dates: March 8<sup>th</sup> and 9<sup>th</sup>, 2021

**Reference file number: P-9248**

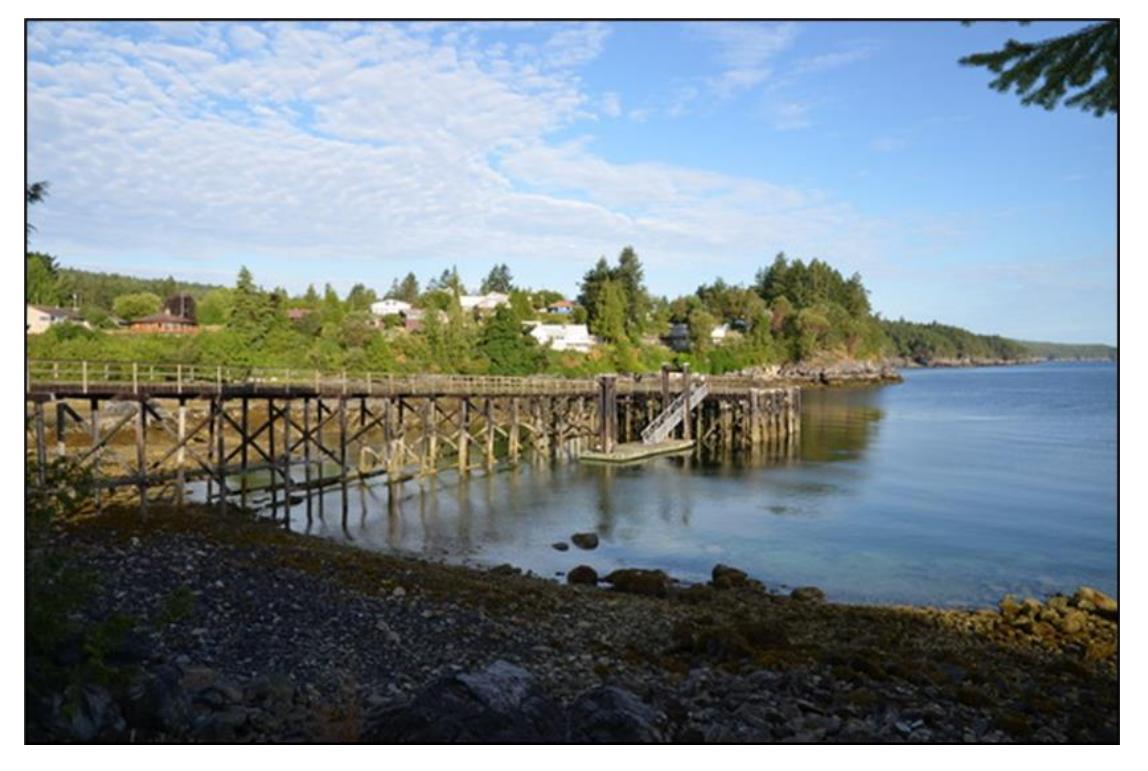
Photograph 1: General arrangement of structure.

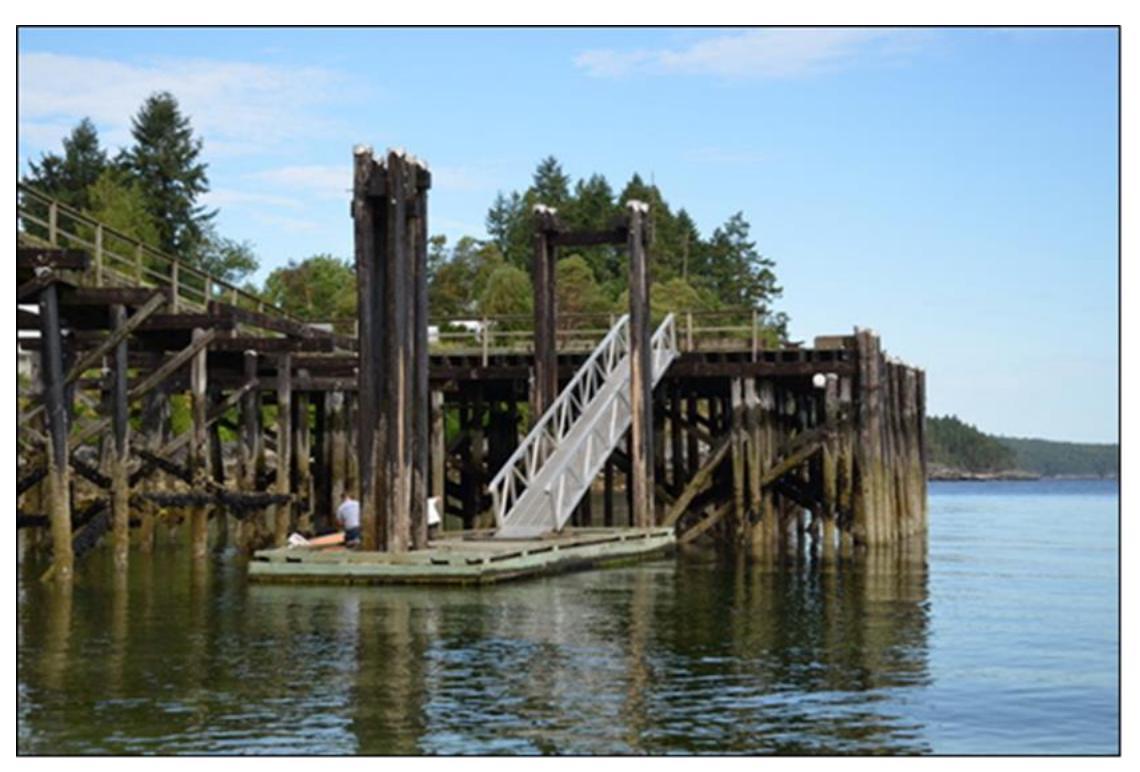
Photograph 2: General arrangement of landing float and gangway.

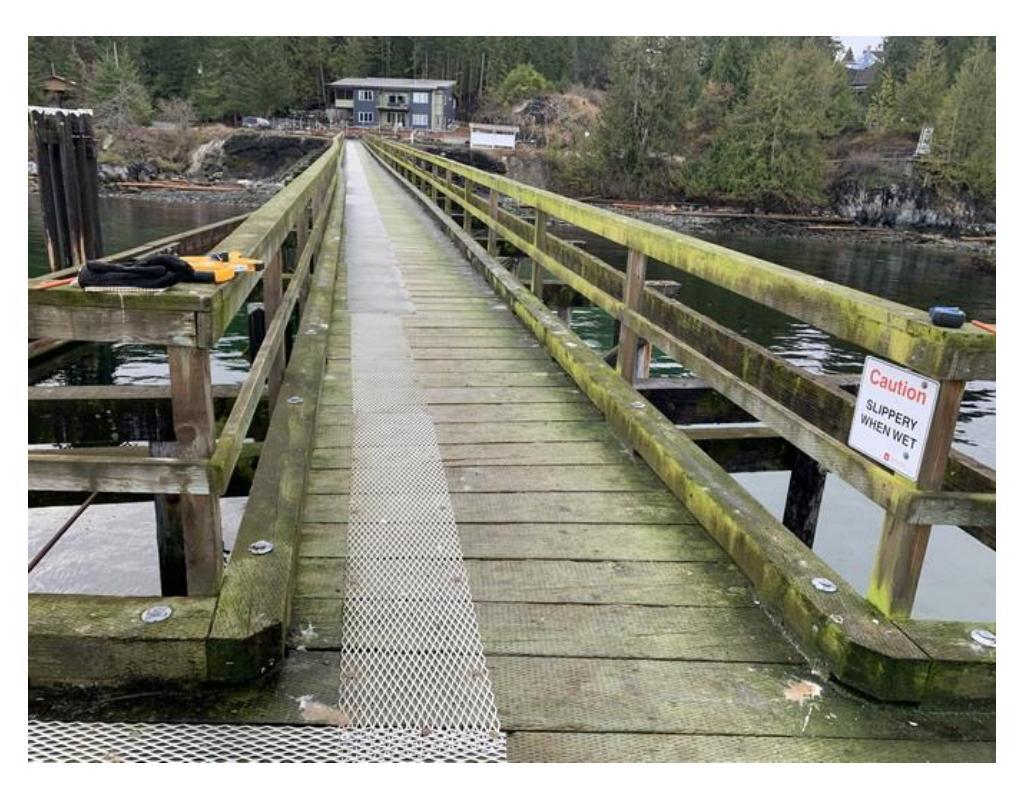
Photograph 3: Approach looking inshore.

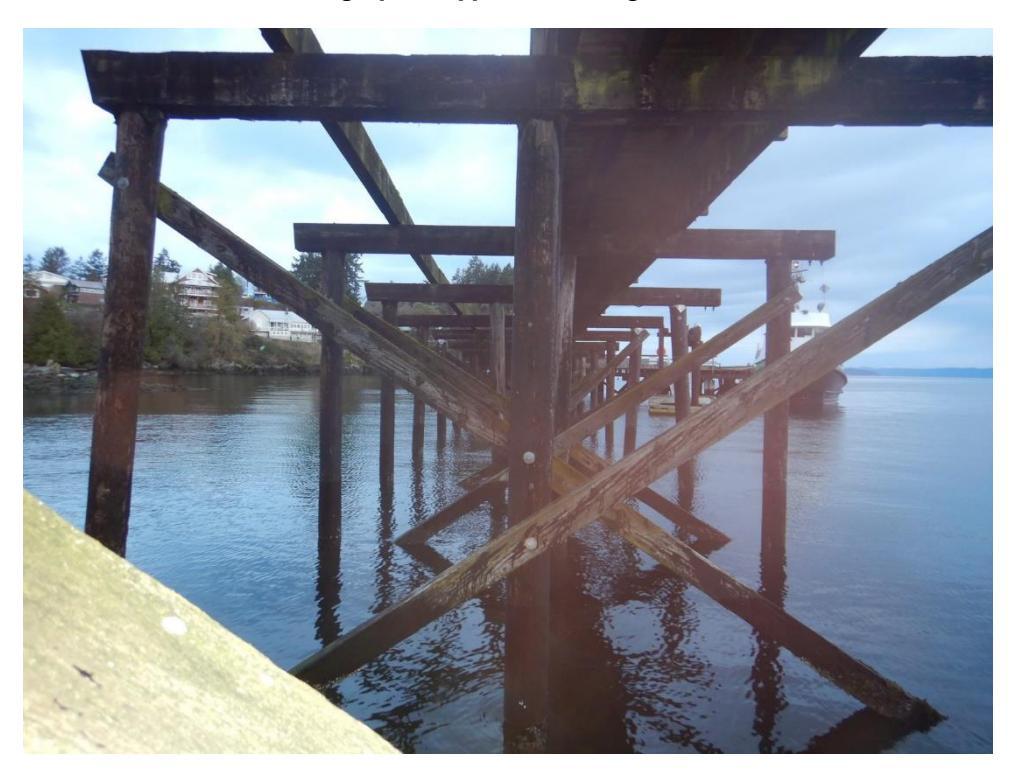
Photograph 4: General arrangement of approach looking offshore.

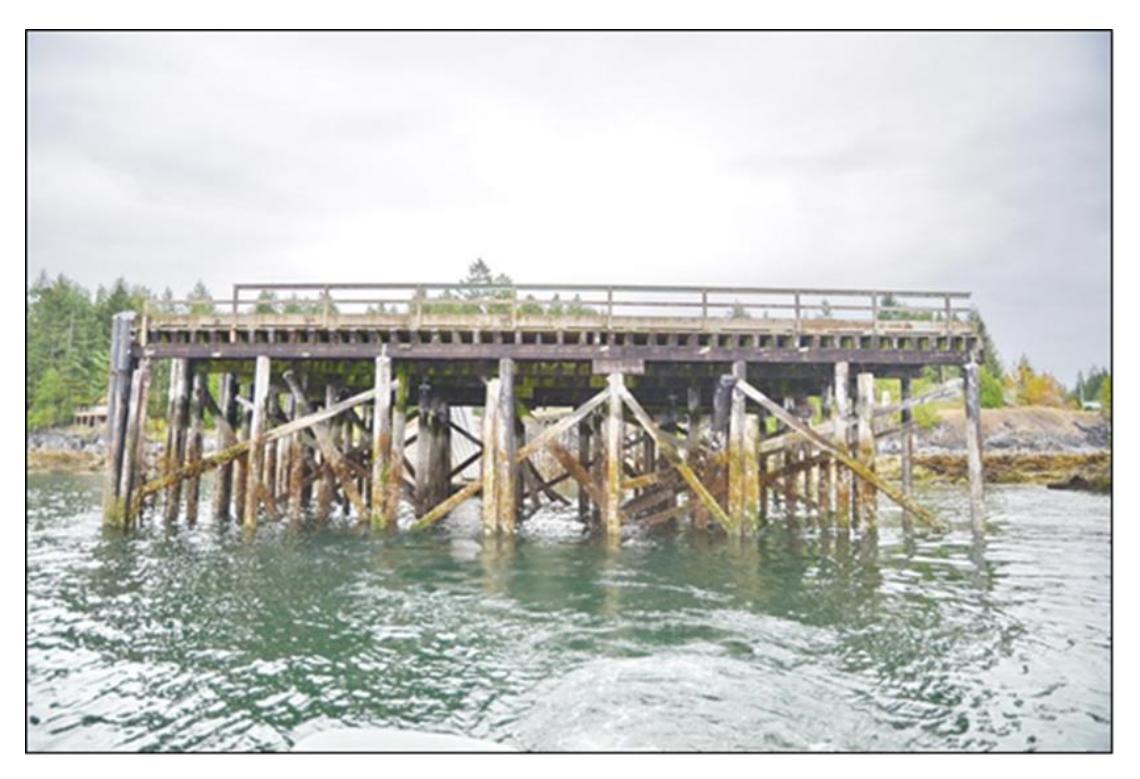
Photograph 5: General arrangement of wharfhead.

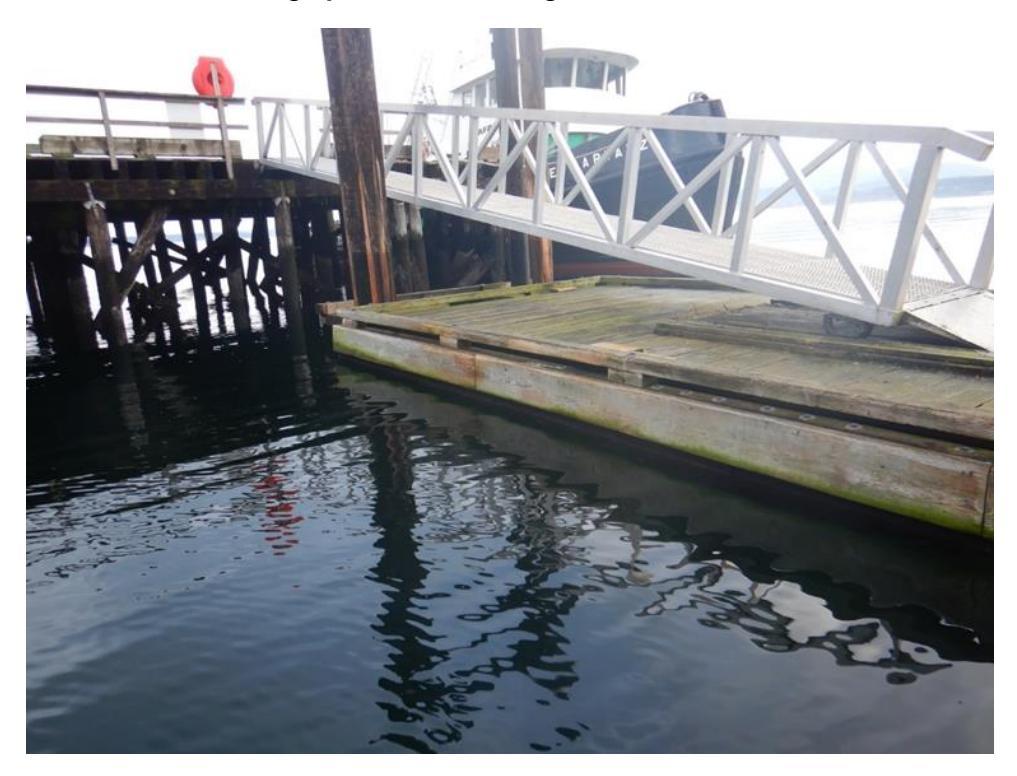
Photograph 6: Gangway to landing float at high tide.

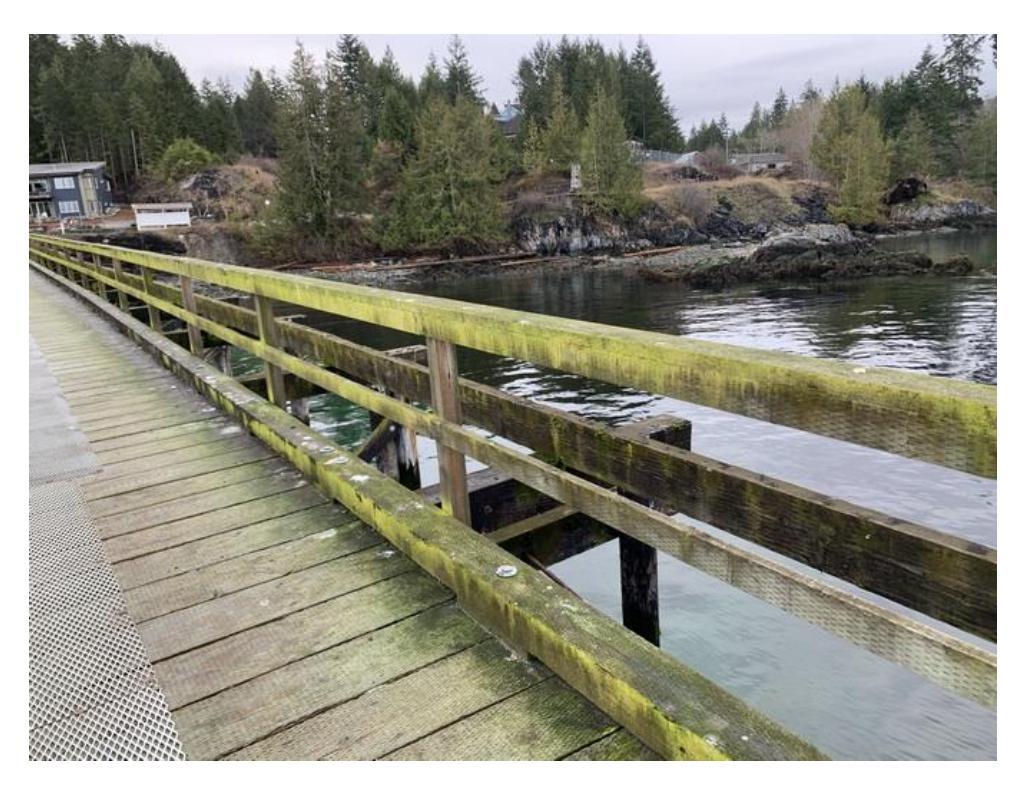
Handrails were visually inspected. The rail timbers and posts are in good condition with light weathering and abrasion wear from use; see Photograph 7.

Photograph 7: Light weathering of wharfhead deck.

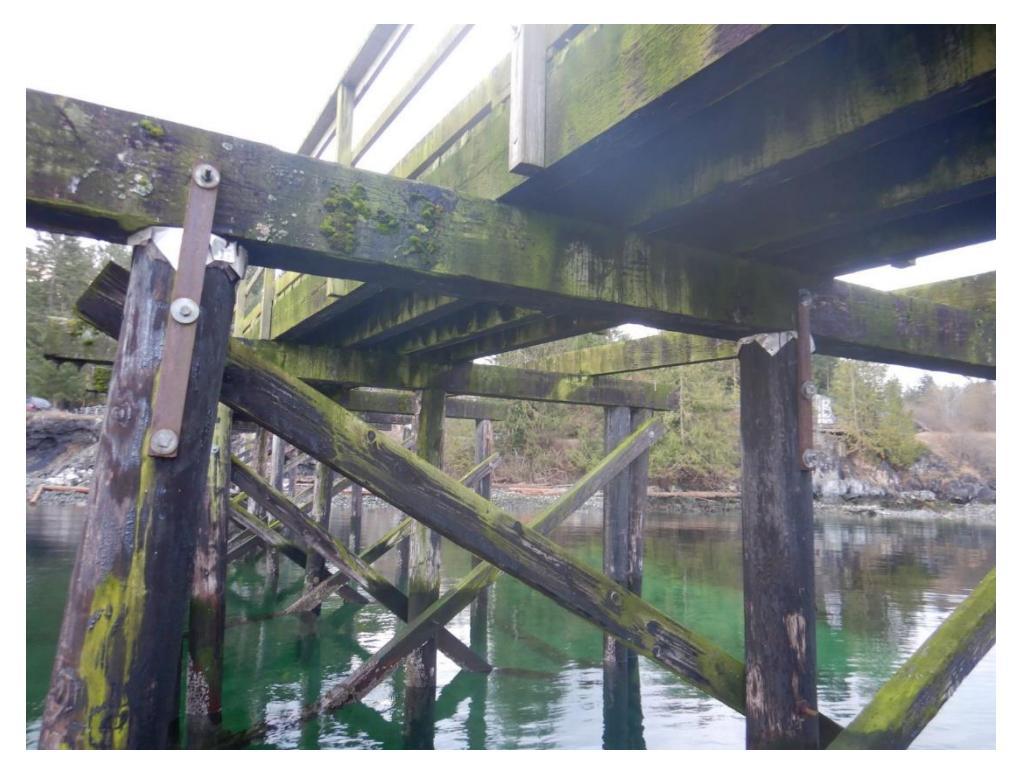
All caps were visually inspected, selectively hammer sounded and cored when suspected to have internal decay. The caps are generally in good condition with light weathering and checking; see Photograph 8. The caps in Bent 11 and Bent 16 were confirmed to still have heavy fungal damage that was identified in the 2017 report. The caps located at Bents 9 and 21 had light to moderate fungal decay. See Table 2 List of Damaged Sub-structure Timbers.

Photograph 8: Weathering of caps, stringers, and piles of approach.

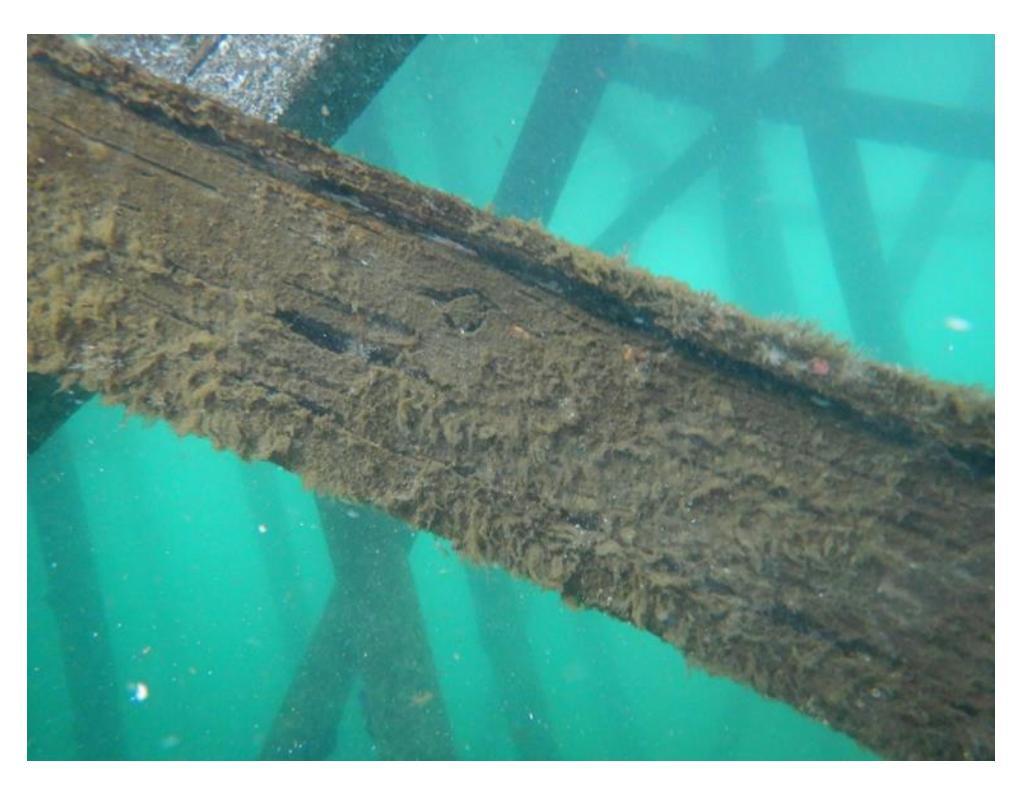
Creosote treated cross-bracing is present throughout the approach. Cross-bracing runs between the piles in each Bent. Seven braces have significant marine borer damage at their lower ends, see Photograph 9. Four spacer blocks (used to take up space between the crossbrace and the pile) have heavy marine borer damage. See Table 2 for details.

Photograph 9: Typical marine borer damage to cross bracing.

MAINTENANCE / REPAIR WORK
APPROACH:
Replace Piles : 5C, 9A, 9B, 10B, 14A, and 17B
Multiple Piles. Plug and patch open bolt holes
Replace 6 Cross-braces (Bents 5, 8, 9, 12, 14 & 15)
Replace 5 Walers
Replace 2 brace spacer blocks (Bents 14 & 16)
Tighten bolts securing handrail post various locations
WHARFHEAD:
Tighten bolts securing curb along Bent 19
Tighten bolts securing handrail posts along Bent 24
Replace section of deck at top of gangway
Replace 4 Bearing Piles (19H, 20G, 22E & 24 H)
Replace four Cross-braces (Bents 20, 22 & 24)
Replace three brace spacer blocks (Bent 20)
Replace 6 Fender Piles (Bent 19 – H Fr 4, Bent 20 – H Fr 1, Bent 23 – H Fr 1 & 3, & Bent 24 – H Fr 3)
Replace Ladder
Tighten Tie-off bollard bolts.
GANGWAY:
Replace/ Repair lower transfer plate
Gangway Sliders abrasion
Replace Guide Timbers at lower wear surface.
Install safety chains between handrail and top of gangway
FLOAT & FLOAT ANCHOR PILES:

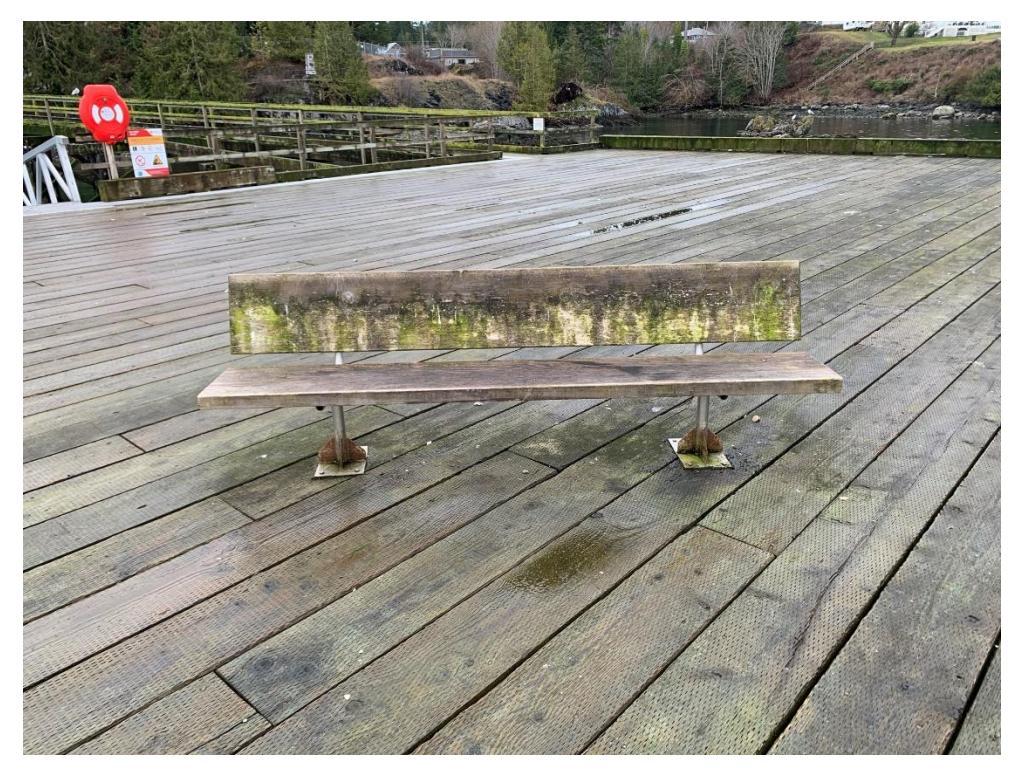
Decking was visually inspected. The decking is in good condition with light weathering and checking; see Photograph 10.

Photograph 10: Wharfhead decking.

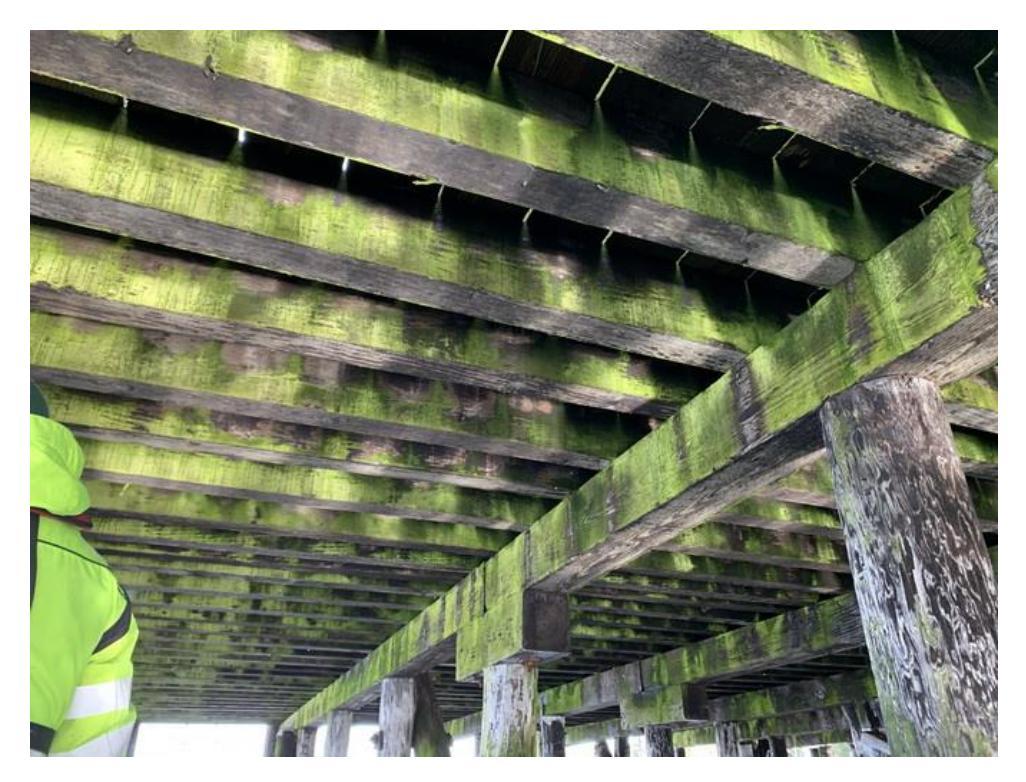
All caps and corbels were inspected visually and selectively hammer sounded and cored where accessible. The caps are in good condition; see Photograph 11. One cap has light mechanical damage at its end; see Photograph 12.

Photograph 11: Weathering of caps, stringers and piles in wharfhead.

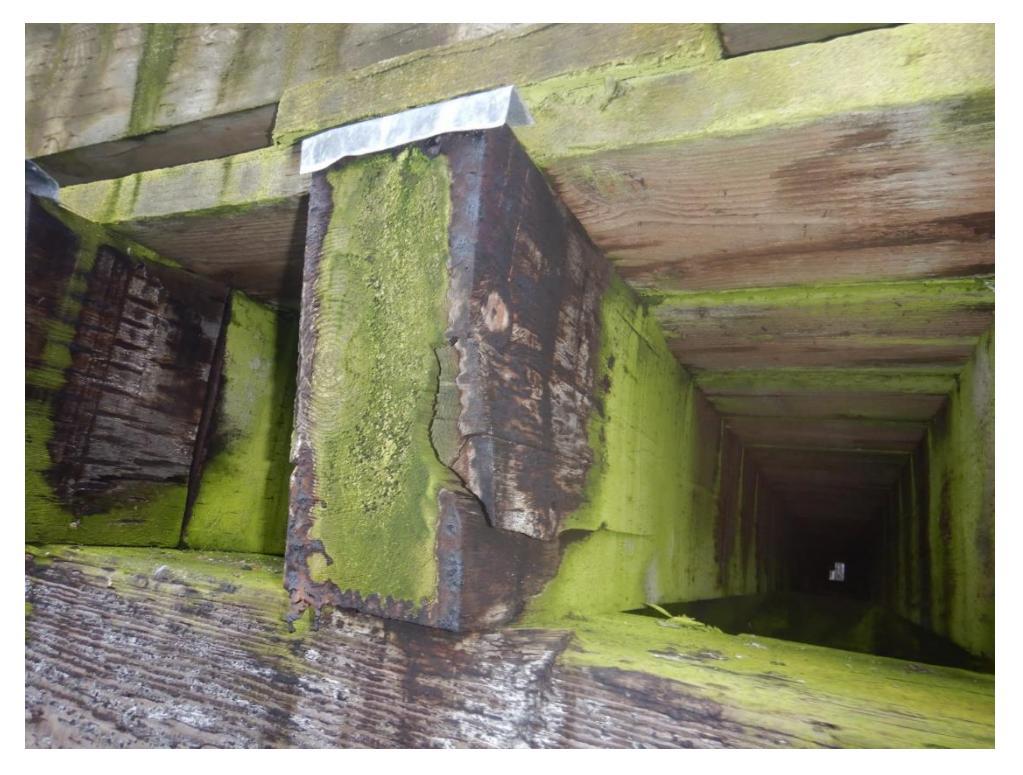
Photograph 12: Light mechanical damage to wharfhead cap.

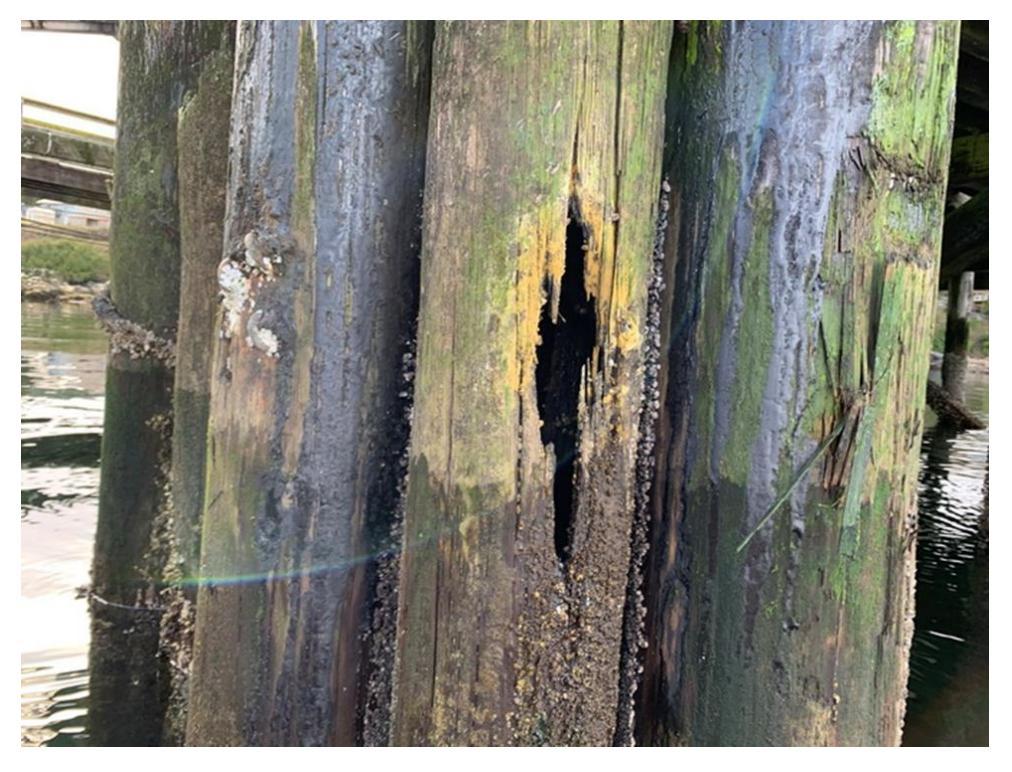
The creosote-treated fender piles are located along the north side of the wharfhead. They are grouped in clusters of three piles except at the north end of Bent 19 which has five piles. Moderate cross-sectional loss located in the intertidal zone has occurred as a result of abrasion damage to the pile surface combined with marine borer attack; see Photograph 13.

Photograph 13: Damage to fender pile bent 19.

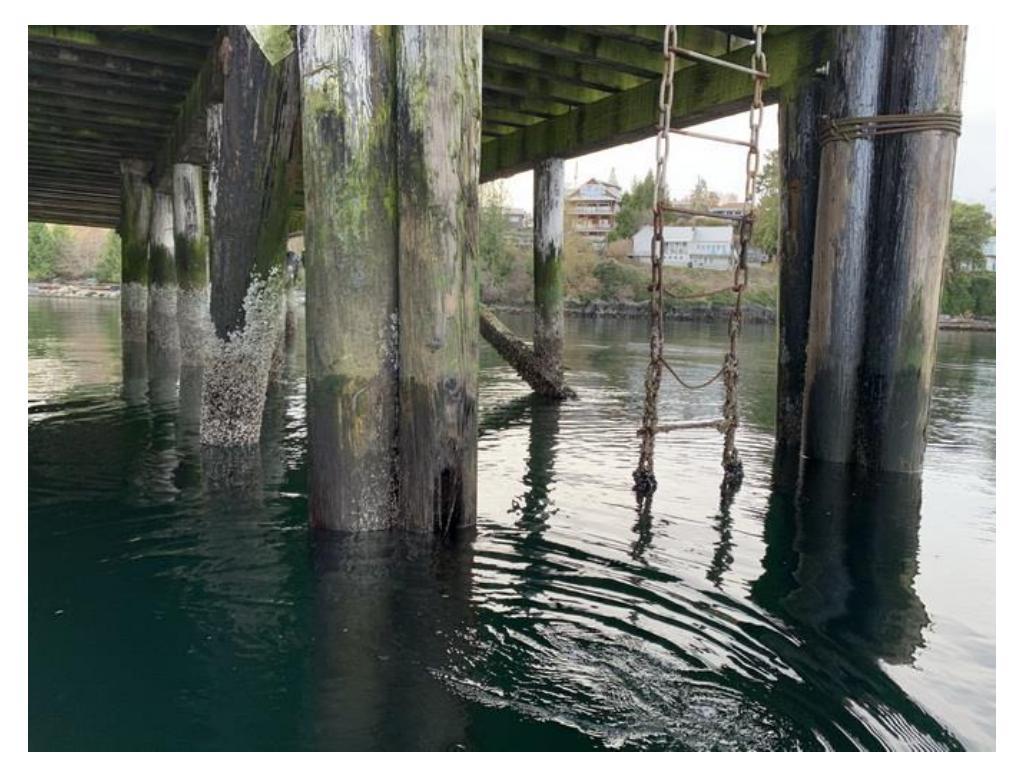
There is one ladder on the north side of the wharfhead. It is in poor condition as one side has failed; see Photograph 14.

Photograph 14: Failed ladder north end of wharfhead.

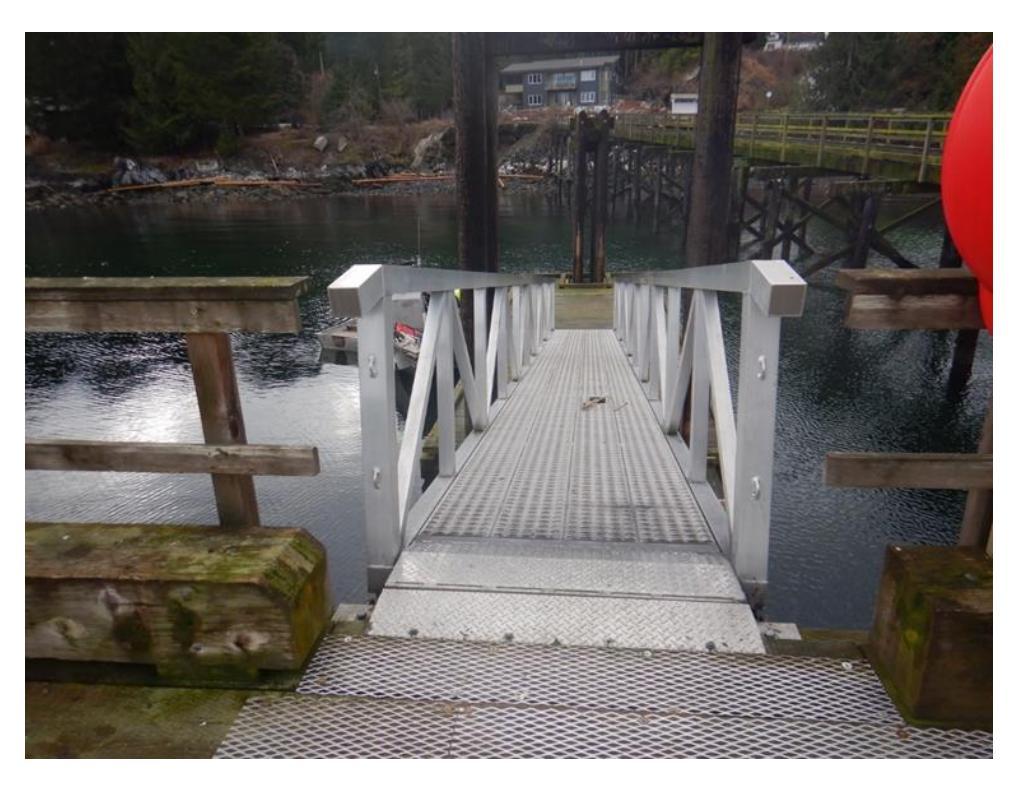
The aluminum gangway is in good condition. There are no safety chains between the top of the gangway and the wharfhead railing leaving a gap; this was previously noted in the 2017 report; see Photograph 15.

Photograph 15: Safety chains missing from top of gangway.

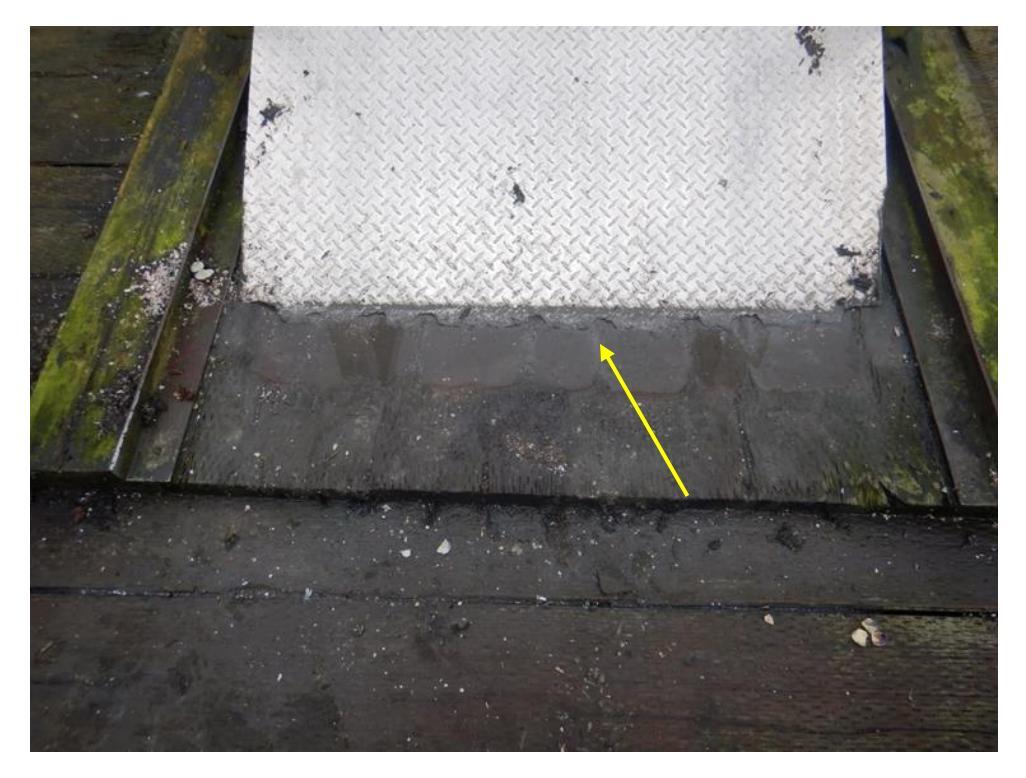
**Lower Transition**: The lower transition is in serviceable condition. The leading edge abrades with the gangway pad and the nails that secure the gangway pad timbers; see Photograph 16. The lower transition remains functional.

Photograph 16: Lower transition plate knife edging.

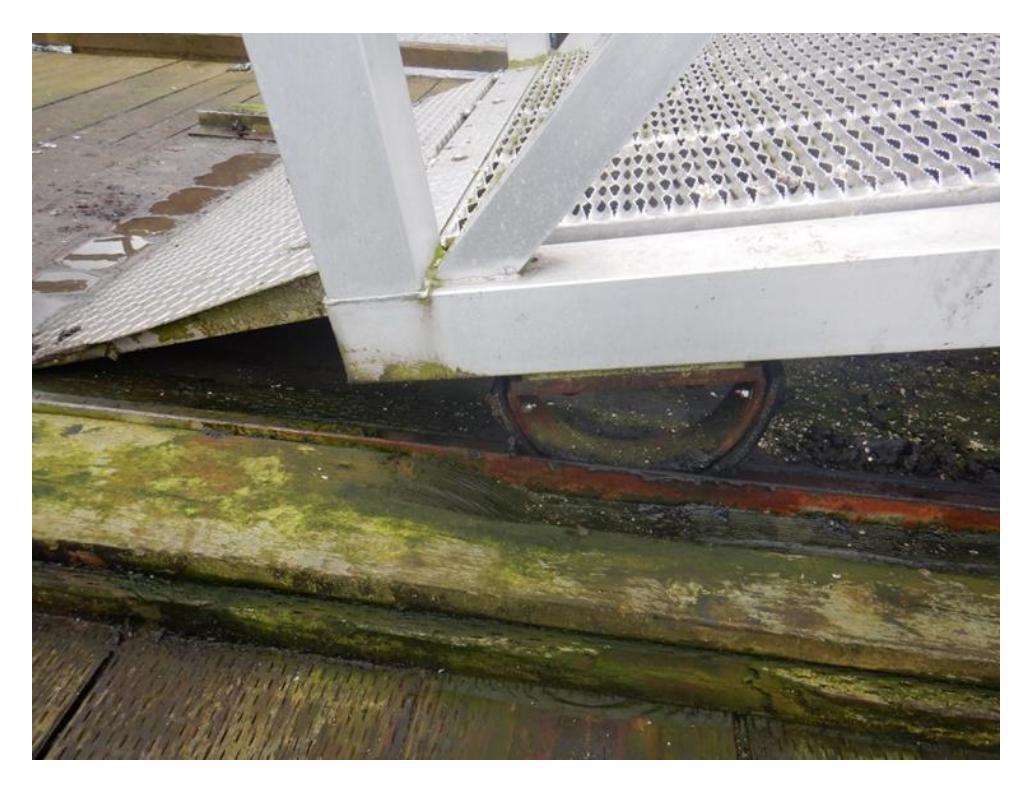
**Sliders & Guide Rails**: The guiderails, sliders and wear surfaces located under the gangway are in serviceable condition with moderate weathering to the timber guide frames; see Photograph 17.

Photograph 17: Moderate deterioration of timber guide frames.

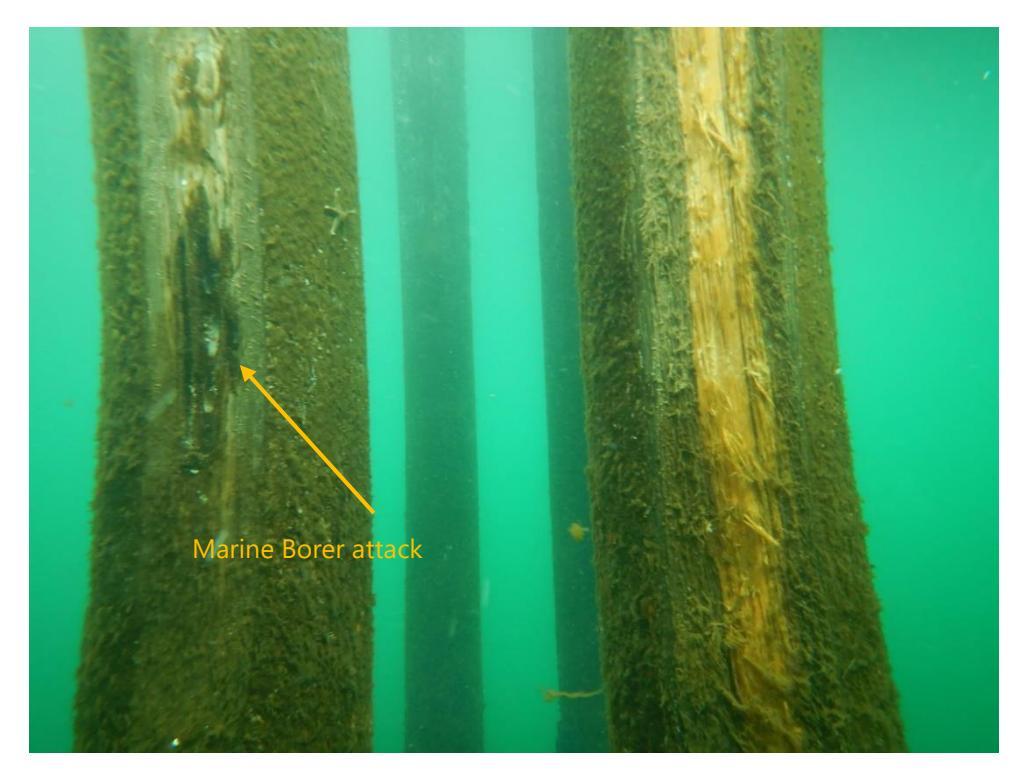
Abrasion damage has taken place to seven of the 10 piles. Generally, this has resulted in a cross-section loss of 10% or less to the piles. One pile (East Cluster SW corner) has more significant damage with marine borers creating additional internal damage to the pile; see Photograph 18.

Photograph 18: Fender pile abrasion and marine borer attack.

Pile Cluster Well Liners. Install strips on piles & replace well liners as required
Replace Float Anchor Pile (E. Cluster – Pile 2 SW and pile 5 NE)(SW cluster pile 1W)
Tighten bull-rail bolts as required
Replace northeast bull-rail
Add Flotation to shore end of float
UPLAND FORESHORE:

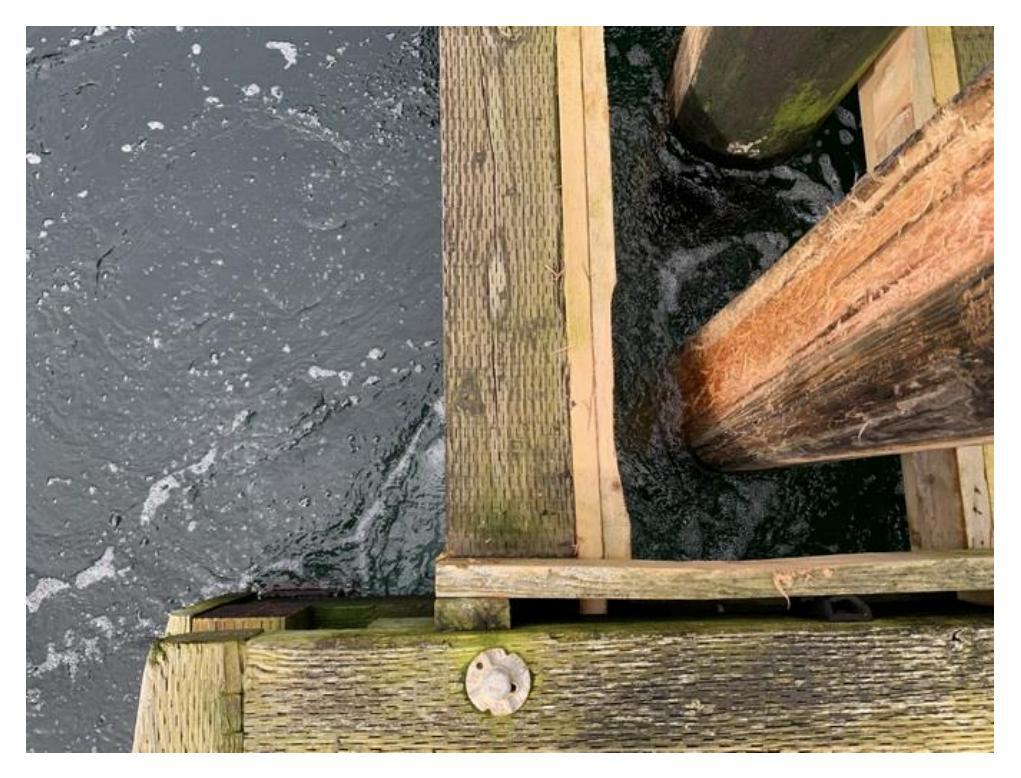
Pile wells were inspected visually. The pile wells around the three pile clusters are in fair to good condition. The well liners continue to abrade and should be replaced regularly; see Photograph 19.

Photograph 19: Typical well and pile abrasion.

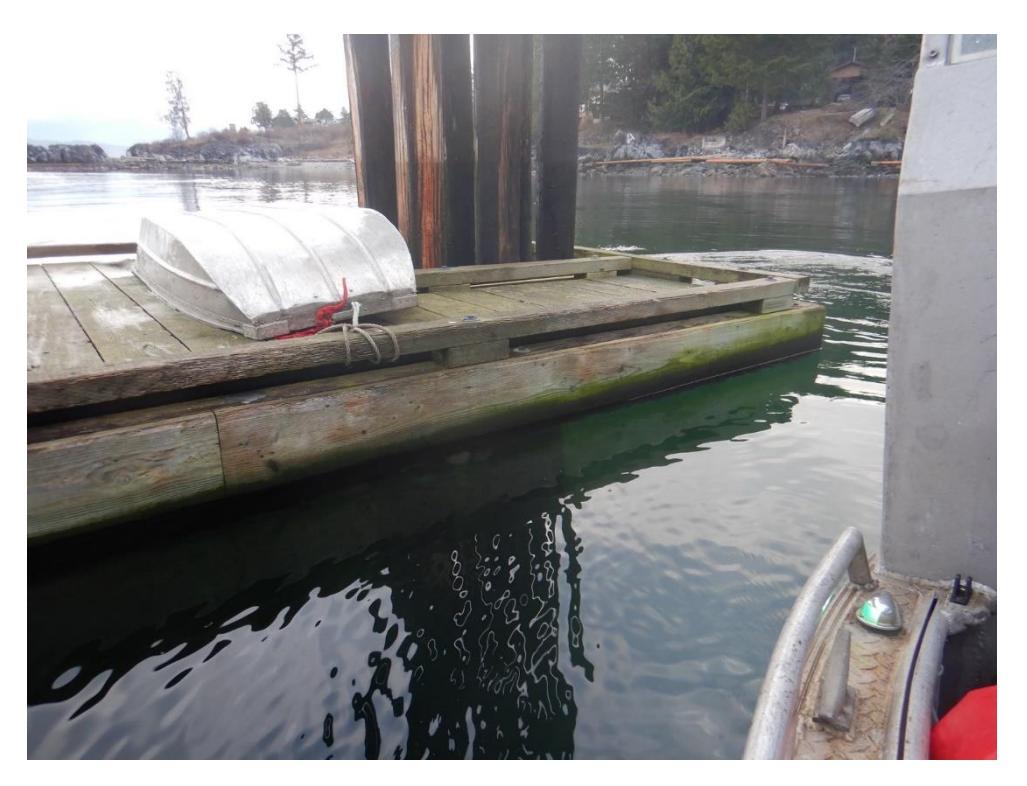
Freeboard was measured to the top of the stringers at the corners of the float. The float sits higher at its west end (ramp end) with a freeboard ranging from 375mm to 400mm. At the east end (inshore end) the freeboard is 300mm. There is more flotation at the west end of the float that probably accounts for the difference in freeboard measurements. This remains unchanged from the previous inspection; see Photograph 20.

Photograph 20: Landing float low on the east end.
