# SAVARY ISLAND DUNE AND SHORELINE STUDY

The Powell River Regional District

Thurber Engineering Ltd.  
Vancouver, BC

File: 14-197-0  
March 12, 2003

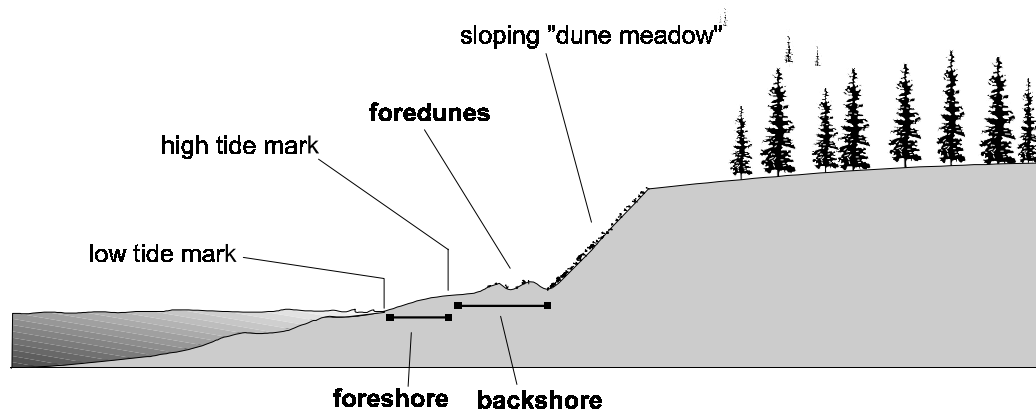
Figure 2. Cross sectional view east to west of the “dune meadows” on the steep slope overlooking the foredune just east of the east terminus of Sunset Trail (DG-2-G). This slope supports a great diversity of herbaceous plants (plus tall Oregon-grape) typical of foredune and coastline dune meadows.

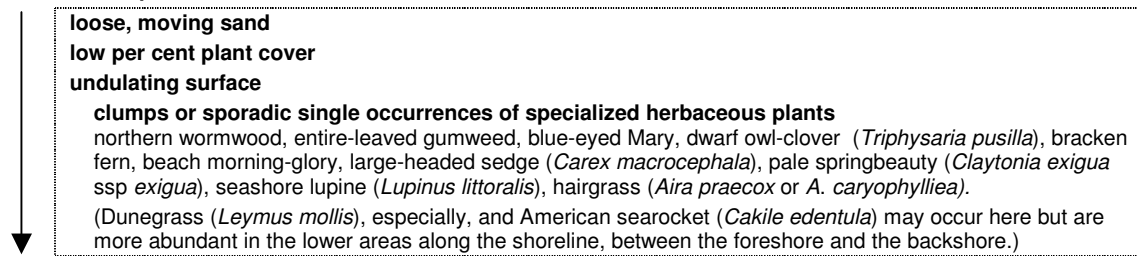
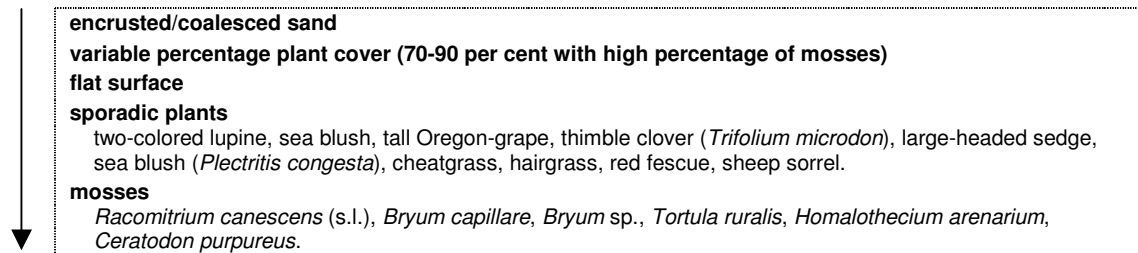
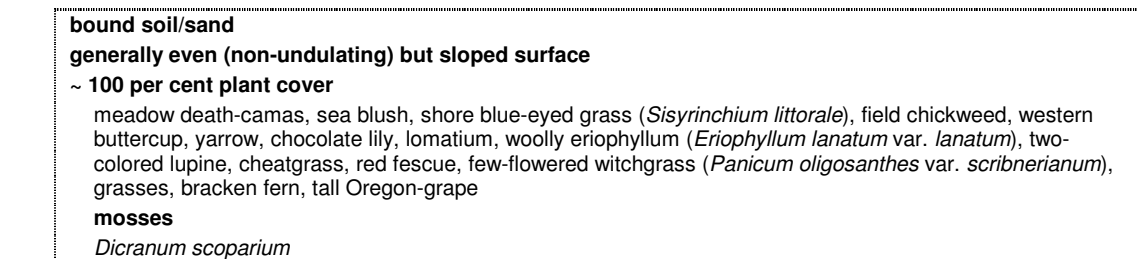
Figure 3. Succession from foredune and unconsolidated sand dune area, to dune meadows.

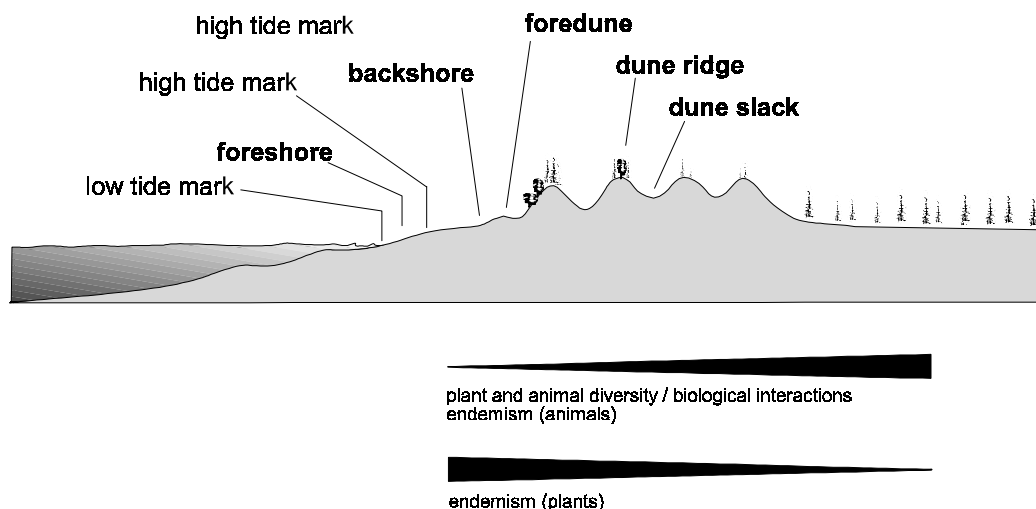
Figure 4. Cross sectional view from east to west of the inland dunes extending northeast from foredunes and dune meadows east of Beacon Point (DG-2-C,D). To illustrate the general configuration, the dunes in this diagram are represented as being parallel to the shoreline when they are actually aligned obliquely to the shoreline: the shoreline is oriented east-west, while the dunes are oriented southeast-northwest. The elongated triangles show trends (increasing or decreasing) in diversity, endemism and biological interactions along a gradient from foredunes/dunes to inland forests (after Brown and McLachlan 1990).

The ancient sand dunes are most fully developed in the centre portion of the island (Figure 4). They comprise one third of the area of Savary Island, or 150 ha (CDC 2002). The series of parallel ridges and slacks (depressions between ridges) are aligned along a southeast-northwest axis, following the alignment of the prevailing southeast winds. These dunes lie mainly within Lot 1375 but extend to and terminate in Lot 1376 to the northwest. The dune ridges reach a maximum elevation of 31 m above sea level. The greatest difference in elevation between dune ridges and adjacent slacks is approximately 20 m.

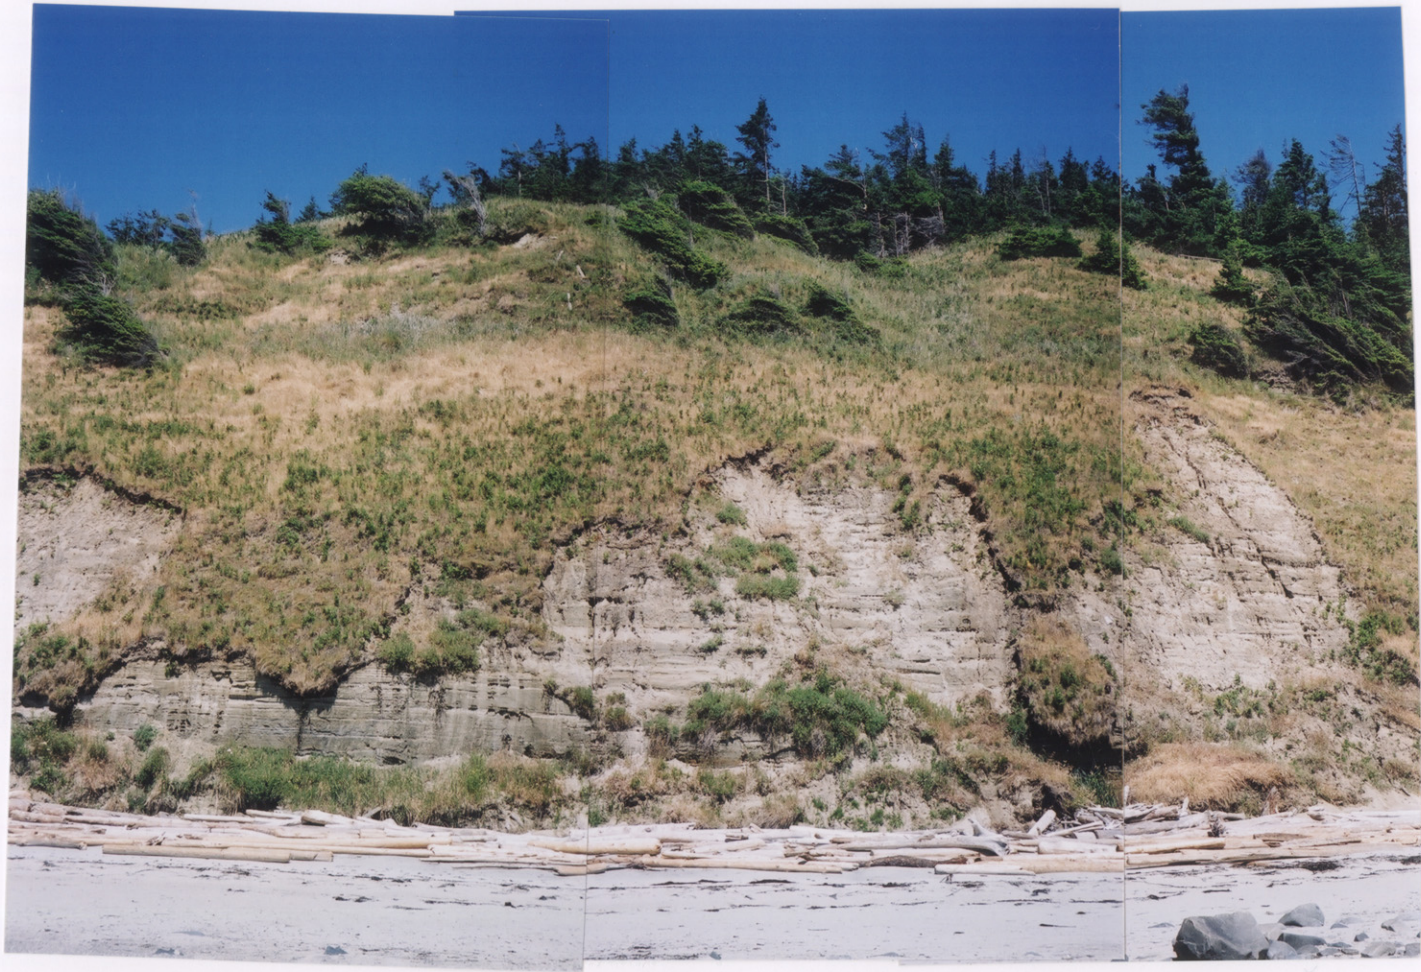
Photo 2 - Looking north at the south shore bluffs between McLean Road and Sutherland Road. Slumps and planar soil landslides are promoted by groundwater discharge in the Quadra Sand. Lines of lush vegetation define seepage zones higher on the slope.

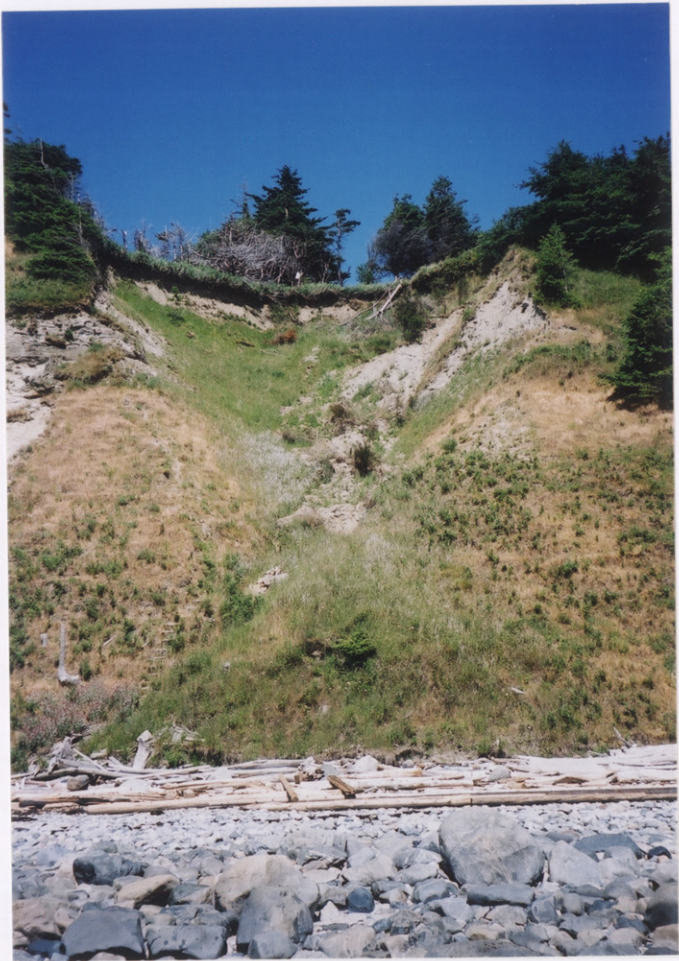
Photo 3 - Looking north at a gully on the south shore near the end of Sutherland Road. A recent slide has taken place, initiating on the east side of the gully head. Slide debris from past events has built up a debris cone at the base of the slope.

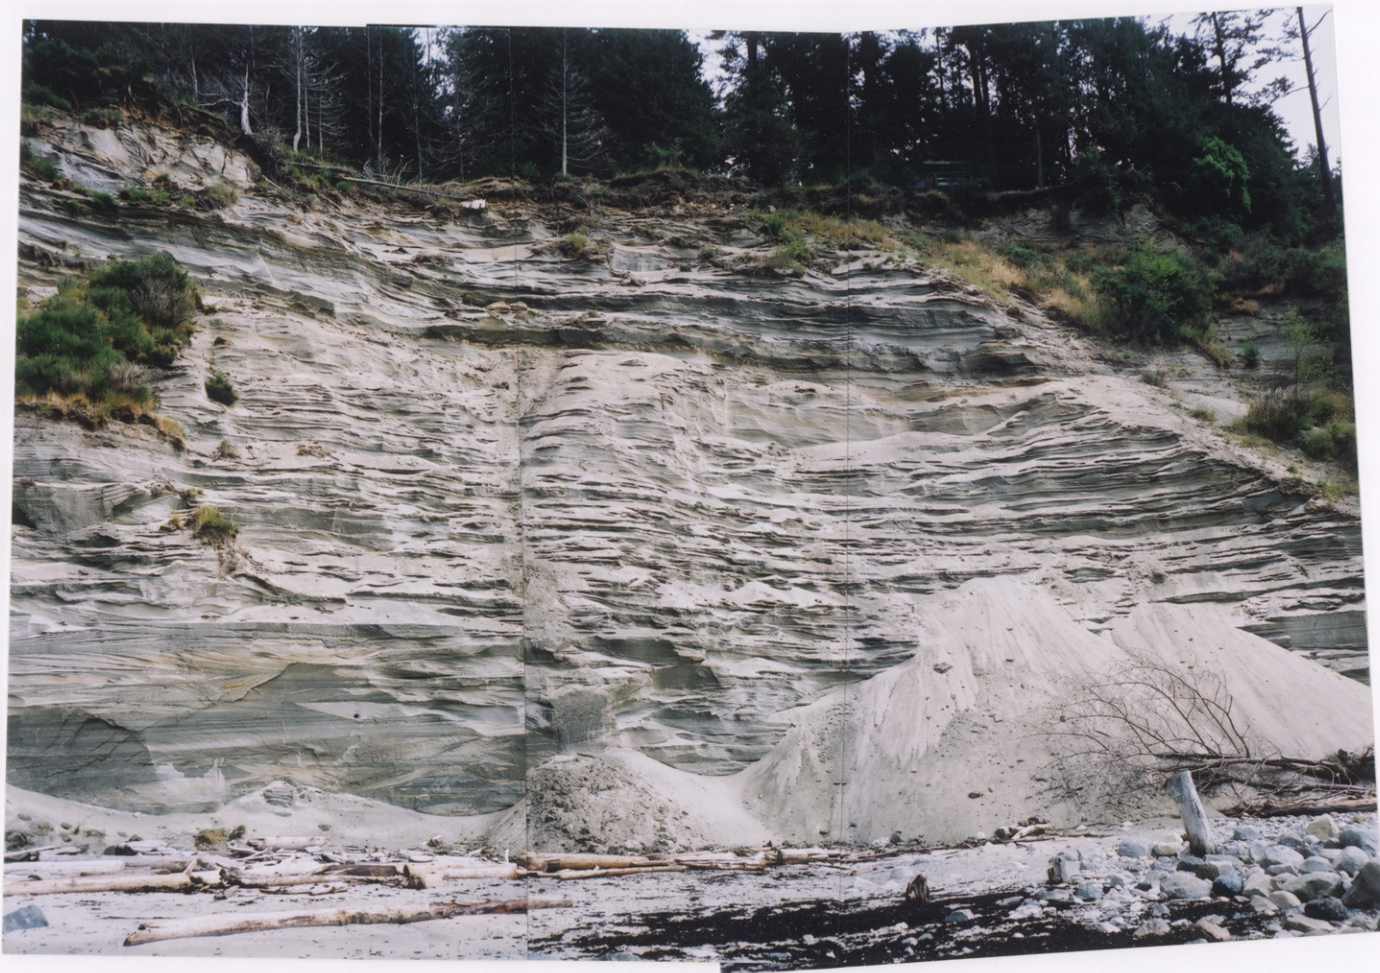
Photo 4 - Looking north at the erosion face in Quadra Sand on the west side of Garnet Point. Eroded sand accumulates at the base of the slope and is removed by wave action. Intense erosion here is ascribed to refracted storm waves from the southeast. The Geological Survey of Canada measured 0.38 m of bluff crest retreat in 1 year at this location.

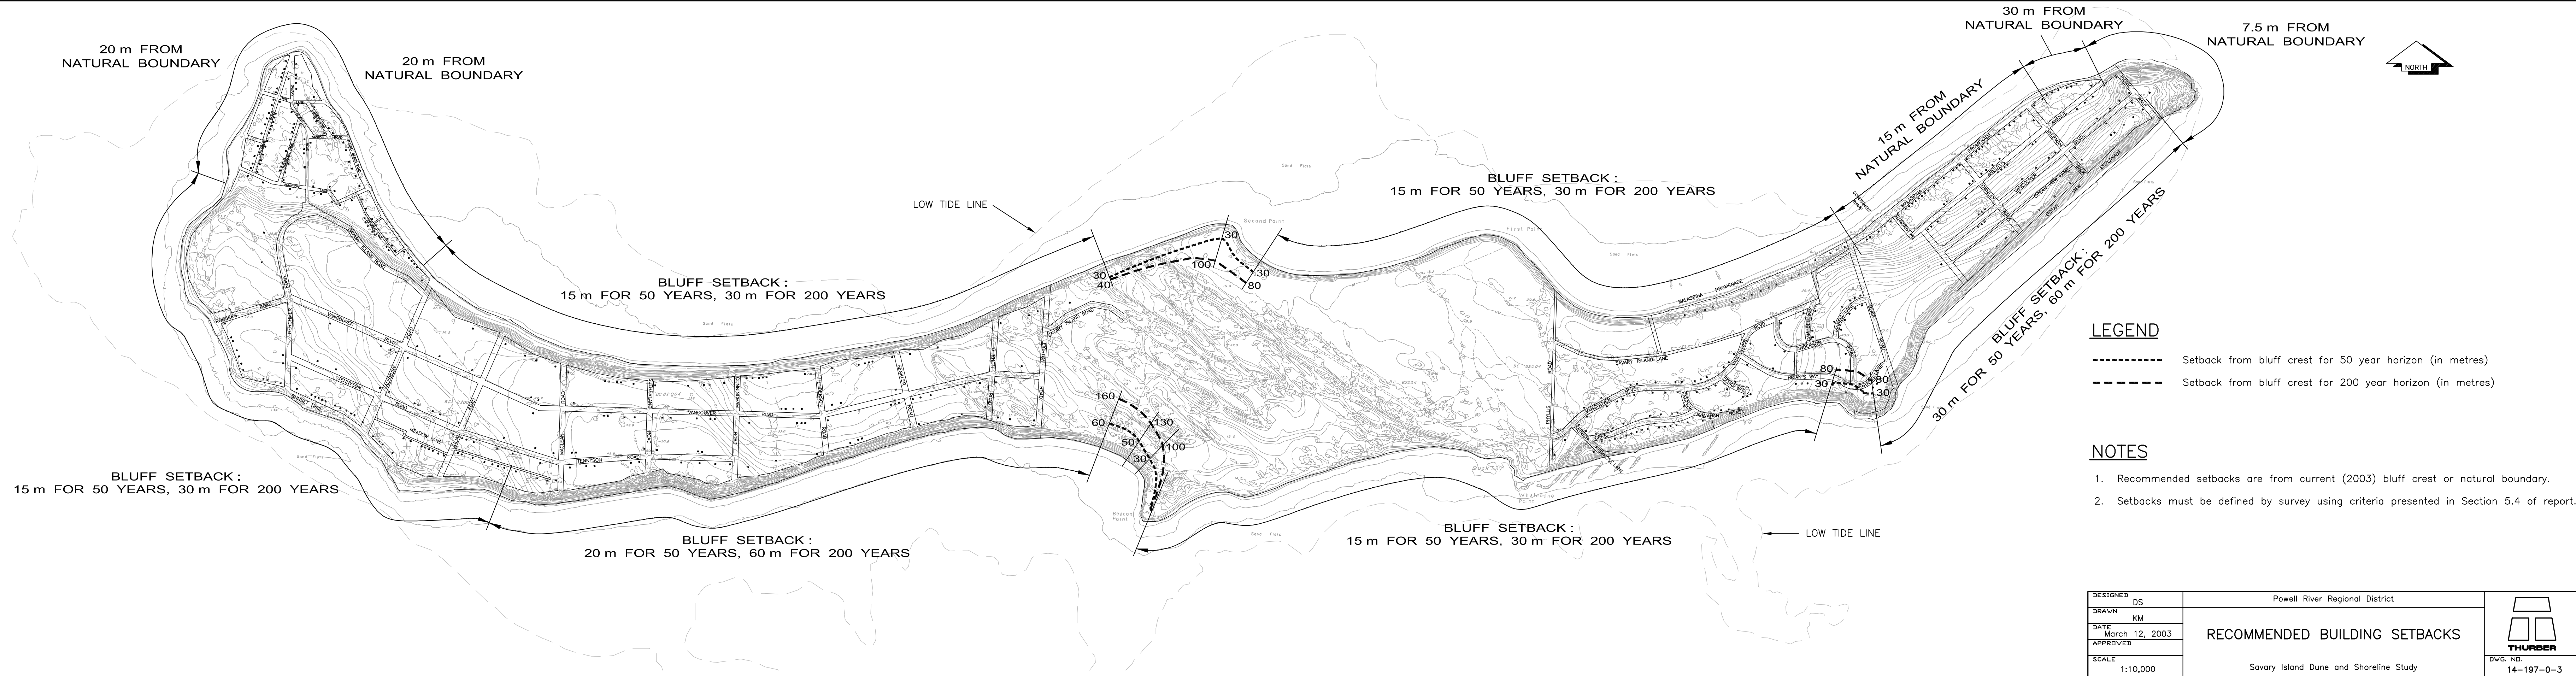
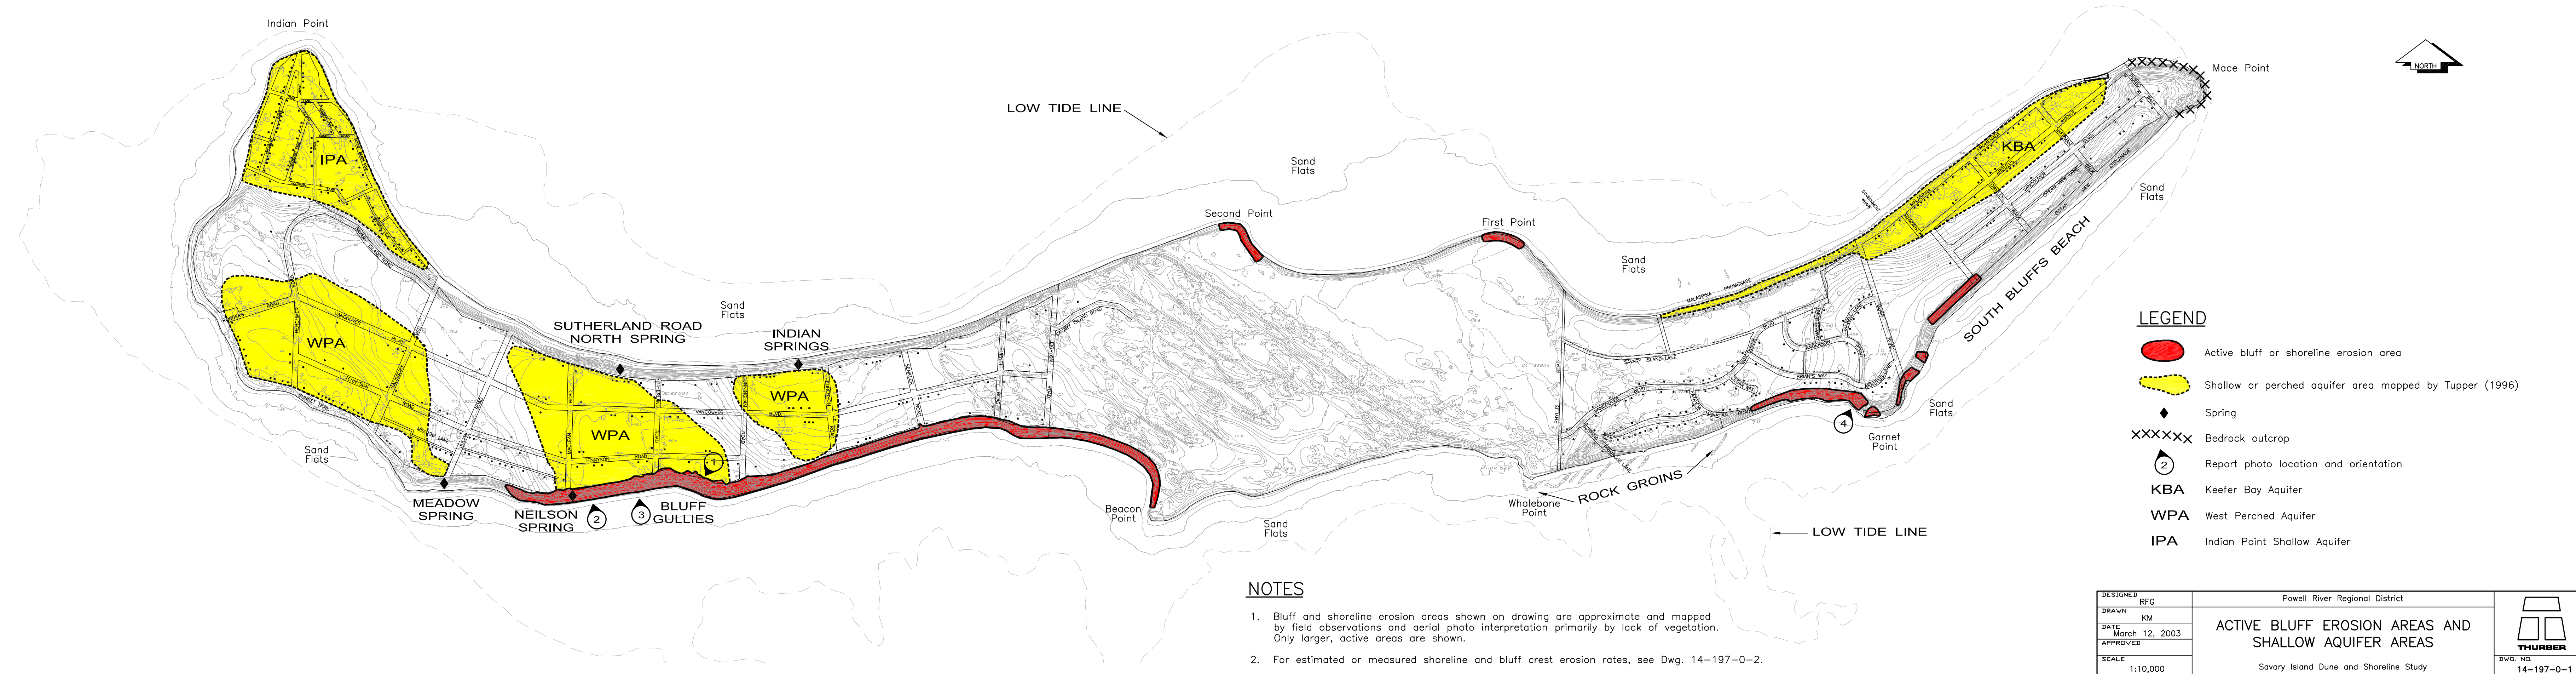
DRAWN KM	ACTIVE BLUFF EROSION AREAS AND SHALLOW AQUIFER AREAS		
DATE March 12, 2003			
APPROVED			
SCALE 1:10,000	Savary Island Dune and Shoreline Study		DWG. NO. 14-197-0-1

1. Bluff and shoreline erosion areas shown on drawing are approximate and mapped by field observations and aerial photo interpretation primarily by lack of vegetation. Only larger, active areas are shown.
2. For estimated or measured shoreline and bluff crest erosion rates, see Dwg. 14-197-0-2.

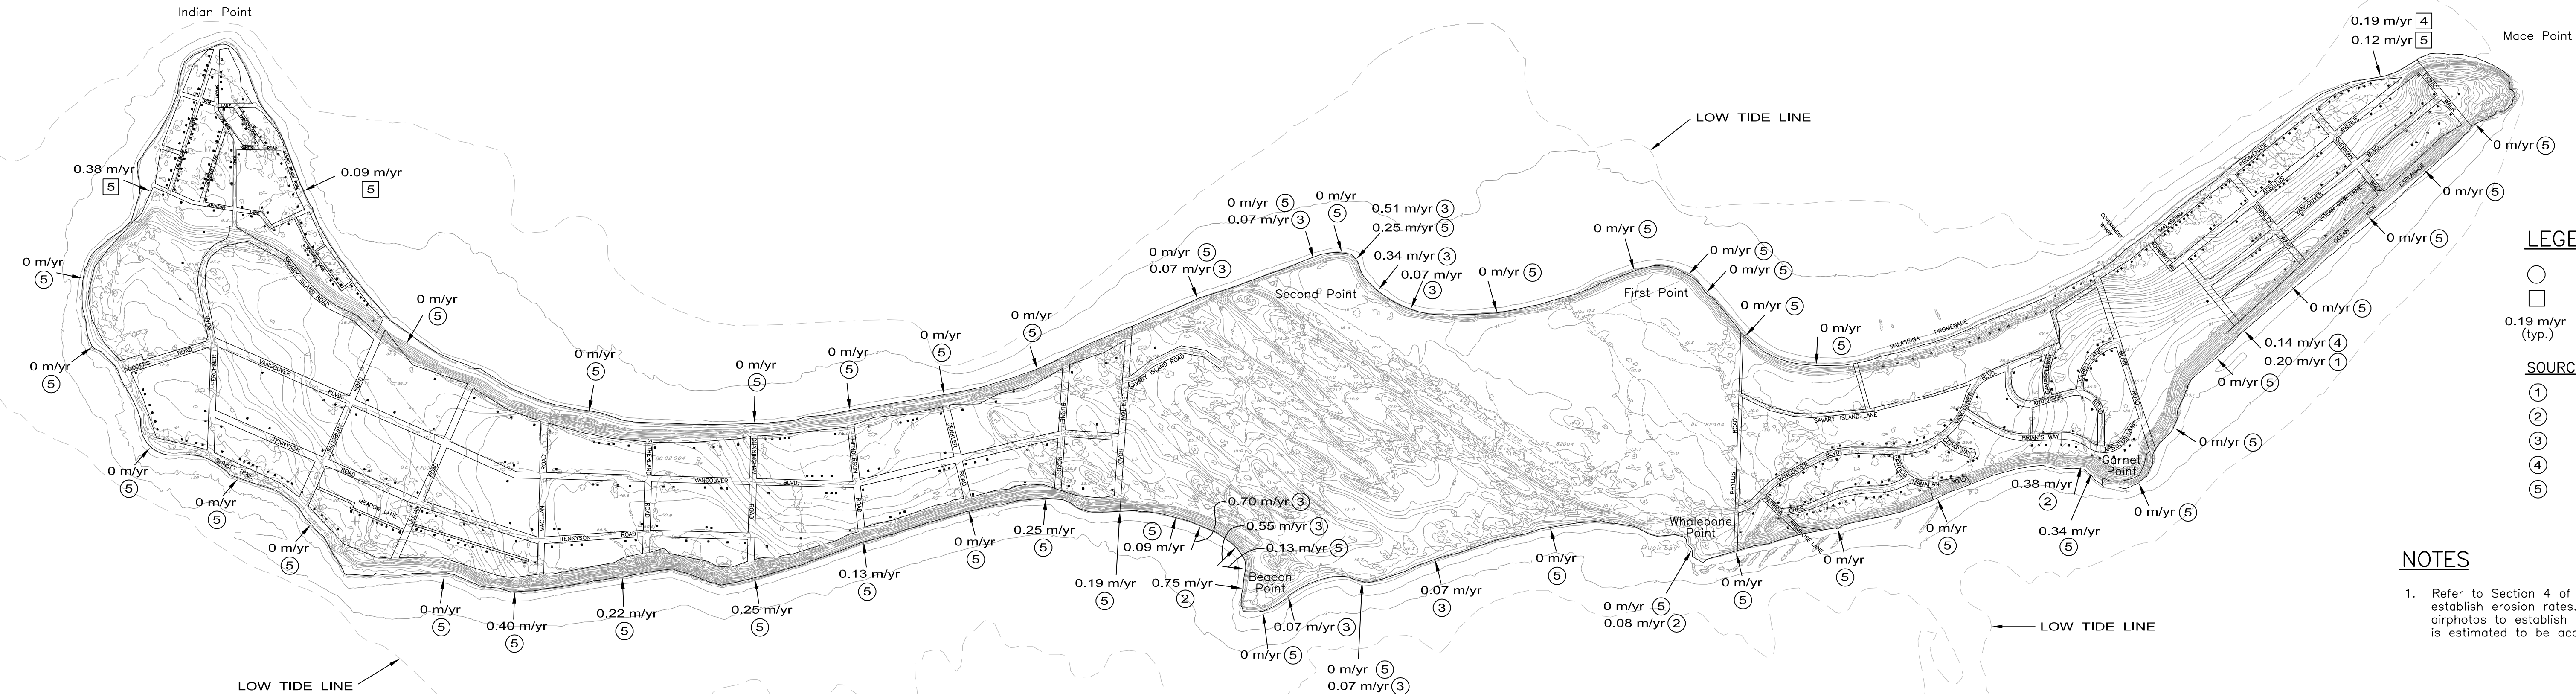
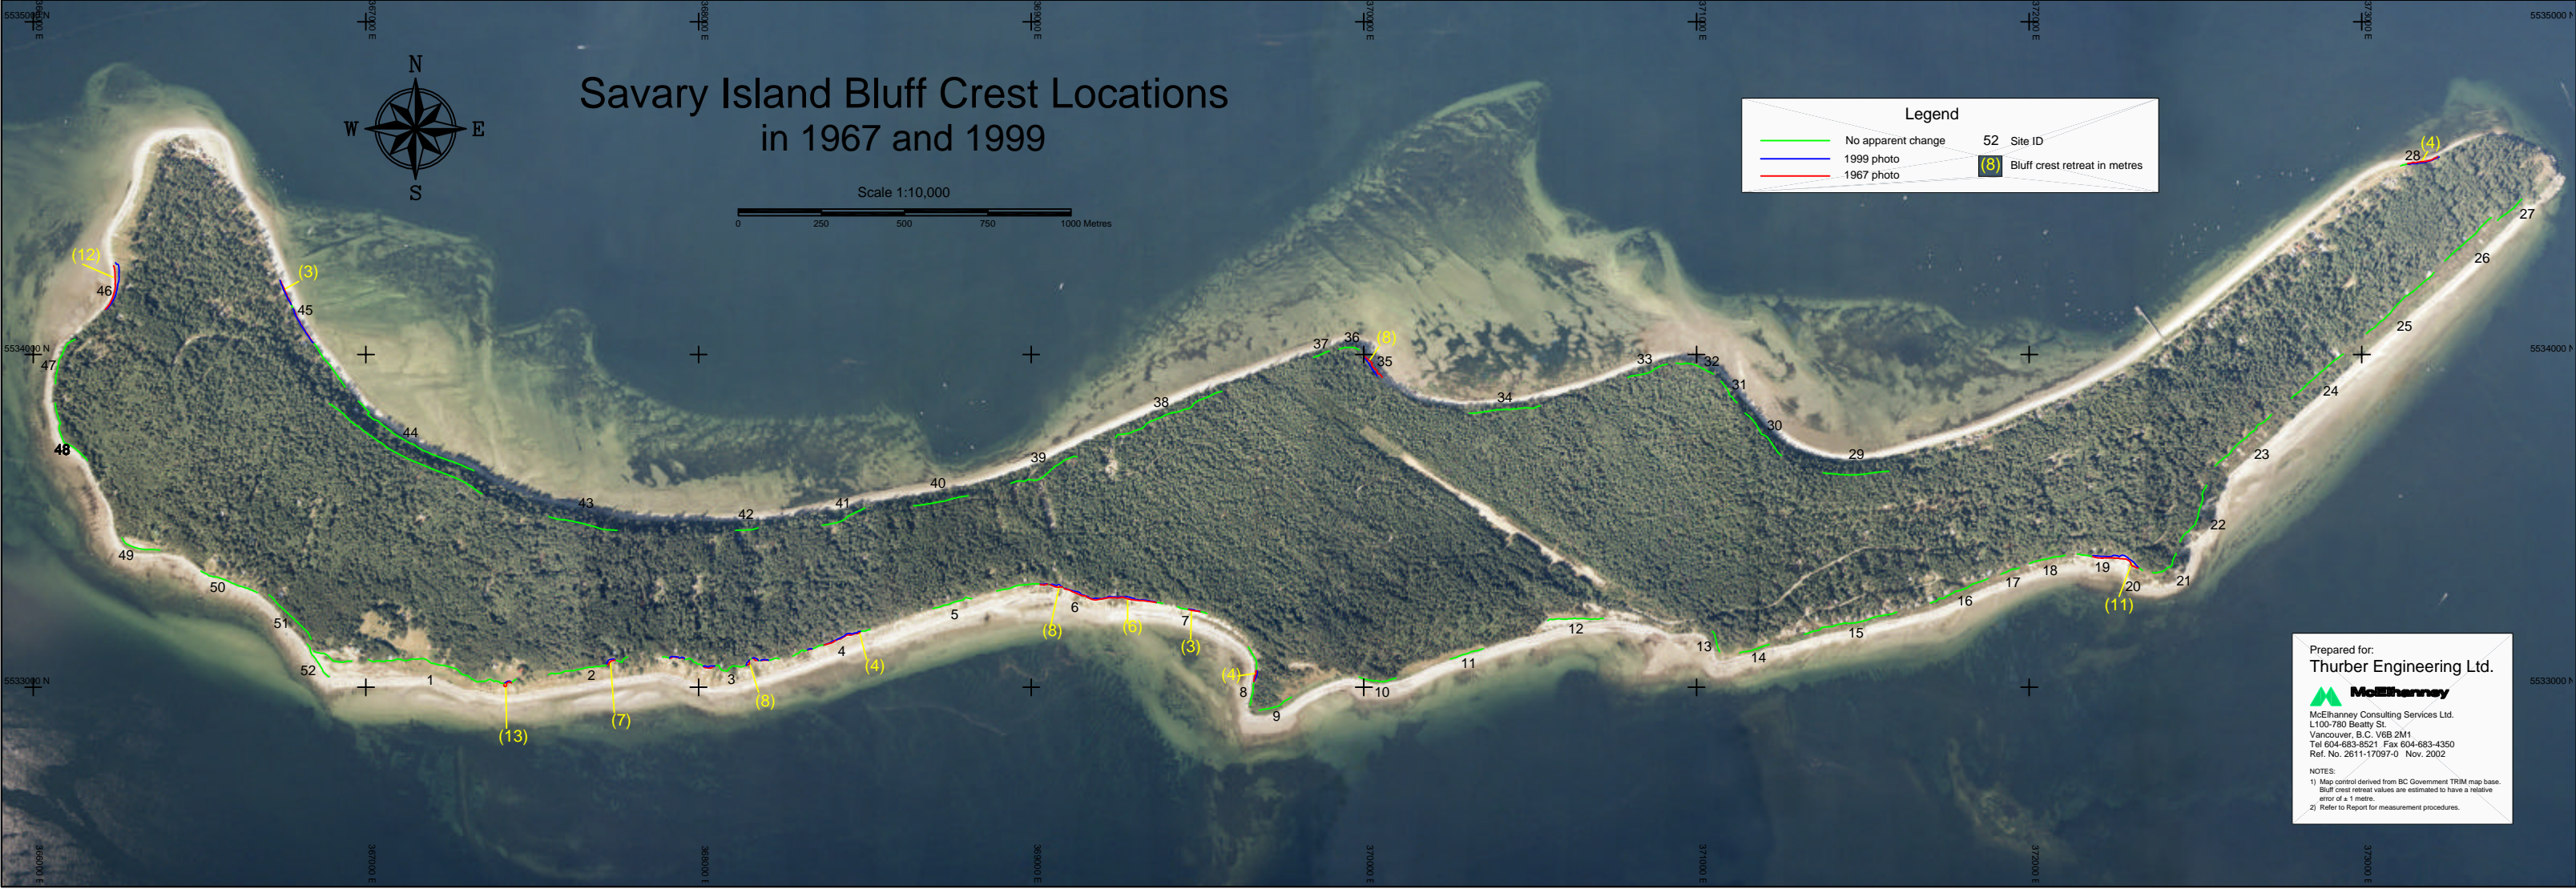
(8) Bluff crest retreat in metres

Building setbacks from the current bluff crest for 50 and 200 year horizons determined by application of the recommendations in Section 5.4 are shown on Dwg. 14-197-0-3. It should be recognized that the setbacks are preliminary and for guidance only. They assume that the current slope angle of the bluff is 40° and that the contours on the base plan accurately represent the bluff height. They should be defined in the field by survey of the bluff height and crest and consideration of the erosion which might have taken place since this report was prepared.
