Powell River Regional District Landslide and Fluvial Hazards Study Electoral Areas B and C

**POWELL RIVER
REGIONAL DISTRICT**

SEPTEMBER 4, 2015

FILE: V13103482-01 DOCUMENT NO. 002

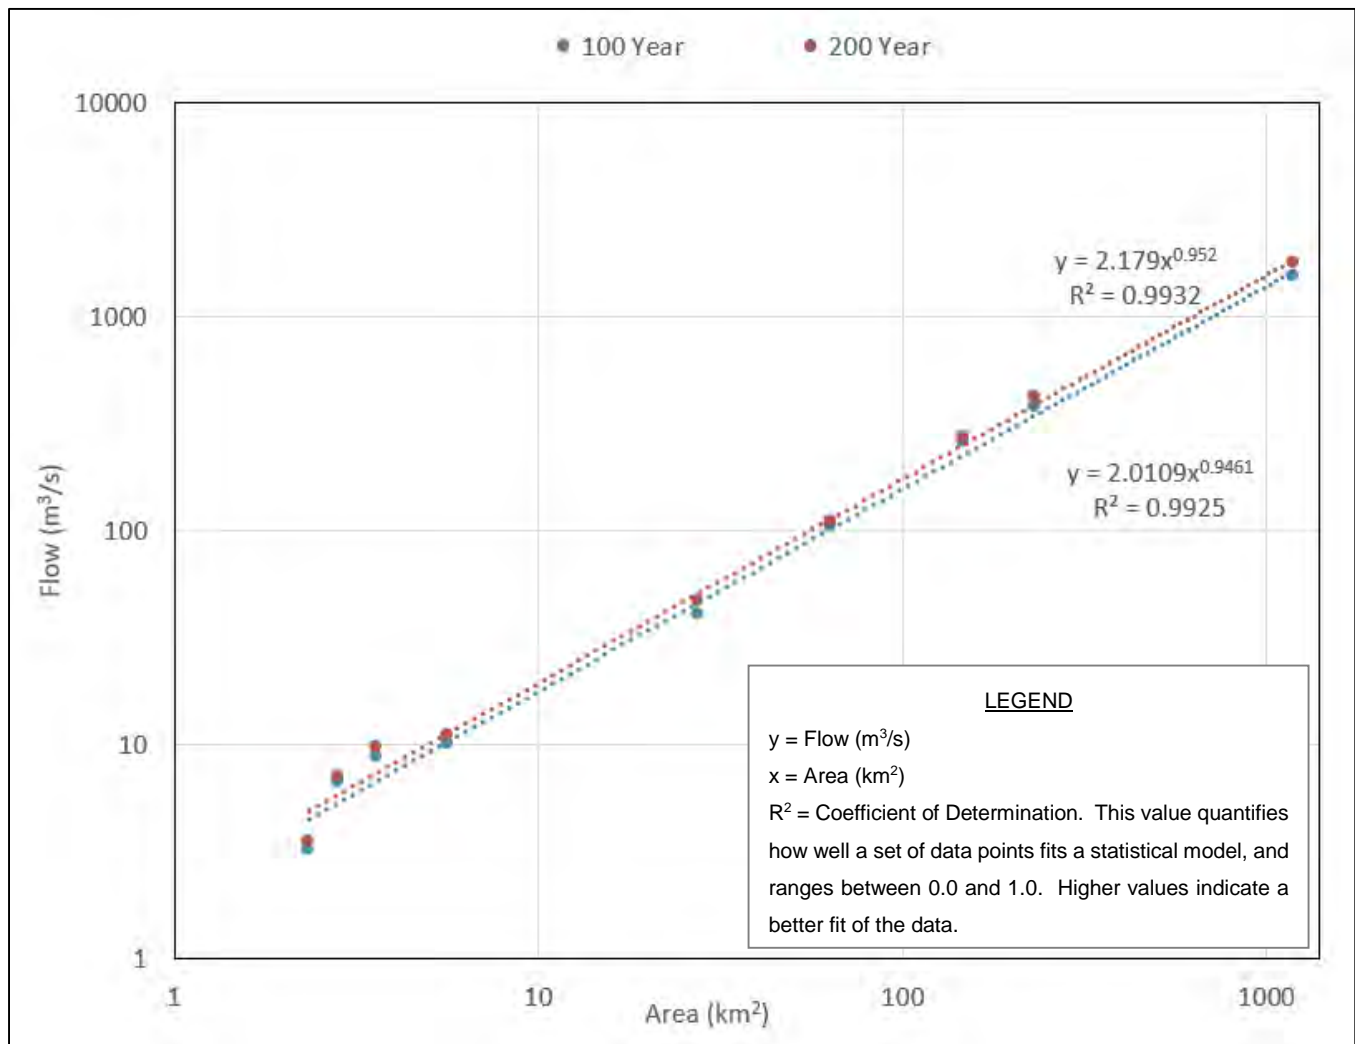
Figure 14: Relationship between peak flow and watershed area for nine WSC stations adjacent to study area for the 100-year and 200-year return periods.

A flood frequency analysis was performed on the flow data from each station and the 100-year and 200-year peak flows were estimated for each of the gauged stations. Figure 14 presents the relationship between watershed area and estimated flow for each return period for the nine stations analysed.

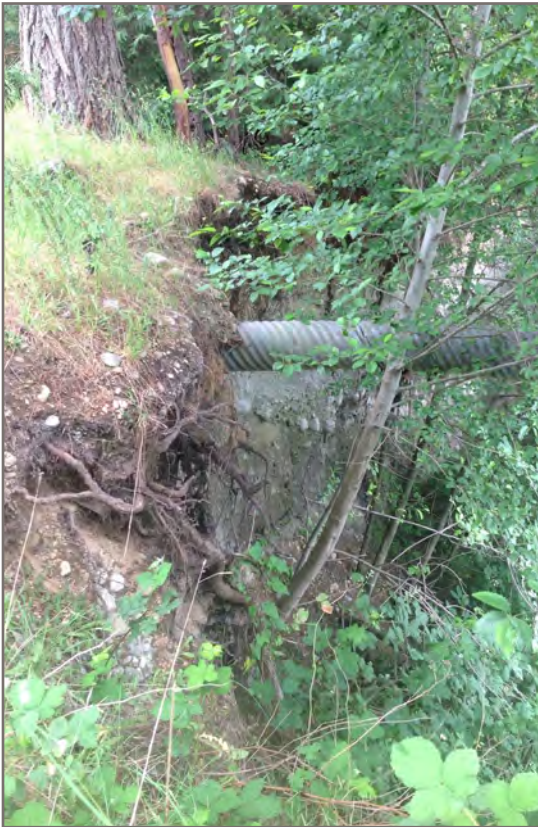
Photo 1: View of near-vertical eroding slope located along the crest of the coastal escarpment near Rifle Range Road. Note highway culvert in centre of photo. (Photo taken June 2015).

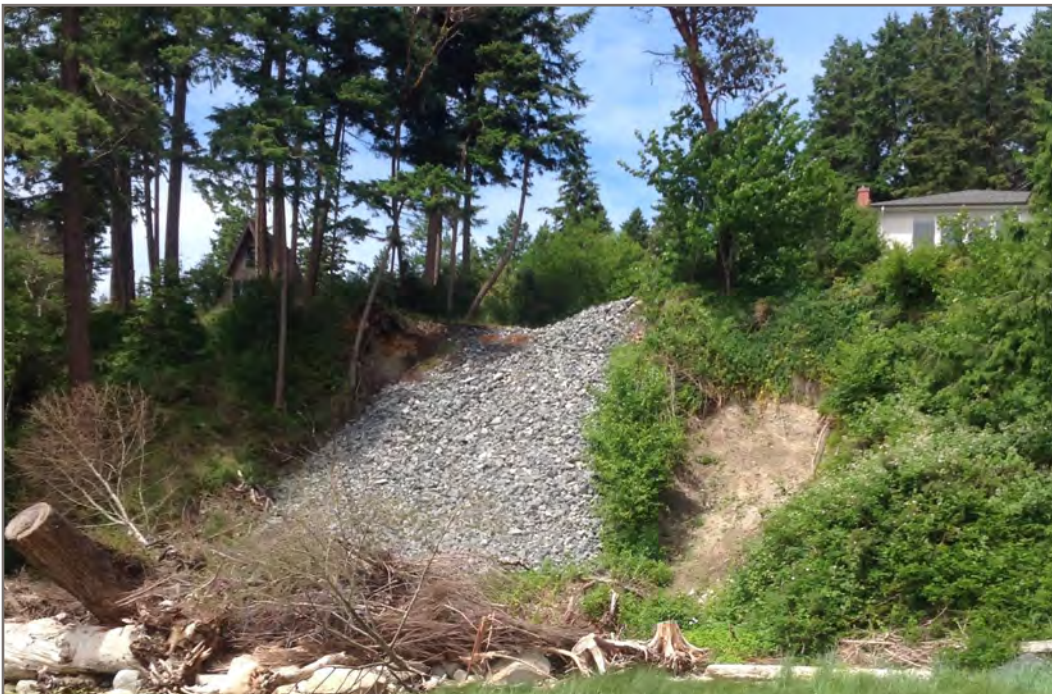
Photo 2: View of recent landslides along the coastal escarpment at Stevenson Road. Note slide debris at the bottom of the photo. Larger slide in the centre of the photo has been subsequently blanketed with riprap. (Photo taken June 2015).

Location	Description of Event	Notes
2977 / 2981 Stevenson Road	<ul style="list-style-type: none"> Failure of coastal escarpment with associated erosion by surface runoff / ditch discharge 	<ul style="list-style-type: none"> Previous failures documented by homeowner in January 2010 and October 2014
Highway 101 Cut Slope	<ul style="list-style-type: none"> Failure of highway cut slope between Maris Road and Deighton Creek 	<ul style="list-style-type: none"> Previous slumping evident from 1974 air photo
9441 / 9449 Stittle Road	<ul style="list-style-type: none"> Large failure (slump); slide debris reached the shoreline 	<ul style="list-style-type: none"> Historic air photos show existing slide scarps / shallow swales in this area Previous slope failure (30+ years old) noted by homeowner (Planterra, 2014).
Pine Tree Road	<ul style="list-style-type: none"> Failure of coastal escarpment with associated erosion by surface runoff / culvert discharge 	<ul style="list-style-type: none"> Previous slope failure evident from 1982 air photo

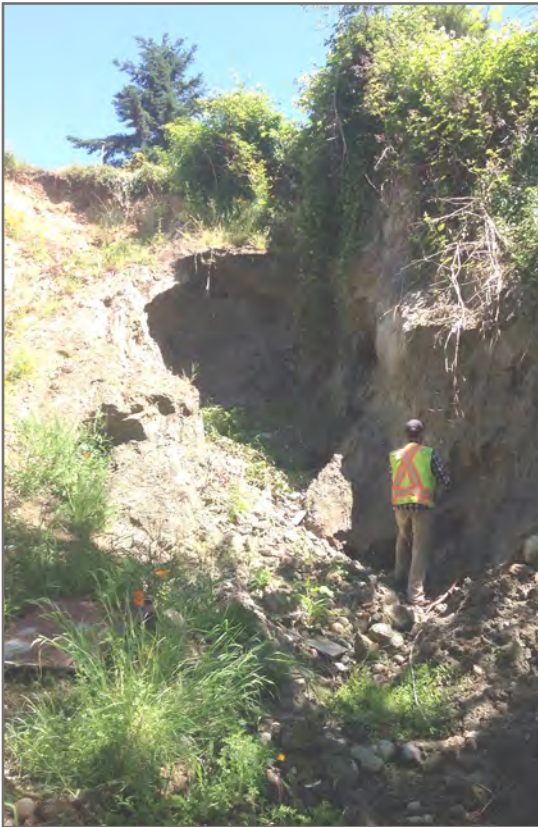
Photo 3: View of December 2014 landslide scarp along the coastal escarpment at Stittle Road. (Photo taken June 2015).

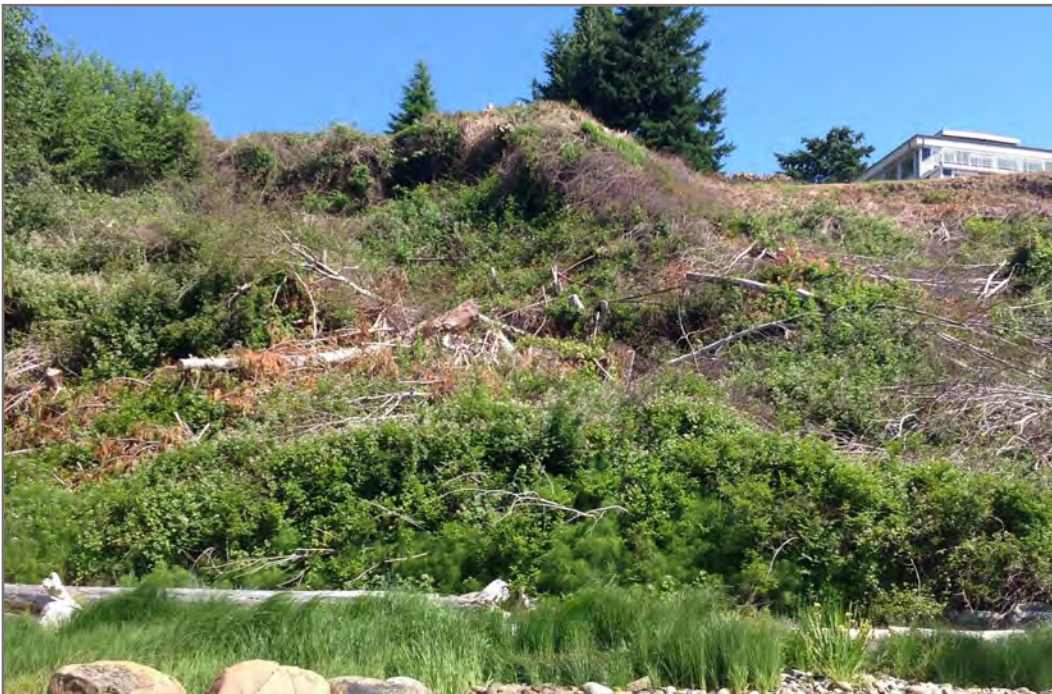
Photo 4: View of older landslide scarps (bowl-shaped depressions) along the coastal escarpment near Fleury Road. (Photo taken June 2015).

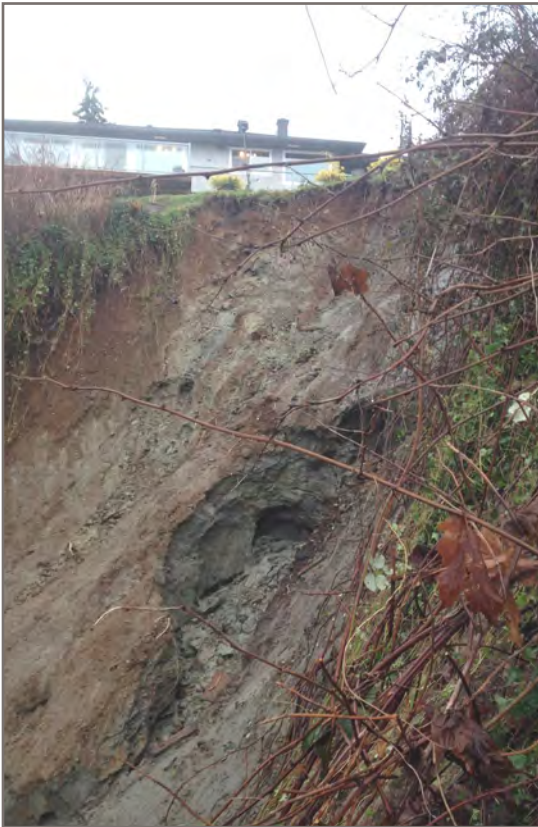
Photo 5: View of landslide scarp at Stittle Road, taken shortly after the failure occurred in December 2014. (Photo provided by PRRD).

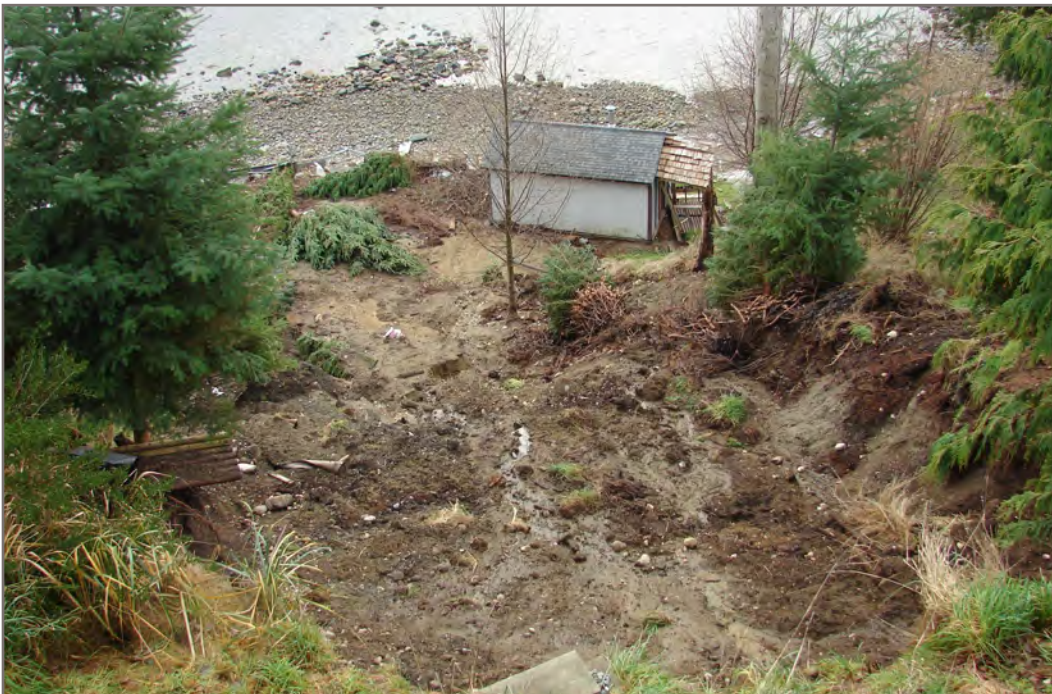
Photo 6: View of landslide debris along the coastal escarpment at Random Road, taken shortly after the failure occurred in December 2014. (Photo provided by PRRD).

9661 Random Road	<ul style="list-style-type: none"> Large failure (slump); slide debris reached the shoreline 	<ul style="list-style-type: none"> Historic air photos show existing slide scarps / shallow swales in this area
Victory Road	<ul style="list-style-type: none"> No information available 	<ul style="list-style-type: none"> Previous slope failure evident from 1974 air photo

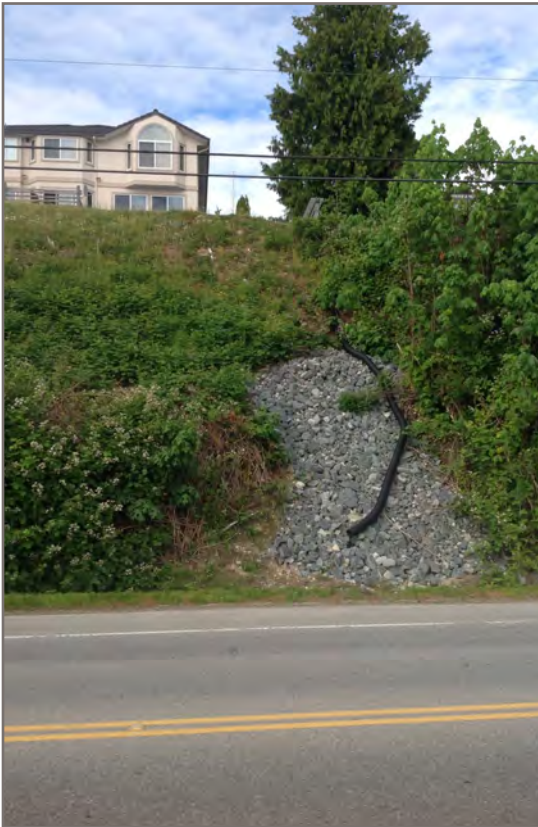
Photo 7: View of December 2014 landslide along Highway 101 near Deighton Creek. Failure has been subsequently blanketed with riprap with drainage pipe extended to the base of the slope. (Photo taken June 2015).

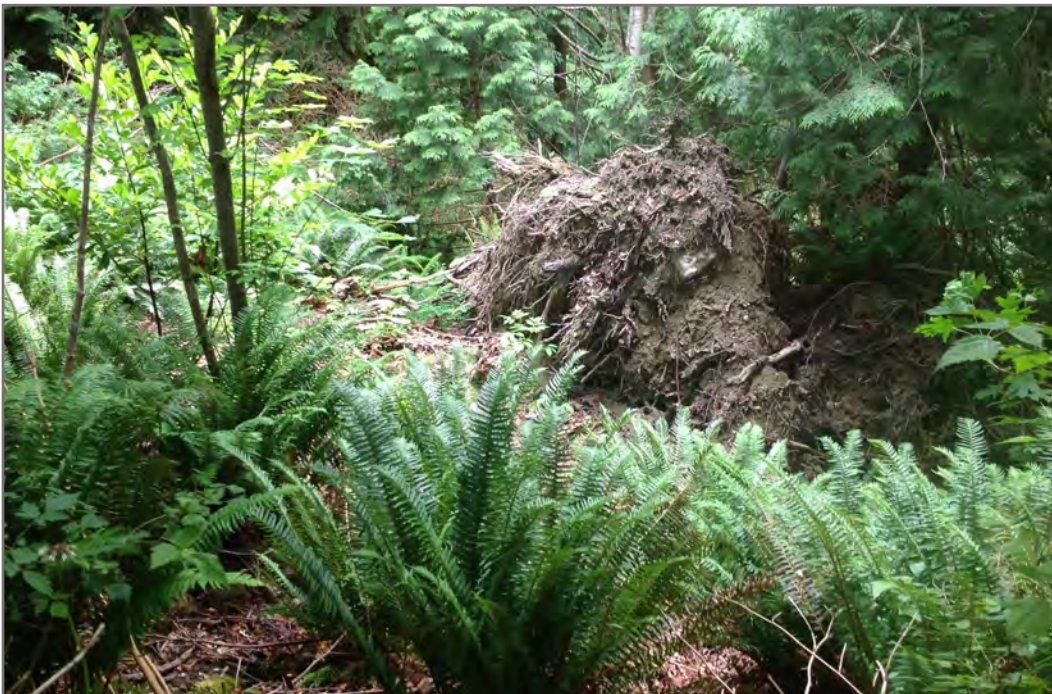
Photo 8: View of recent landslide on steep forested slopes near Myrtle Creek. Note over-turned tree in centre of photo. (Photo taken June 2015).

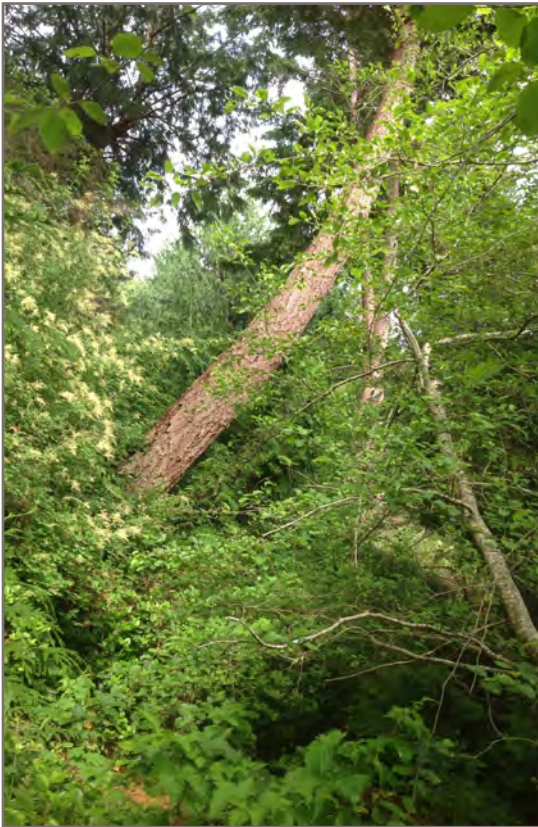
Photo 9: View of coastal escarpment near McCausland Road. Curved tree trunk indicative of slope creep and potential landslide activity. (Photo taken June 2015).

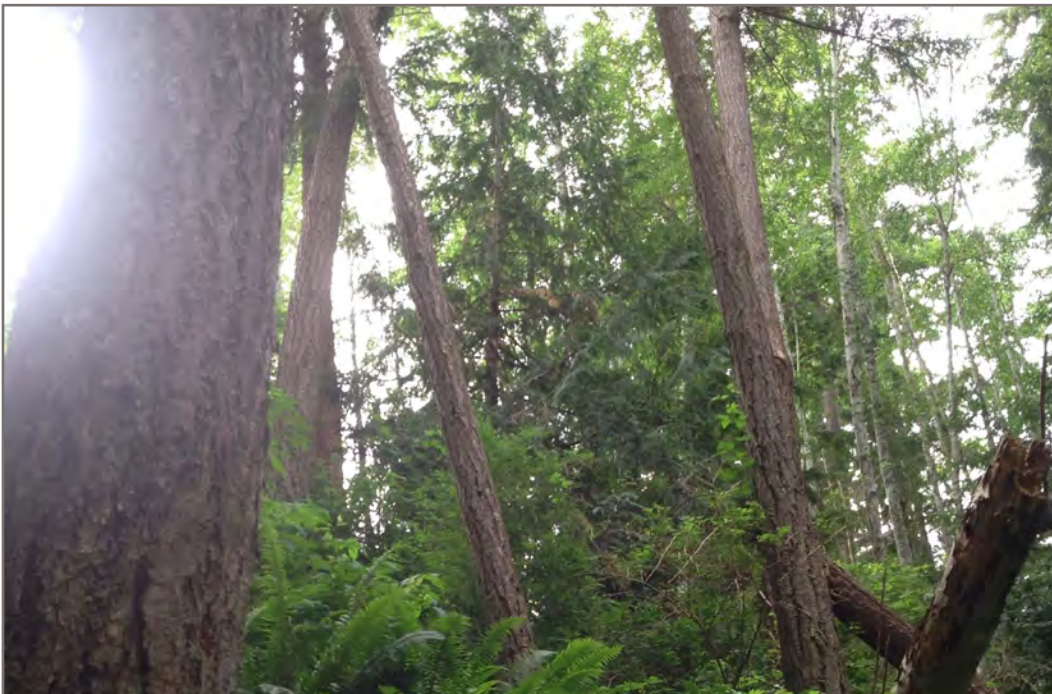
Photo 10: View of steep forested slopes near Myrtle Creek. Curved / tilted tree trunks indicative of slope creep and potential landslide activity. (Photo taken June 2015).

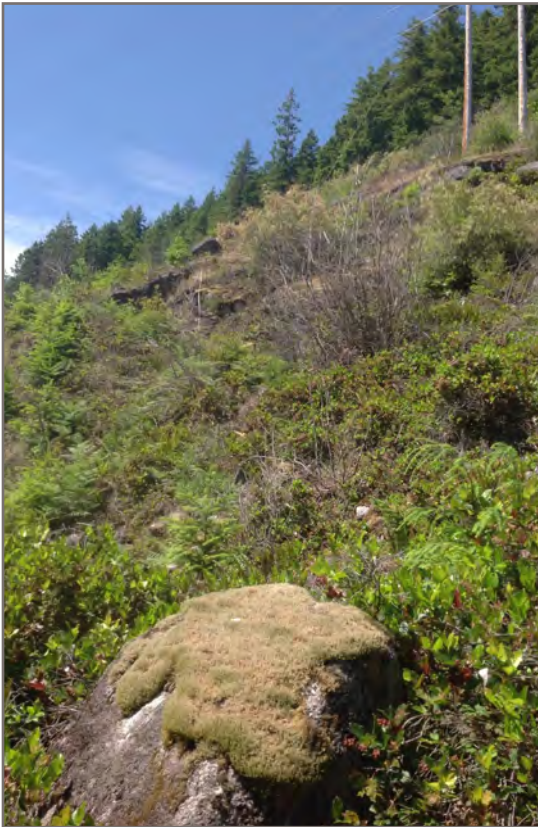
Photo 11: View of rock fall debris within the transmission line right-of-way near Highway 101 at the Malaspina Viewpoint. (Photo taken June 2015).

Rock fall hazards were identified at the following locations within the study area (see Photos 11 and 12):

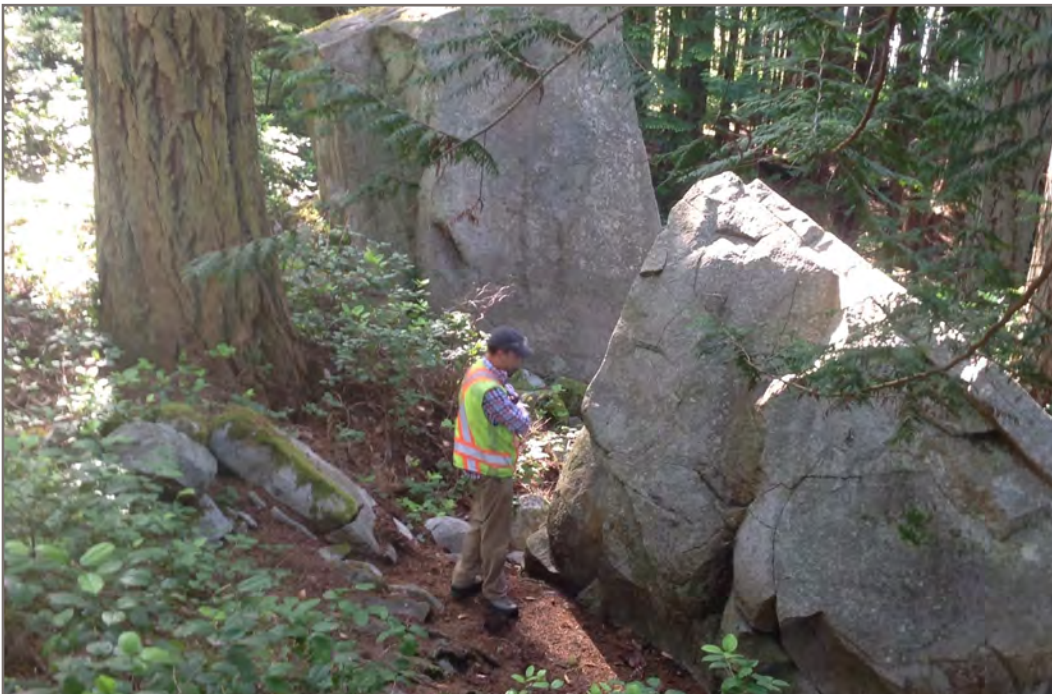
Photo 12: View of rock fall debris near Stillwater Bay, sourced from an approximately 8 m high bedrock bluff located to the left of the photo.

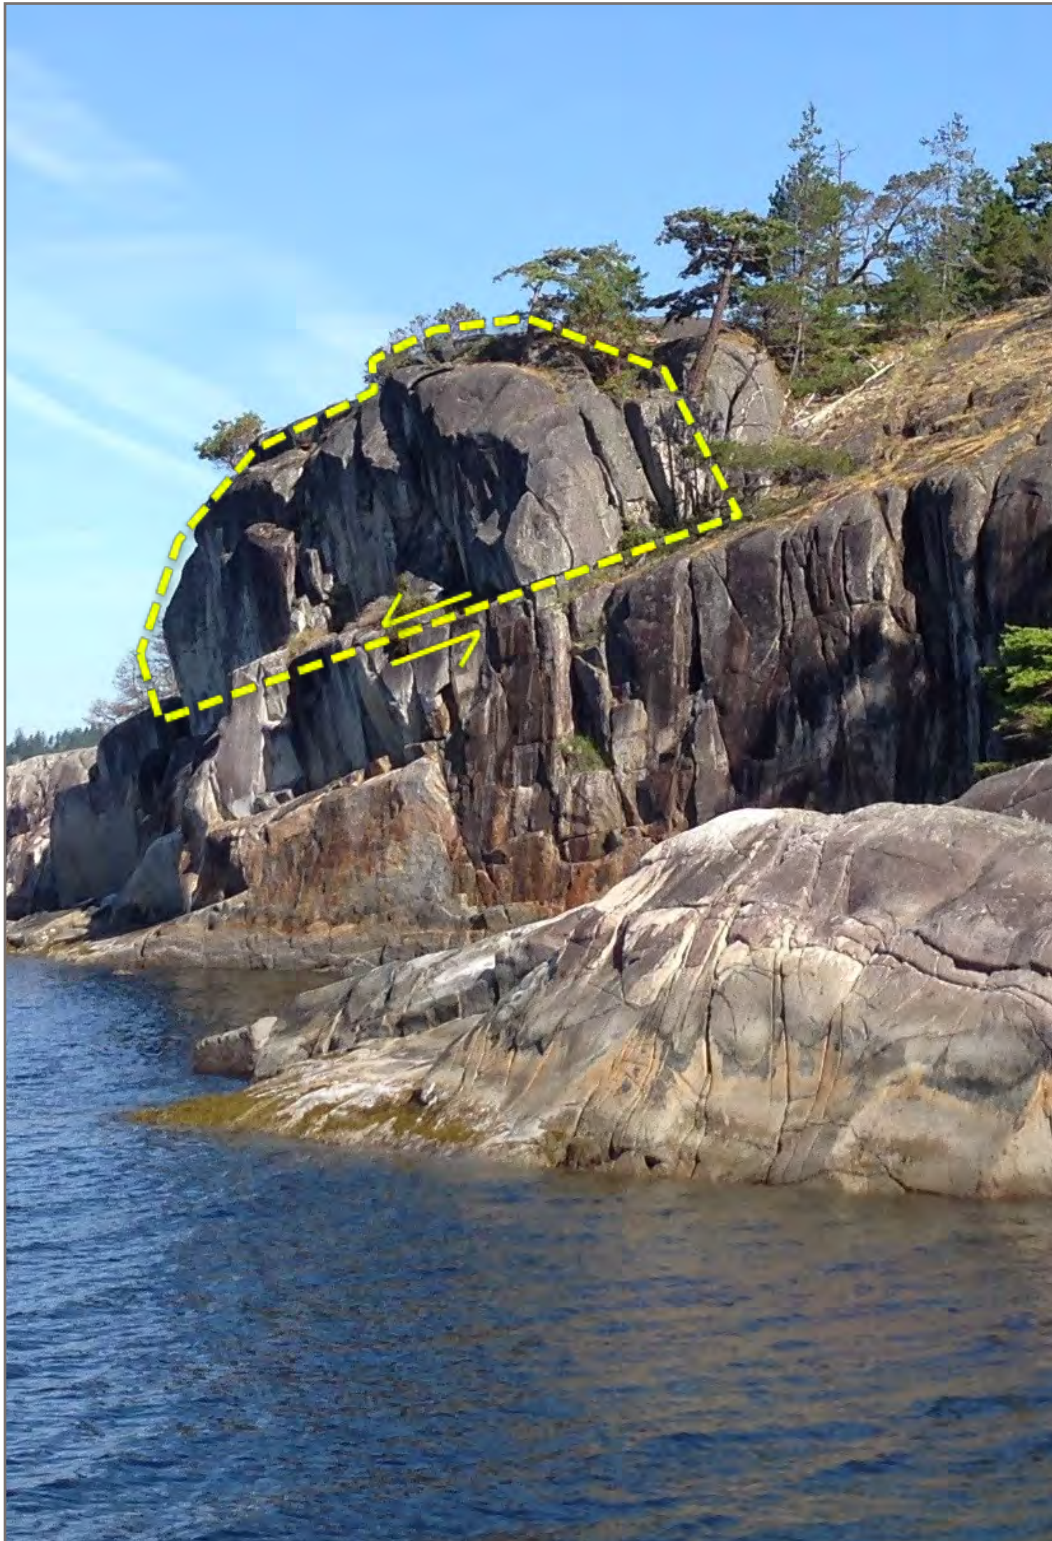
Photo 13: View of potentially unstable bedrock bluff (area circled in yellow), located near Stillwater Bay. (Photo taken June 2015).
