Texada Airport (YGB) Assessment for Hangar Expansion Project

Project No. 16008

Prepared For
Powell River Regional District
Powell River, BC

Prepared by
Enterprise Geoscience Services Ltd.
Vancouver, B.C.

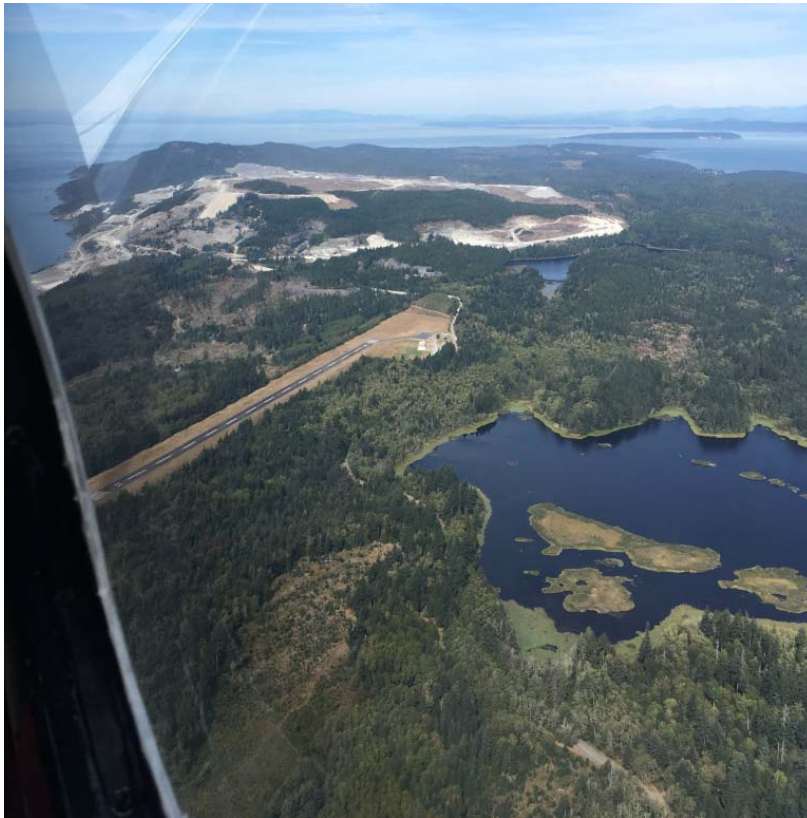
Photograph 1: YGB with Cranby Lake to the east (right side of photo) and the Lafarge Quarry in the background (looking north).

The Cranby Lake Community Watershed boundary encompasses most of the airport property and is shown in Figure 2. The entire watershed boundary as defined in the bylaw is approximately 890 ha in area with YGB contributing drainage from a relatively small area west of the lake. The topographic divide runs essentially down the centerline of the runway. Drainage to the west of runway centerline flows towards Strait of Georgia and drainage to the east flows towards Cranby Lake. The airport and surrounding area are illustrated below in Photograph 1.

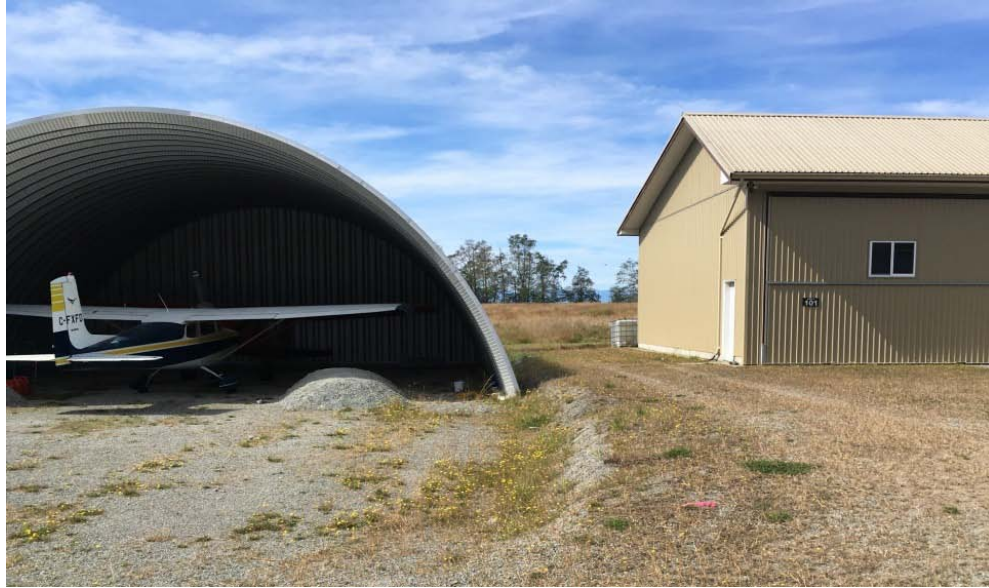
Photograph 2: Mismatching surface grades between adjacent hangar lots

The existing hangar lease lots have differing grades in some cases that direct drainage from one lot onto the next (Photograph 2). Roof drainage typically exhausts directly onto the ground surface creating ponding conditions and minor erosion during wet periods (Photograph 3). Based on these observations, it is concluded that a lack of drainage measures for the existing hangar lots produces nuisance runoff and minor erosion which could be controlled with simple improvements.

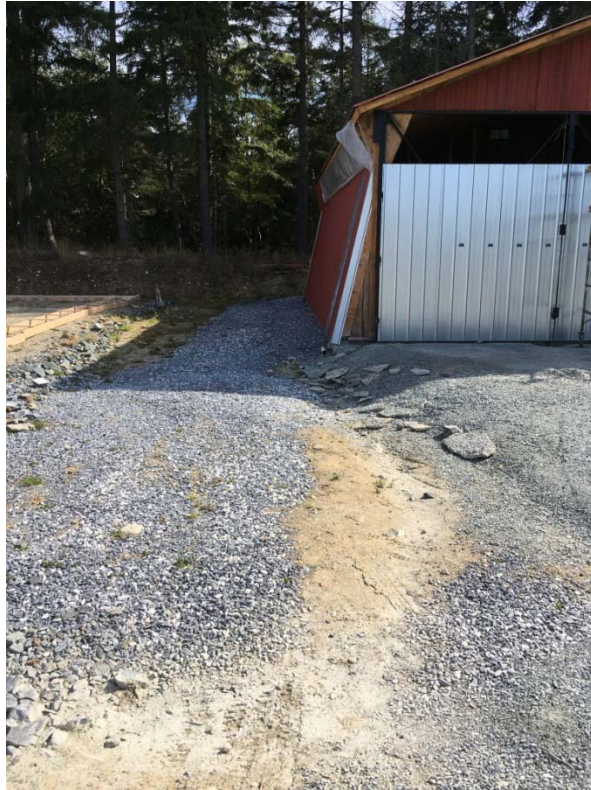
Photograph 3: Roof drainage causing minor erosion and wet season ponding

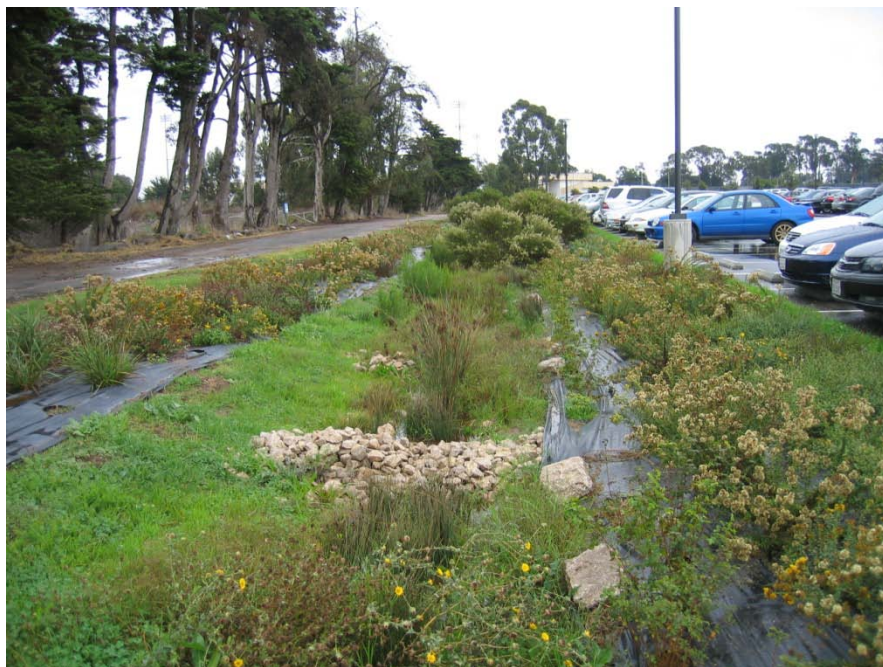
Photograph 4: Example of bioswale and rock check dam for sediment and erosion control

A check dam is a small dam constructed across a ditch to counteract erosion by reducing water flow velocity. A check dam constructed at the downstream outlet of a small sedimentation pond would be effective at removing larger sediment particles by gravity settlement in the pond. A bioswale is a swale with gently sloped sides and planted with vegetation. The purpose of a bioswale is to remove silt and finer particles in the drainage that do not settle as easily by gravity. An example of a rock check dam and bioswale is shown in Photograph 4.
