Identification of Natural Hazard Areas

Malaspina Peninsula / Okeover Inlet

Marion Blank, P.Geo.
Planterra Environmental Consulting

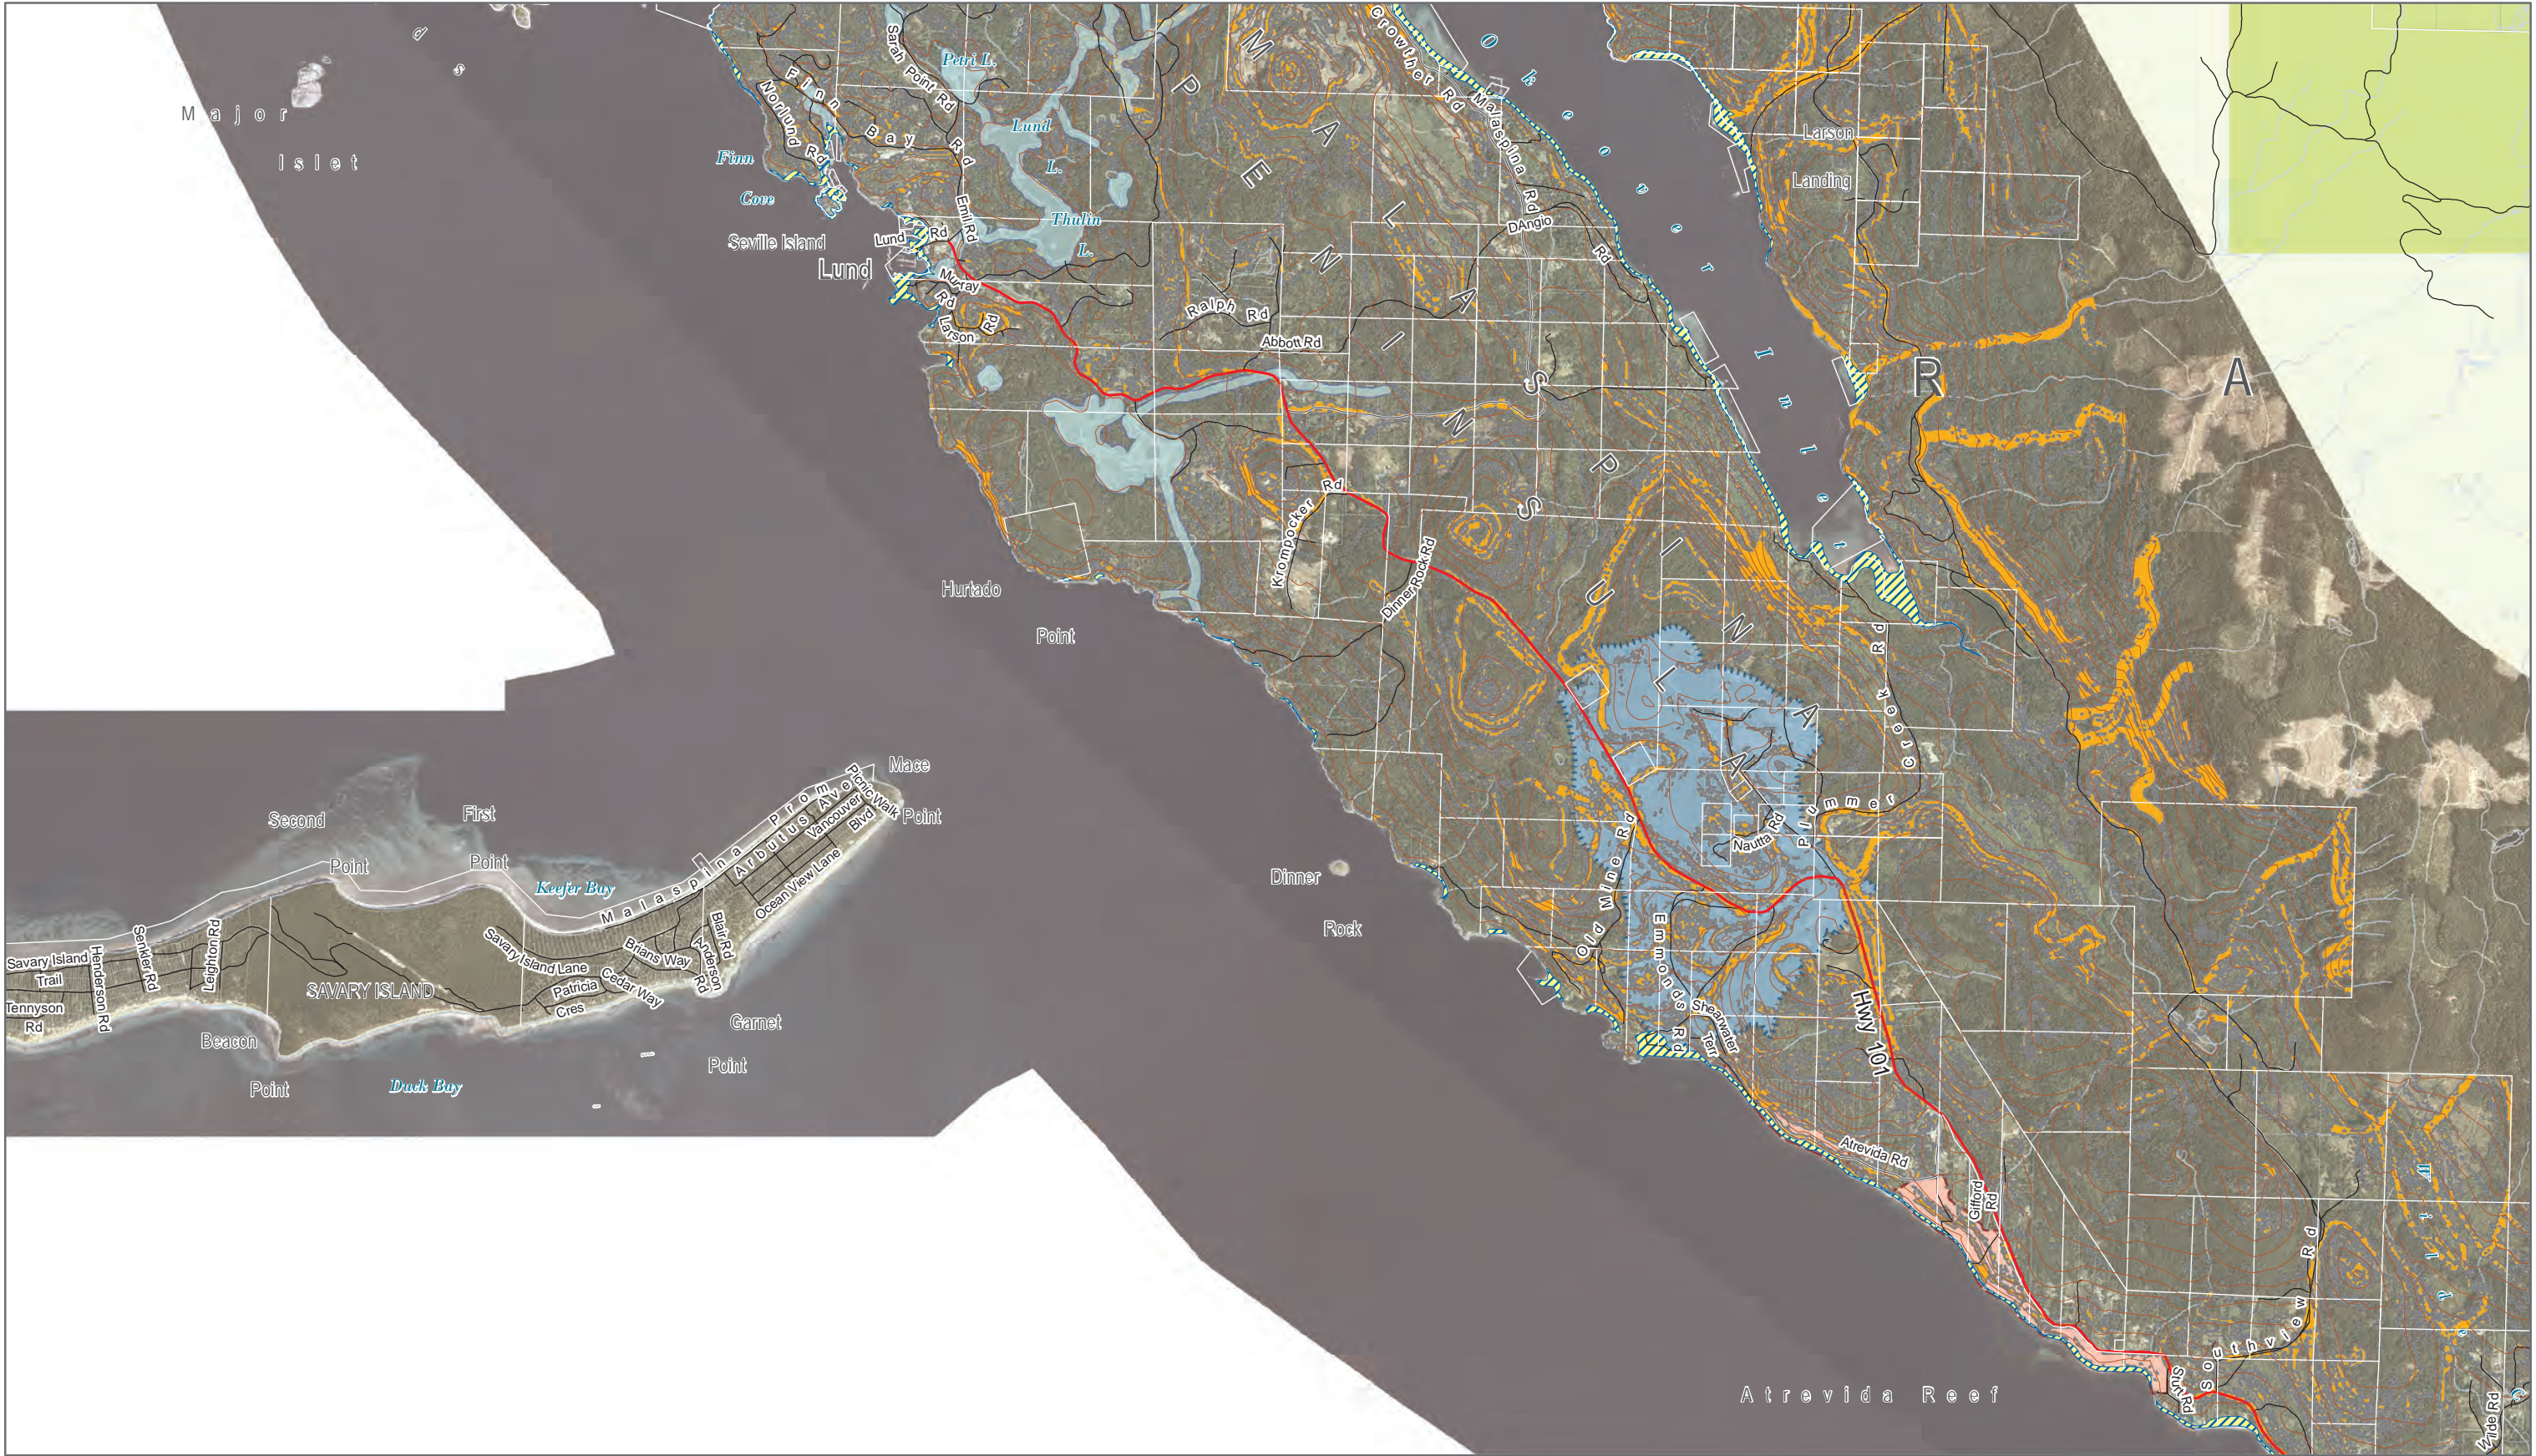
Southern Key Map 1-2

Natural Hazard Areas

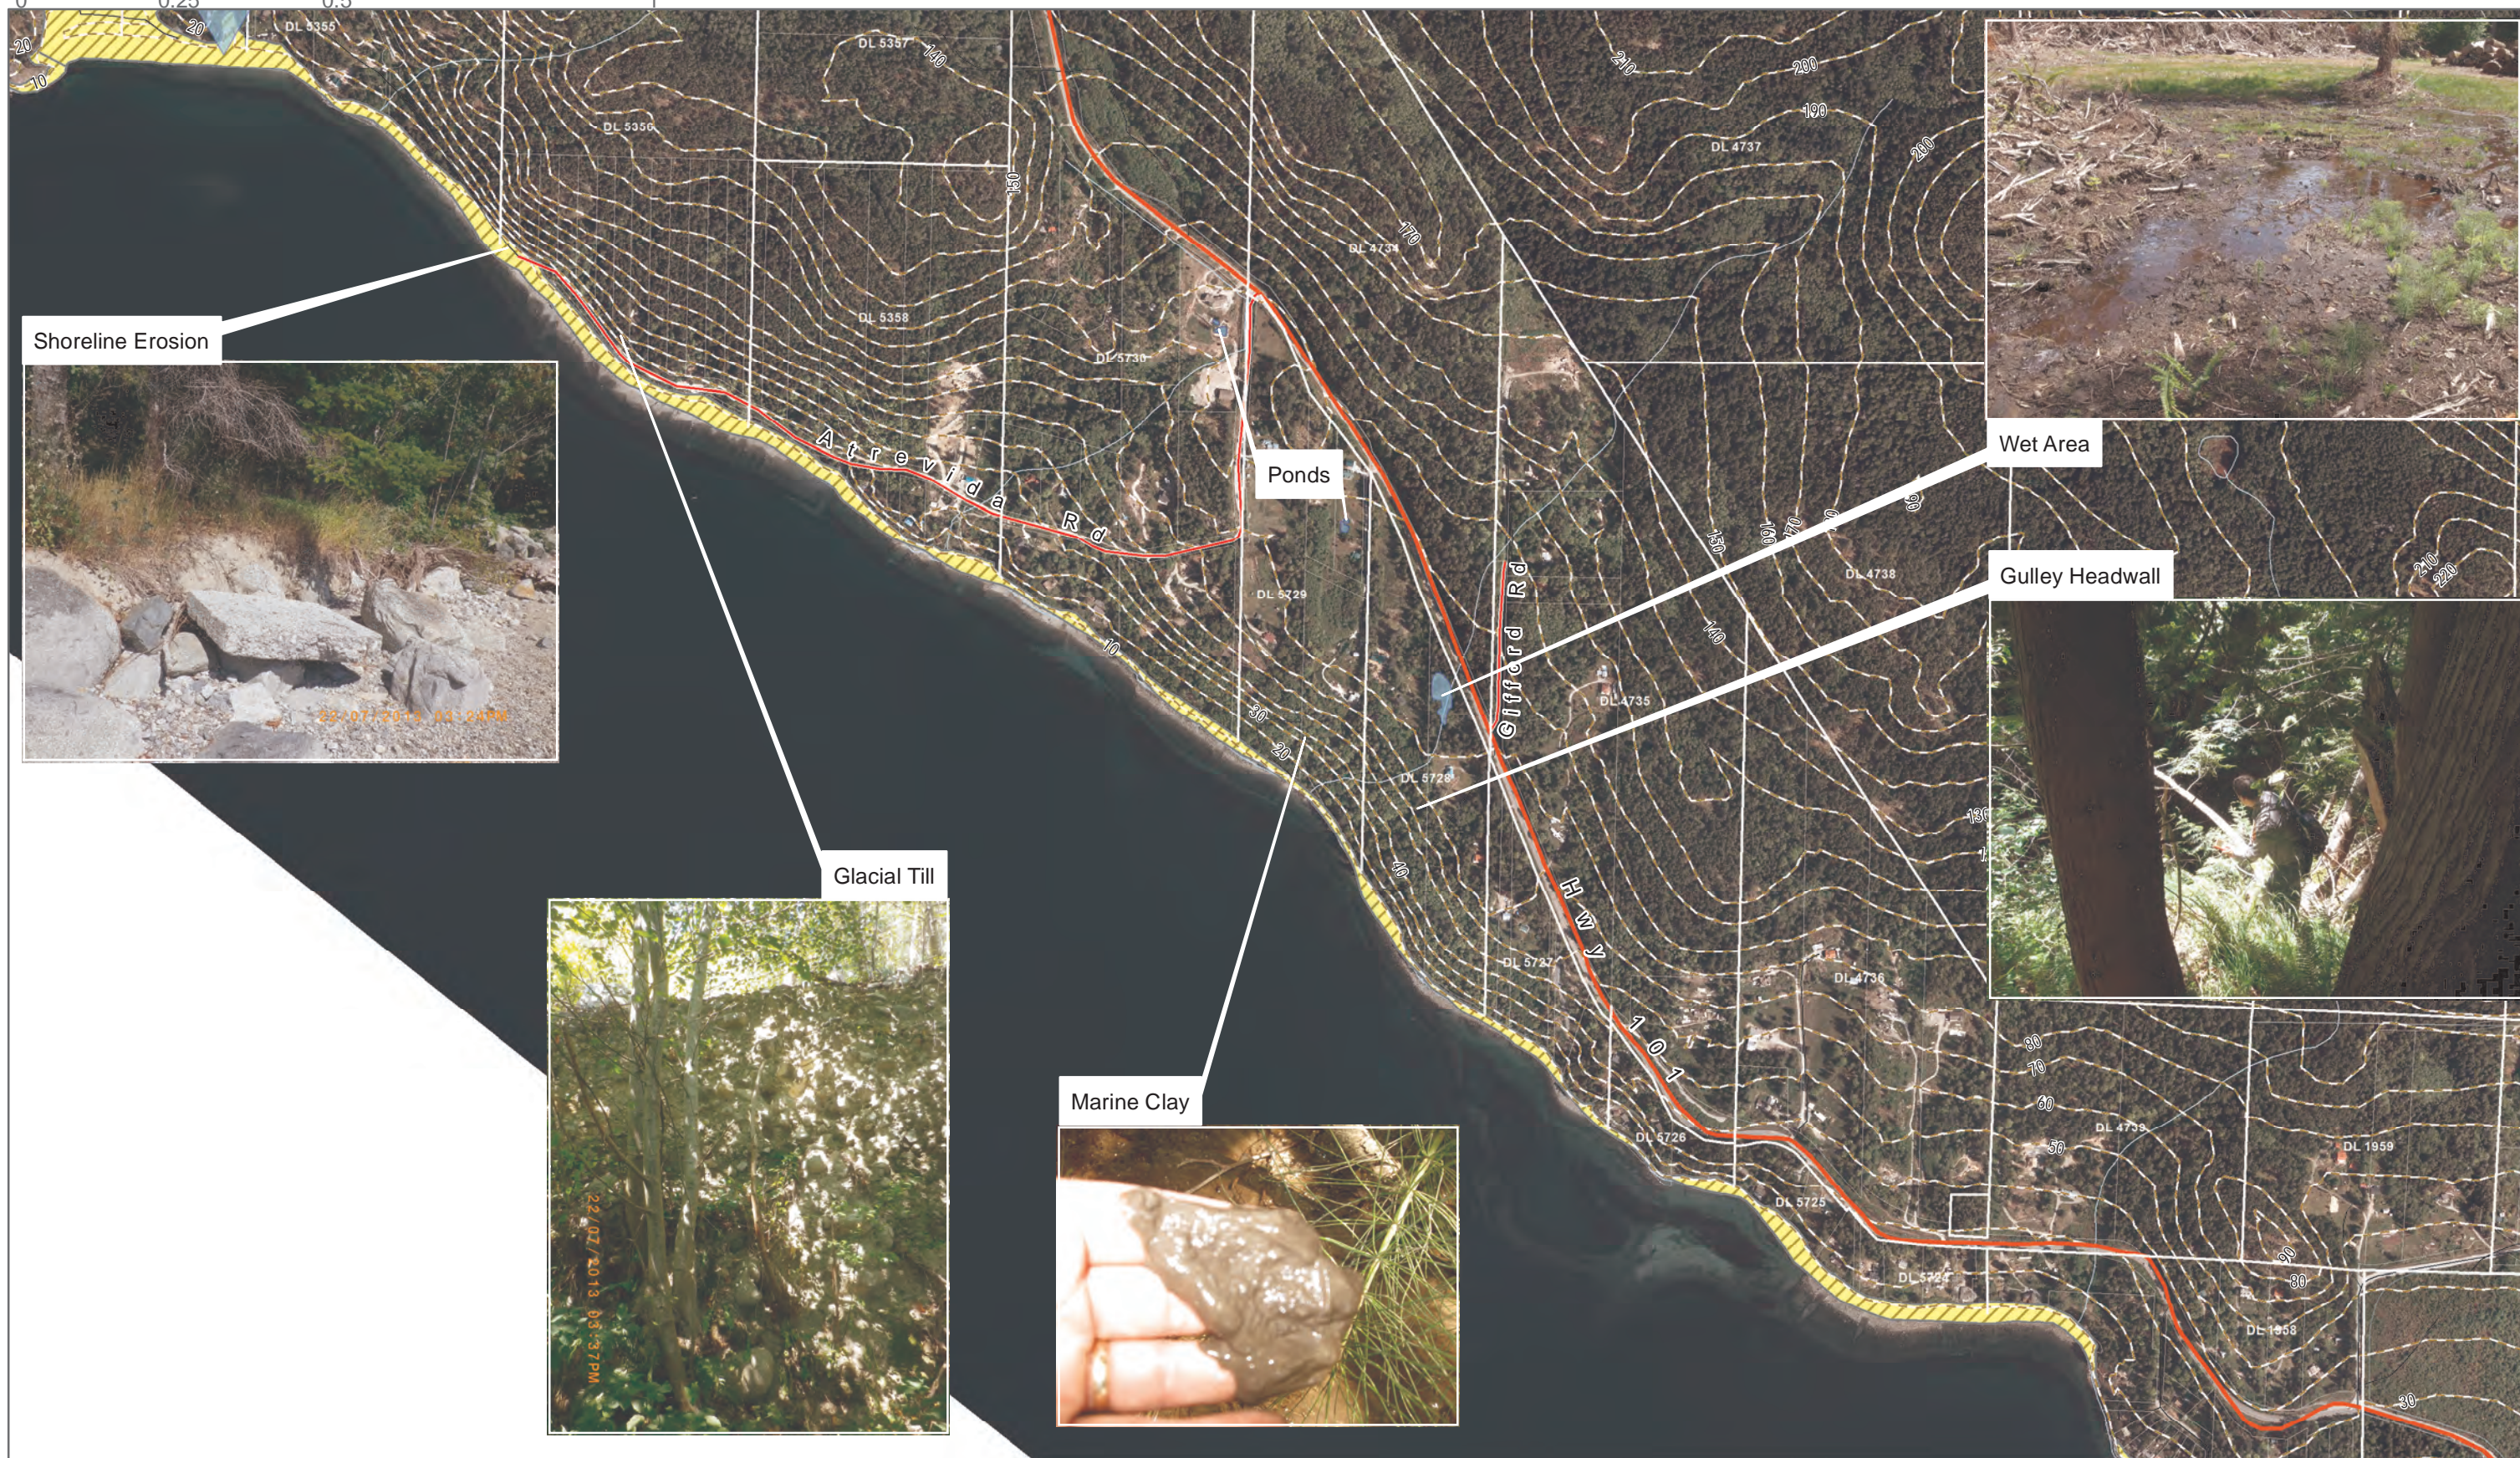
Shoreline Erosion

Possible Storm Surge

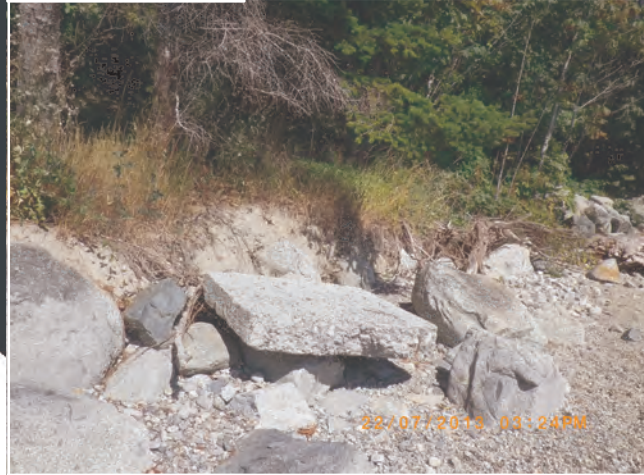
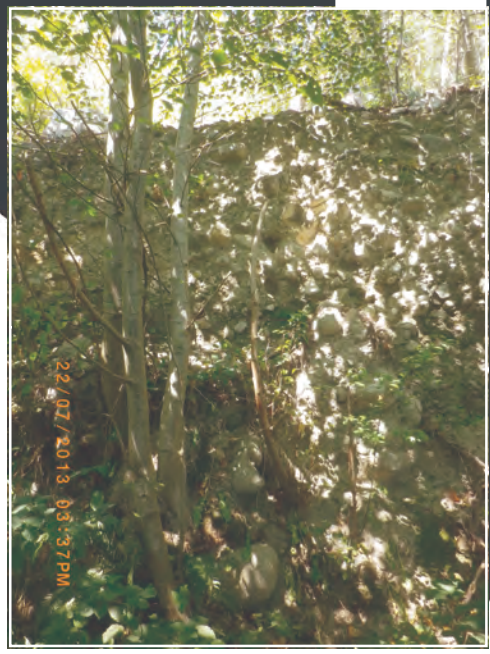
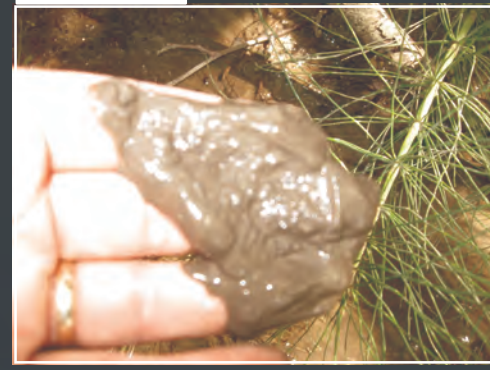
A field visit was conducted to determine the extent and cause of these features. Several traverses were completed and features were referenced on Map 2-1. Wet areas and ponds were located on a bench above the steep slopes. The wet area located on Map2-1 had active water movement at the time of the field visit (see Photo 9). The water on the property flowed over the steep escarpment to form a gully headwall as indicated (approximately 80m contour, Photo 10). The material within the gully was identified as marine clay. It appeared that the gully was formed by active erosional processes directly caused from surface drainage.

Ponds

Wet Area

Gully Headwall

Glacial Till

Marine Clay

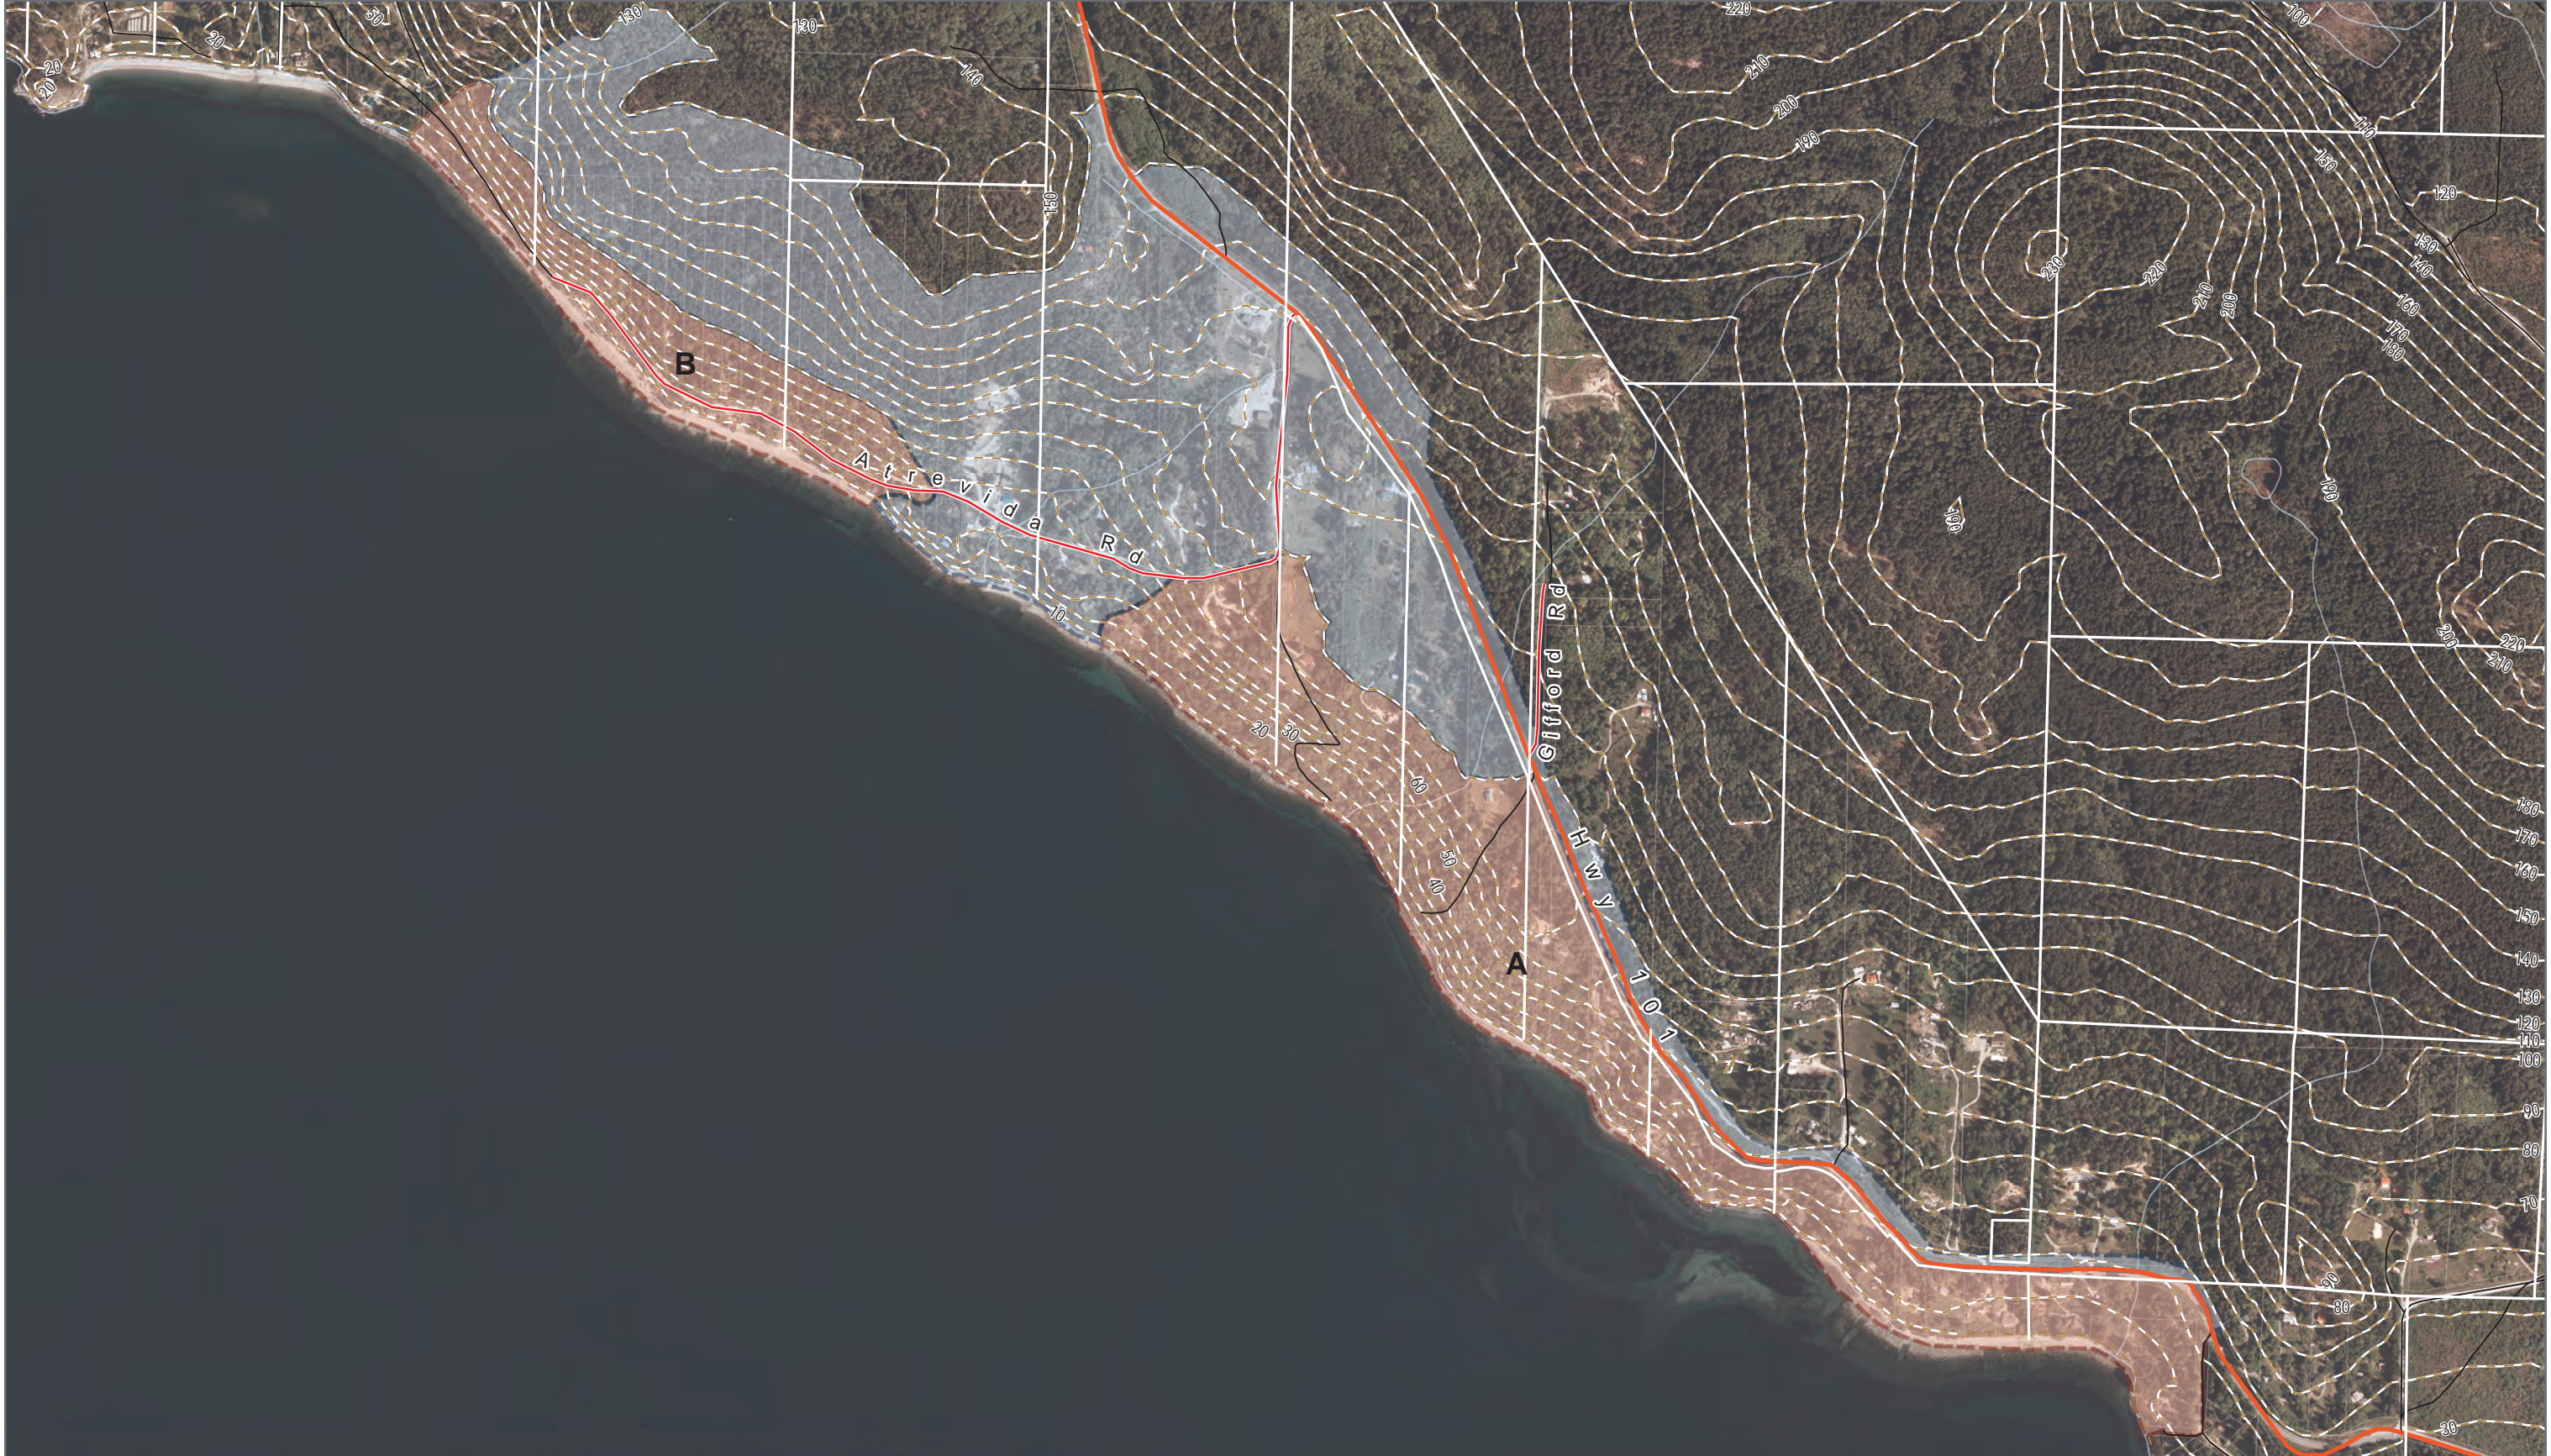
Drainage Review Area

The surficial material underlying most of this area has been identified as marine clay. Clays are fine textured materials that are cohesive under dry conditions. They usually have high shear strength with high cohesion and angle of internal friction. In the presence of excess water clay has a high potential for deformation and loss of cohesion. Under these conditions failures may occur in slopes of about 5%, with creeps, slumps and earth flows .

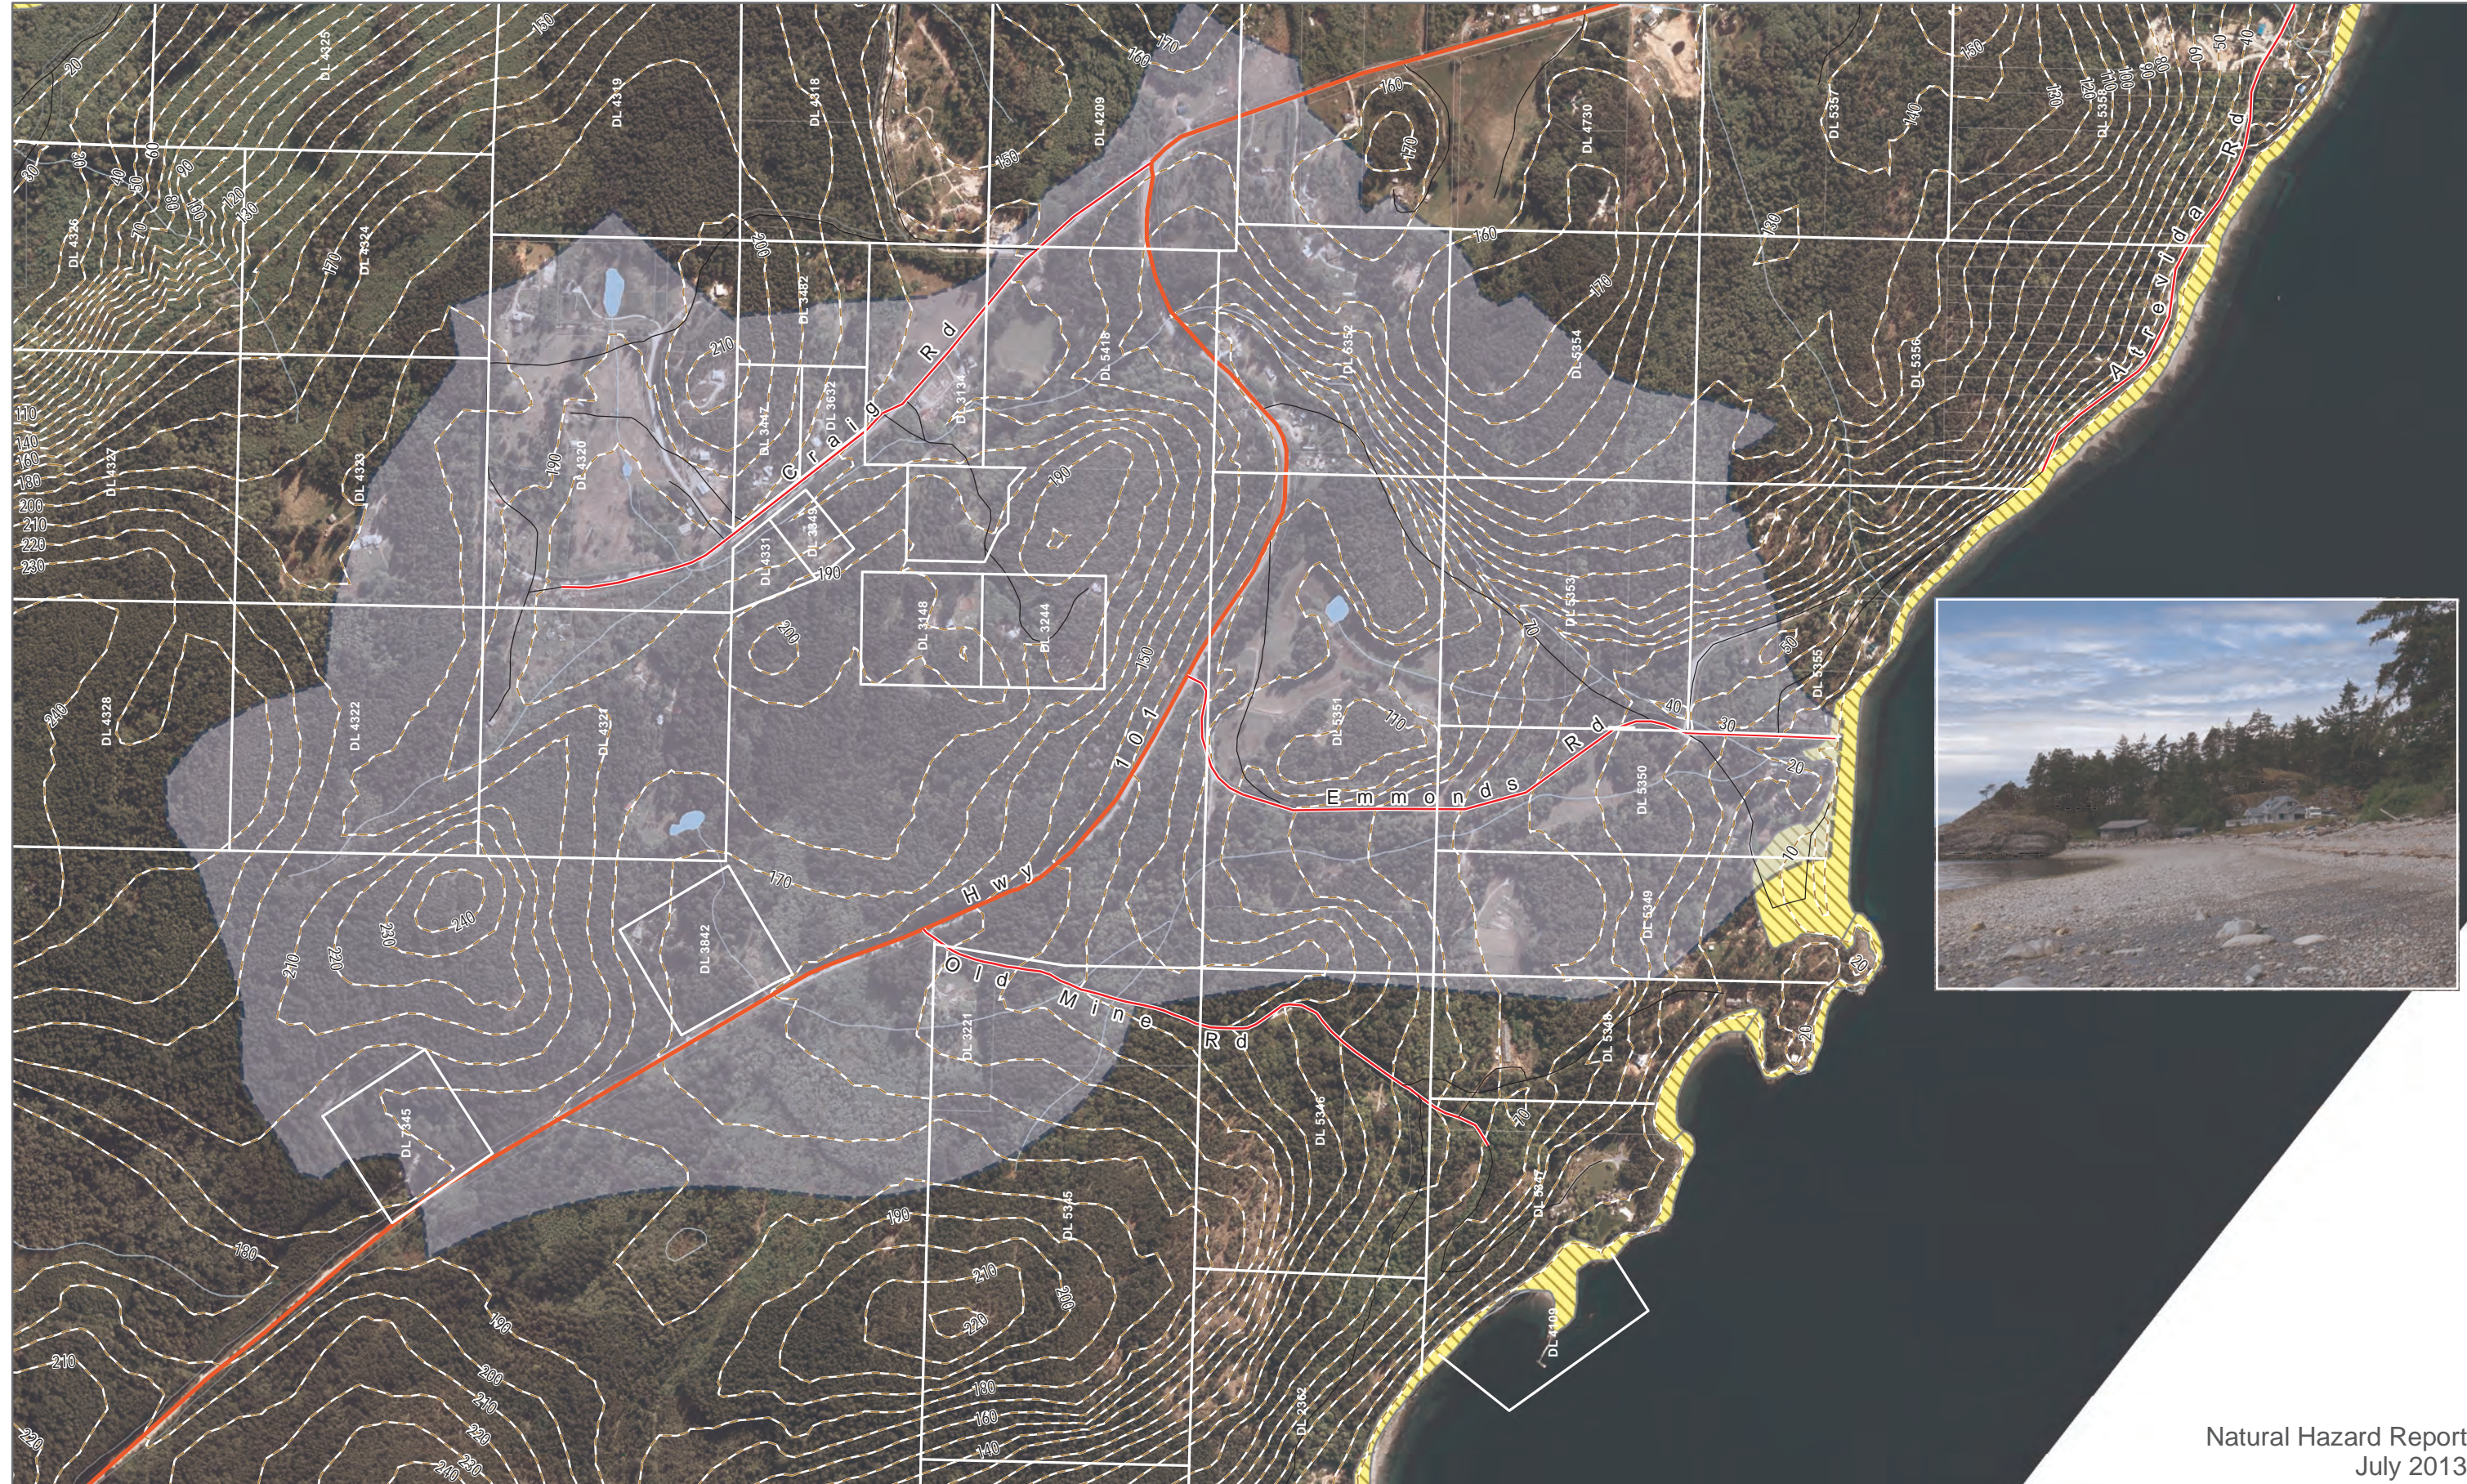
Map 3

Emmonds Beach Drainage Area

Though the risk is low for landslides and other mass movement of materials, the overall size of catchment area and the drainage concentration into a few creeks may pose some future flood risk. Based on the model of probably storm surge, the low lying area of Edmonds Beach may be vulnerable to sea water inundation.

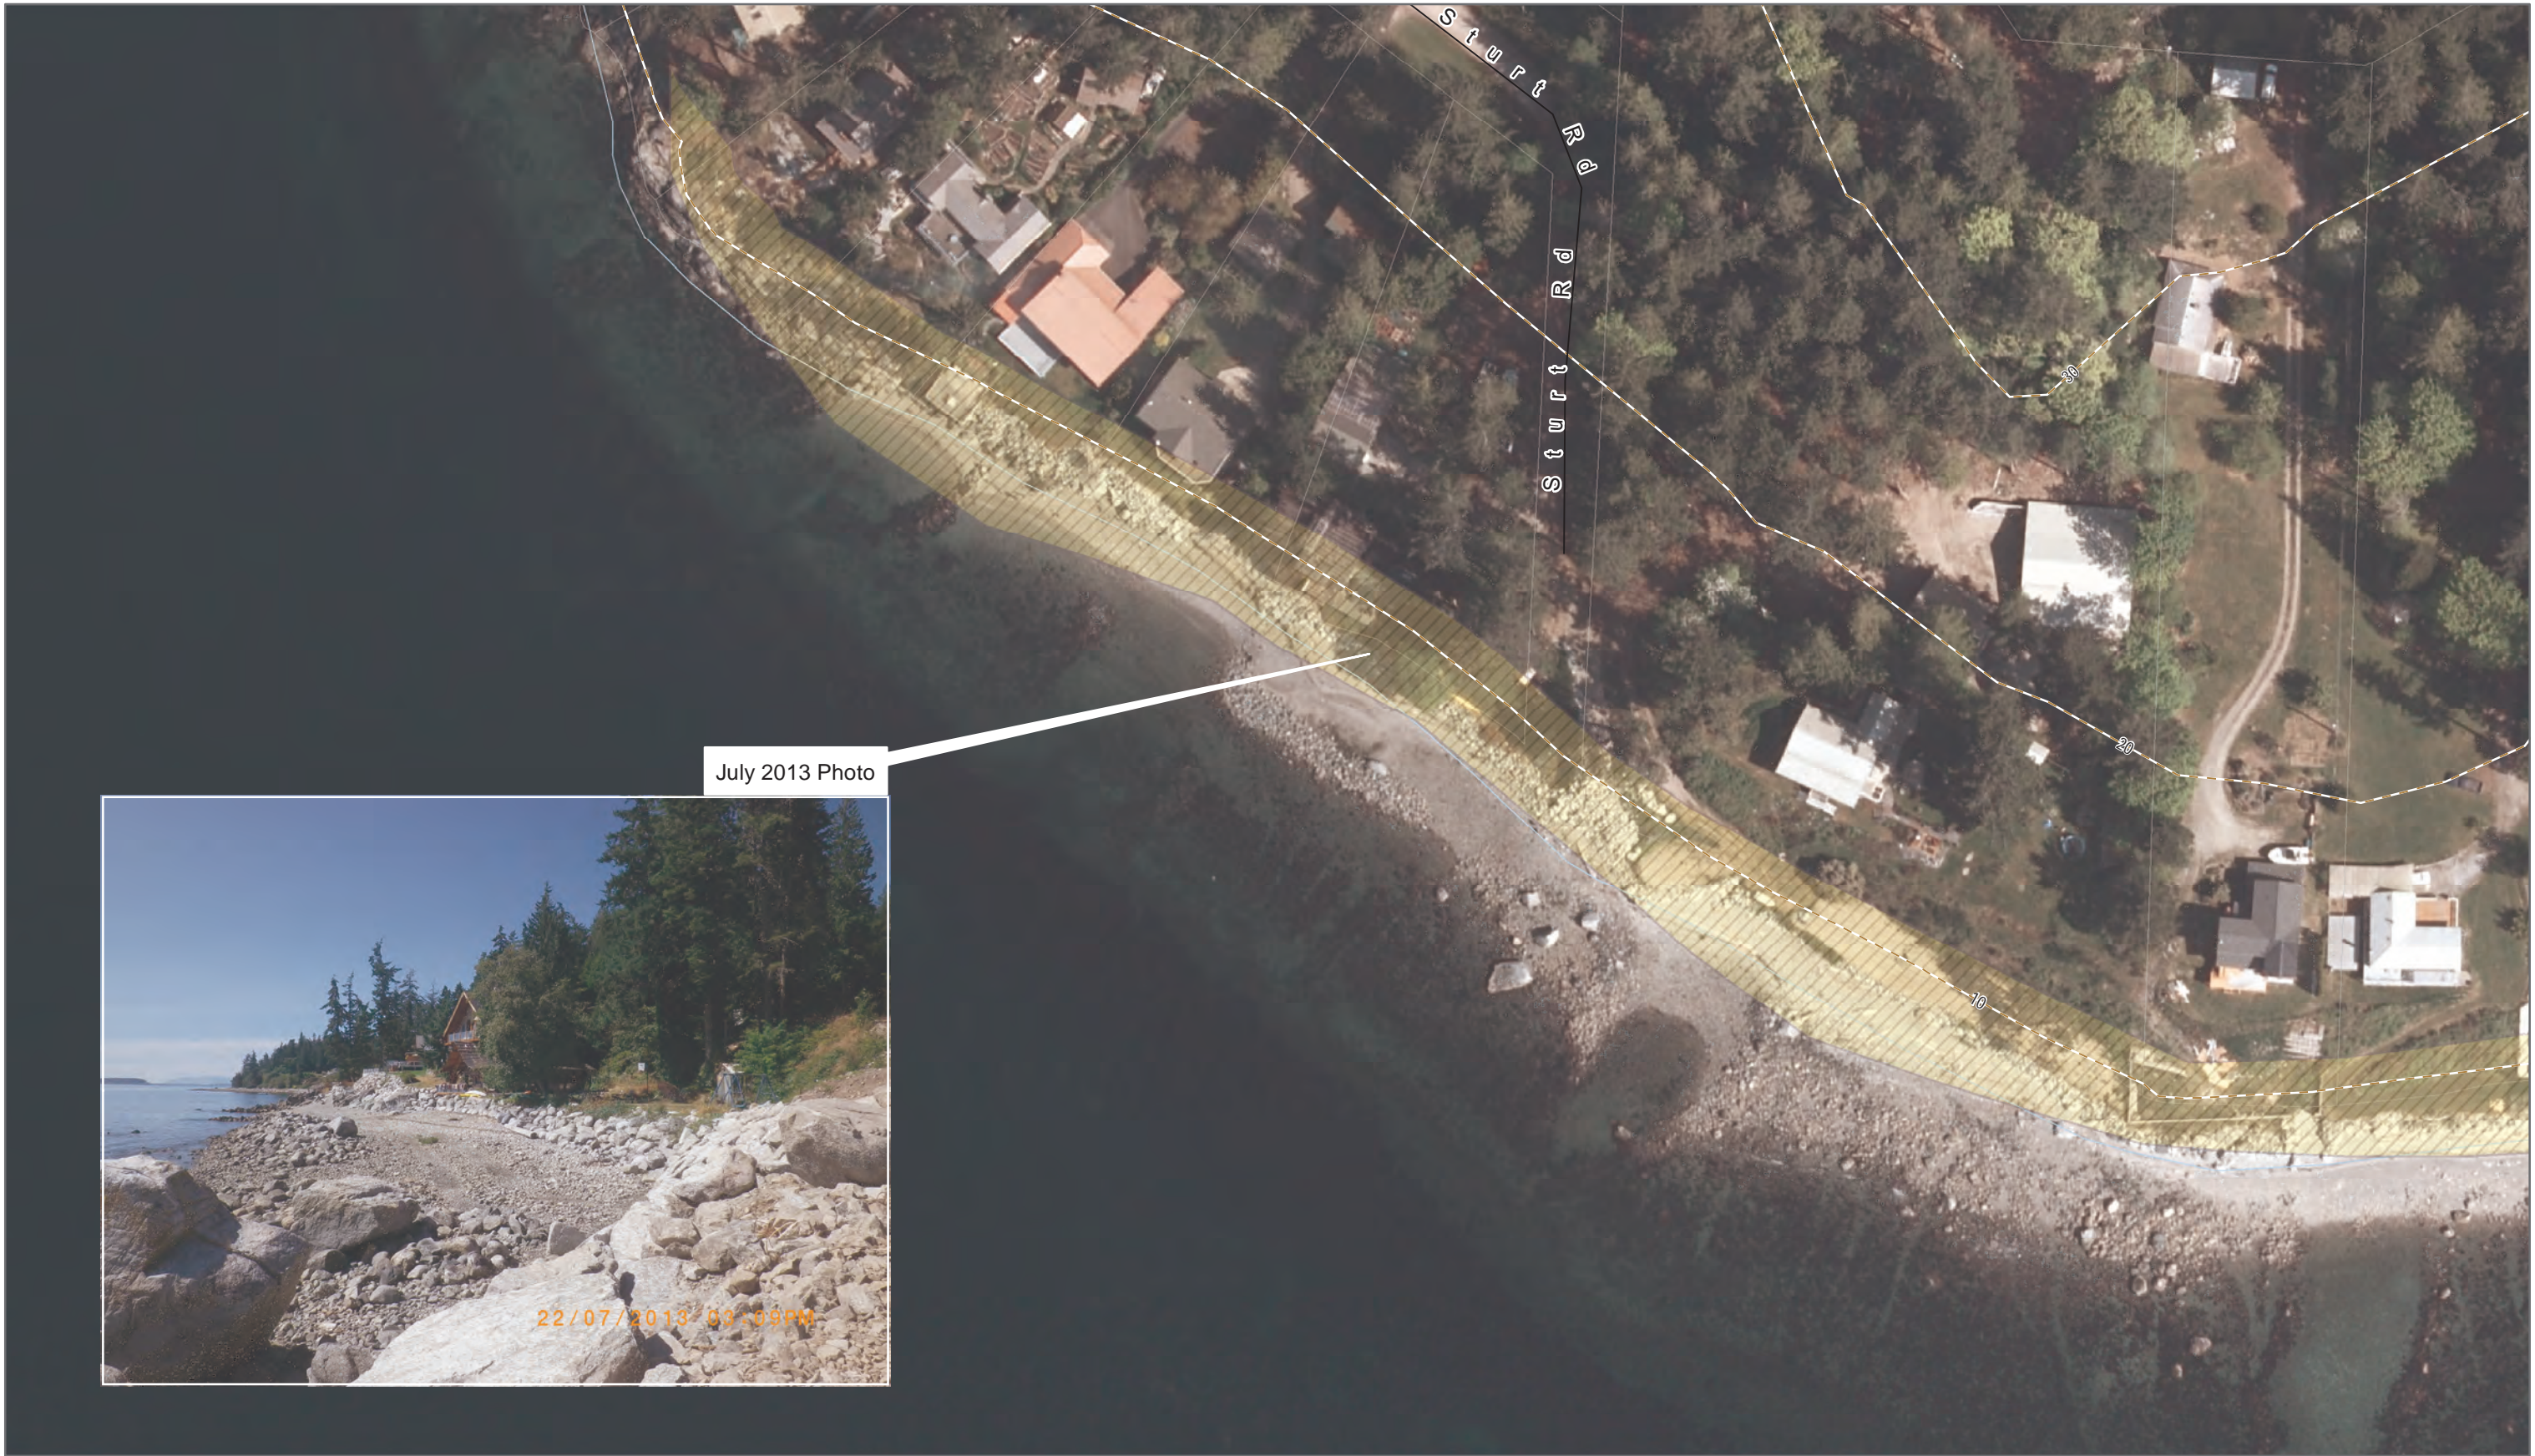
Figure 3 (April 2012 Aerial Image)

During the review of the 2012 Regional District imagery some small scale shore line protection appears to have been built to abate/protect shoreline erosion. A field check of an area at the end of Sturt Road revealed that shore line protection measures have increased since 2012. Figure 3 shows a photo taken in July 2013 and the aerial image of 2012. The area in the photograph has been completely rip-rap. There was also evidence of present development beyond the foreshore that may further alter erosional processes.
