July 12, 2016

**Subject: Intertidal Assessment for an Existing Barge Ramp  
Savary Island, B.C.**

Project: Savary Island Government Wharf and Barge Ramp

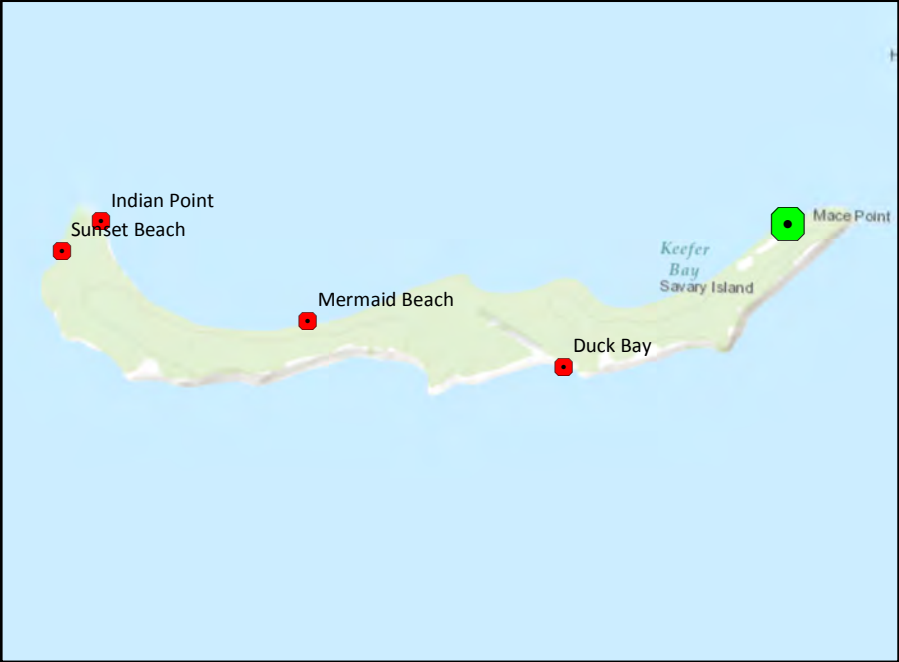
Figure 1: Location Map

While propeller wash occurred during the barge landing, no major sedimentation issues were observed that indicated significant scouring was occurring during operations. A post-field analysis of the bathymetry of the barge ramp identified gradients steep enough to prevent significant sedimentation during lower tide barge landings (Figure 1 and Appendix 2).

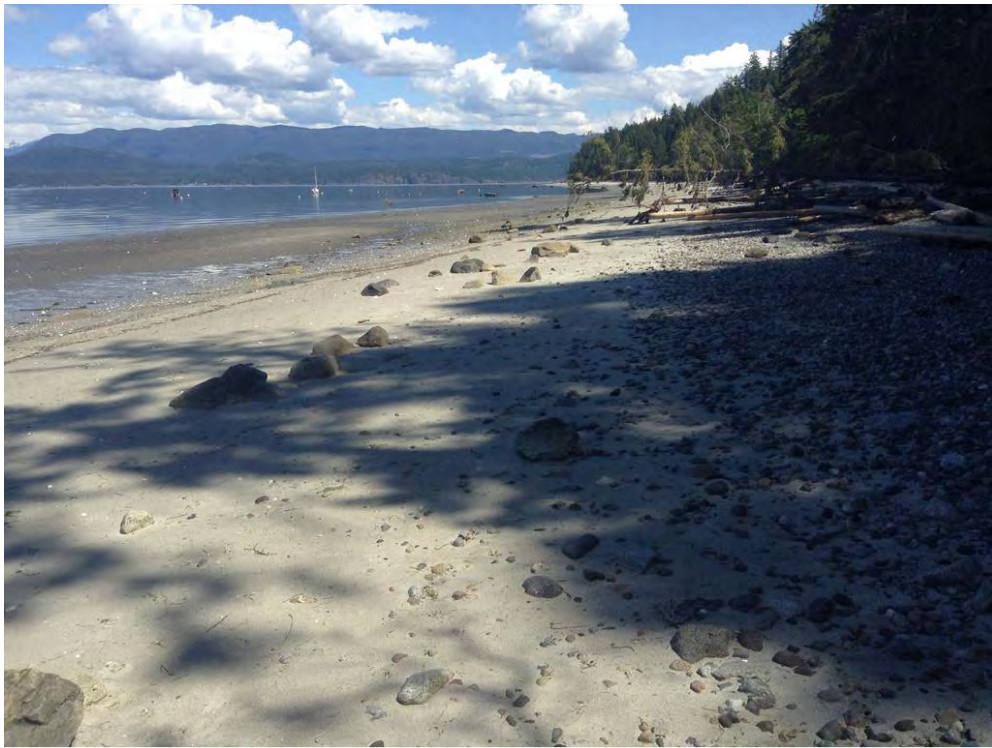
Photo: 23  
Mermaid beach, location proposed as a potential alternative barge ramp location by some Savary Island residents.  
( Date Taken: May-12-16 1:24:18 PM, Latitude: 49°56'23.51", Longitude: -124°49'57.03" )

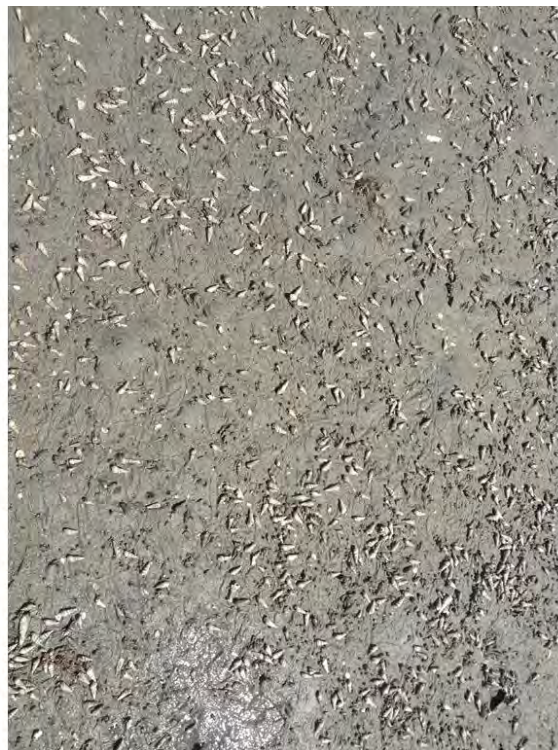
Photo: 24  
Mermaid beach, location proposed as a potential alternative barge ramp location by some Savary Island residents.  
( Date Taken: May-12-16 1:27:24 PM, Latitude: 49°56'24.72", Longitude: -124°49'54.25" )

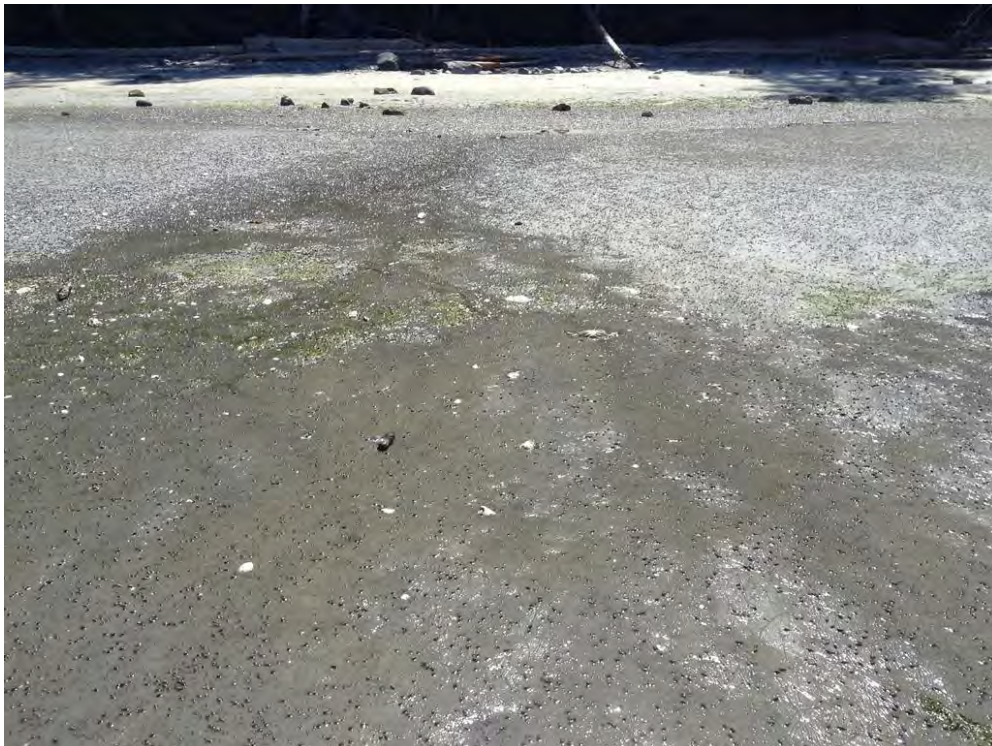
Photo: 26

Mermaid beach, location proposed as a potential alternative barge ramp location by some Savary Island residents.  
( Date Taken: May-12-16 1:28:49 PM, Latitude: 49°56'25.43", Longitude: -124°49'53.96" )

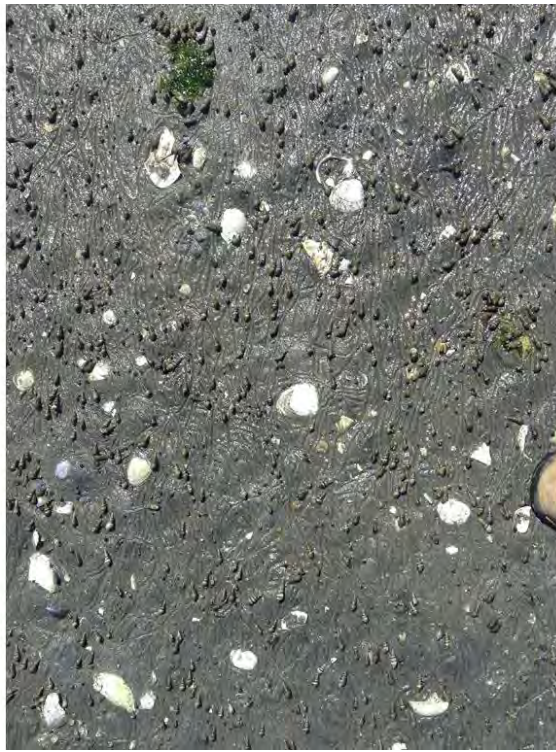
Photo: 27

Mermaid beach, location proposed as a potential alternative barge ramp location by some Savary Island residents.  
( Date Taken: May-12-16 1:29:19 PM, Latitude: 49°56'25.18", Longitude: -124°49'53.75" )

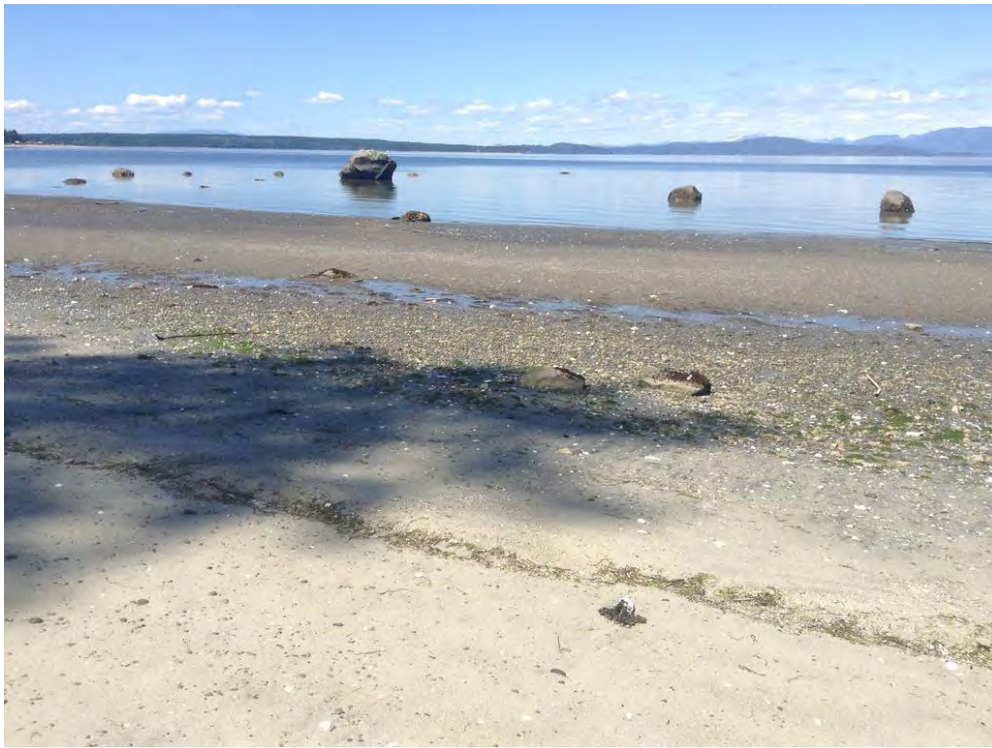
Photo: 29  
Mermaid beach, location proposed as a potential alternative barge ramp location by some Savary Island residents.  
( Date Taken: May-12-16 1:31:27 PM, Latitude: 49°56'23.96", Longitude: -124°49'54.76" )

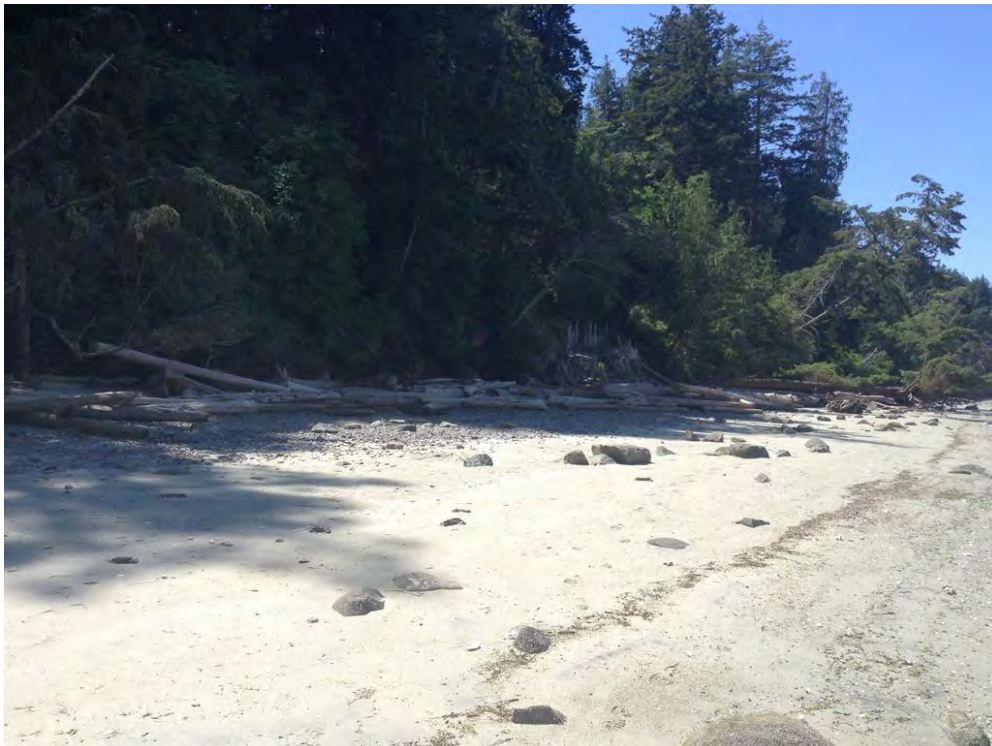
Photo: 30  
Access point down the bank for the Mermaid Beach barge ramp location.  
( Date Taken: May-12-16 1:32:20 PM, Latitude: 49°56'24.05", Longitude: -124°49'55.22" )

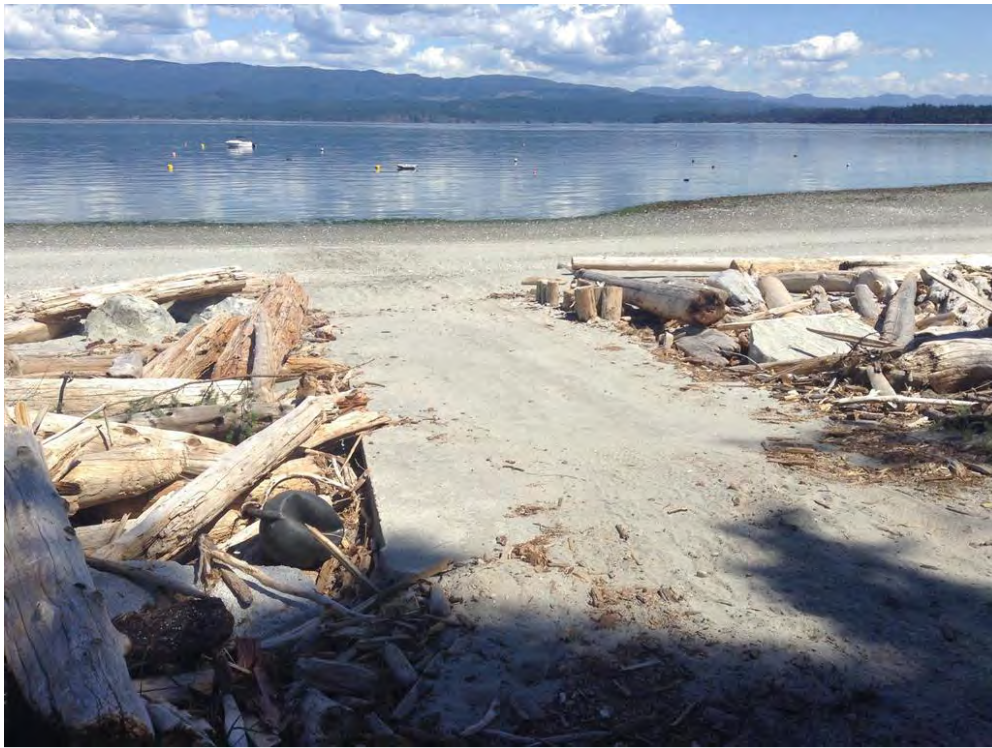
Photo: 31  
 Indian Point boat ramp, proposed as an alternative barge ramp location by some Savary Island residents.  
 ( Date Taken: May-12-16 1:49:58 PM, Latitude: 49°56'52.69", Longitude: -124°51'34.53" )

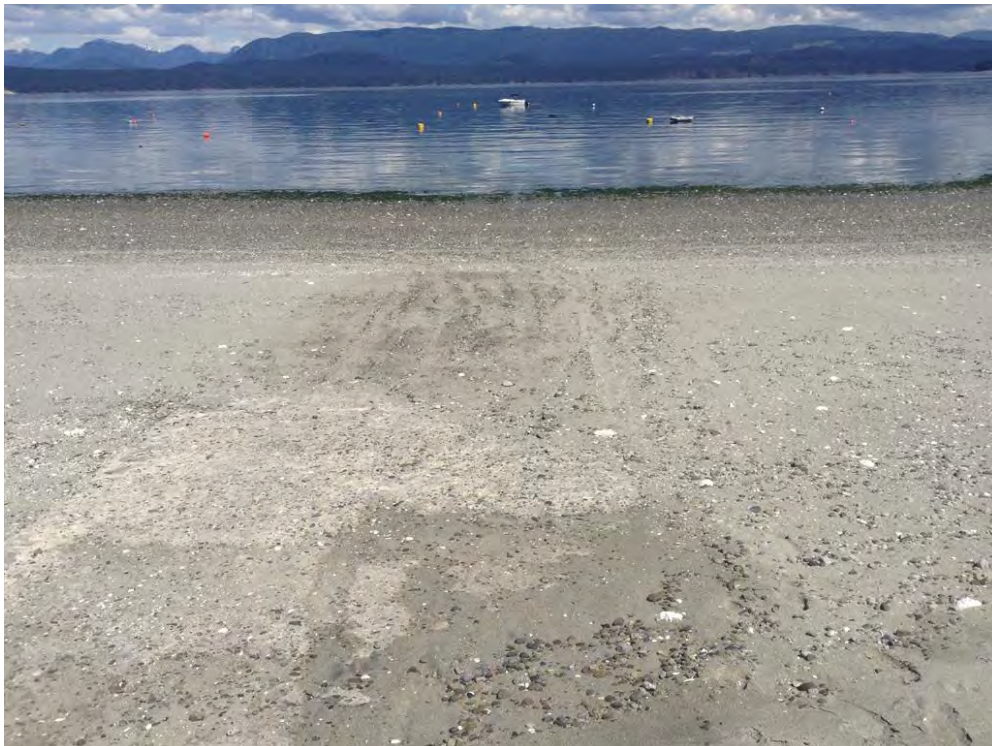
Photo: 32  
 Indian Point boat ramp, proposed as an alternative barge ramp location by some Savary Island residents.  
 ( Date Taken: May-12-16 1:51:34 PM, Latitude: 49°56'52.66", Longitude: -124°51'33.67" )

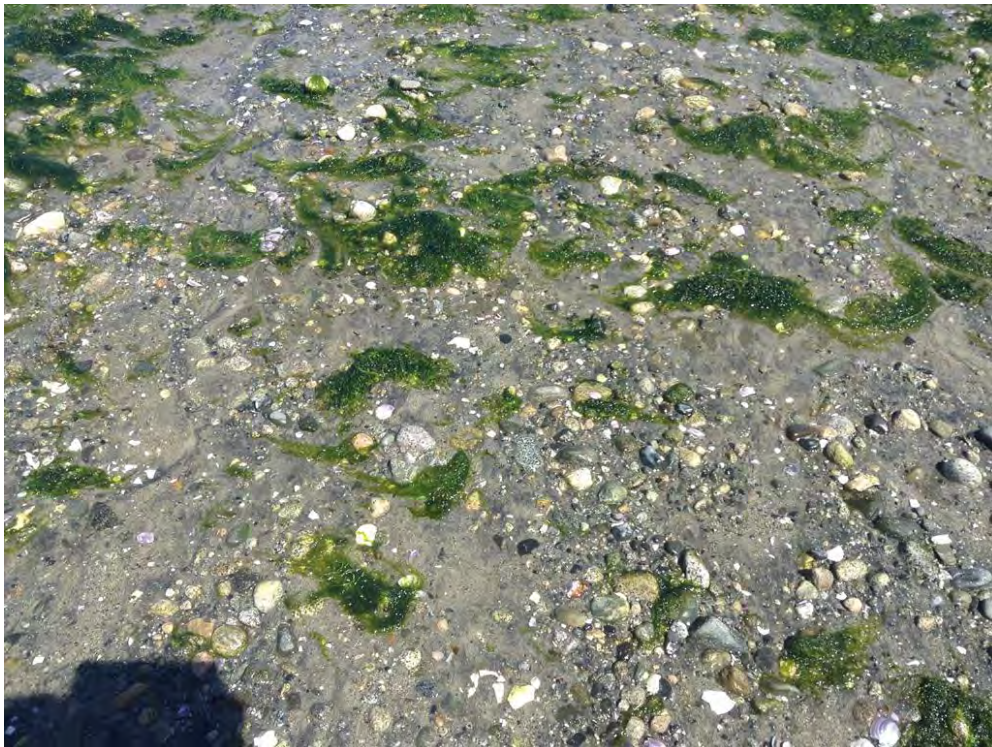
Photo: 34

Indian Point boat ramp, proposed as an alternative barge ramp location by some Savary Island residents.  
( Date Taken: May-12-16 1:53:07 PM, Latitude: 49°56'53.31", Longitude: -124°51'32.30" )

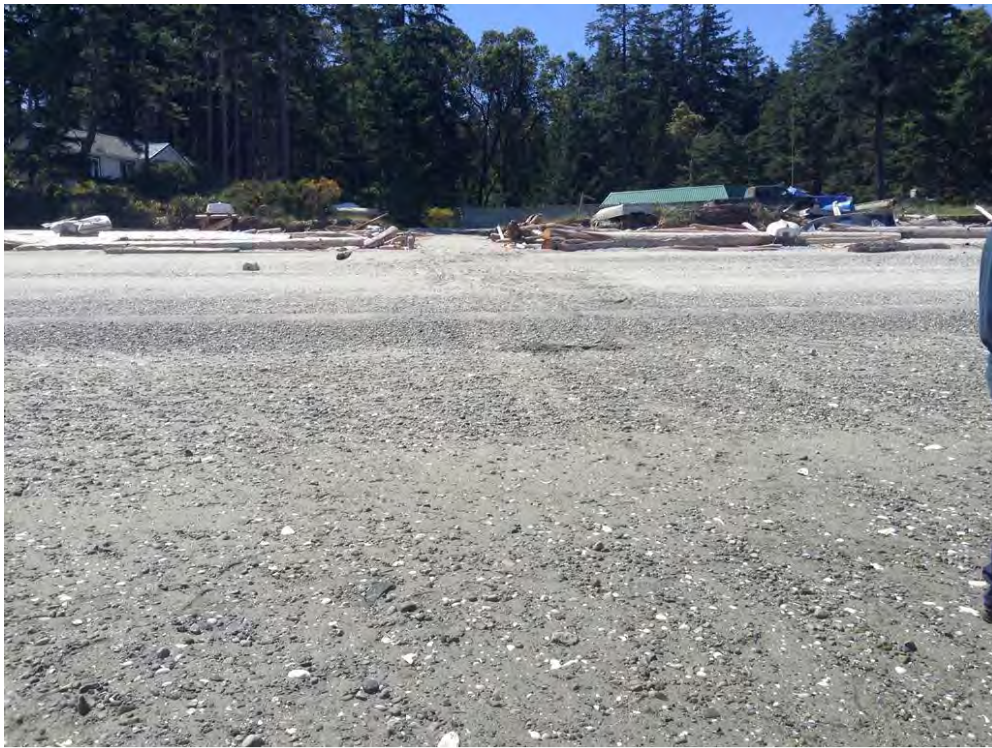
Photo: 35  
 Indian Point boat ramp, proposed as an alternative barge ramp location by some Savary Island residents.  
 ( Date Taken: May-12-16 1:53:48 PM, Latitude: 49°56'53.33", Longitude: -124°51'32.04" )

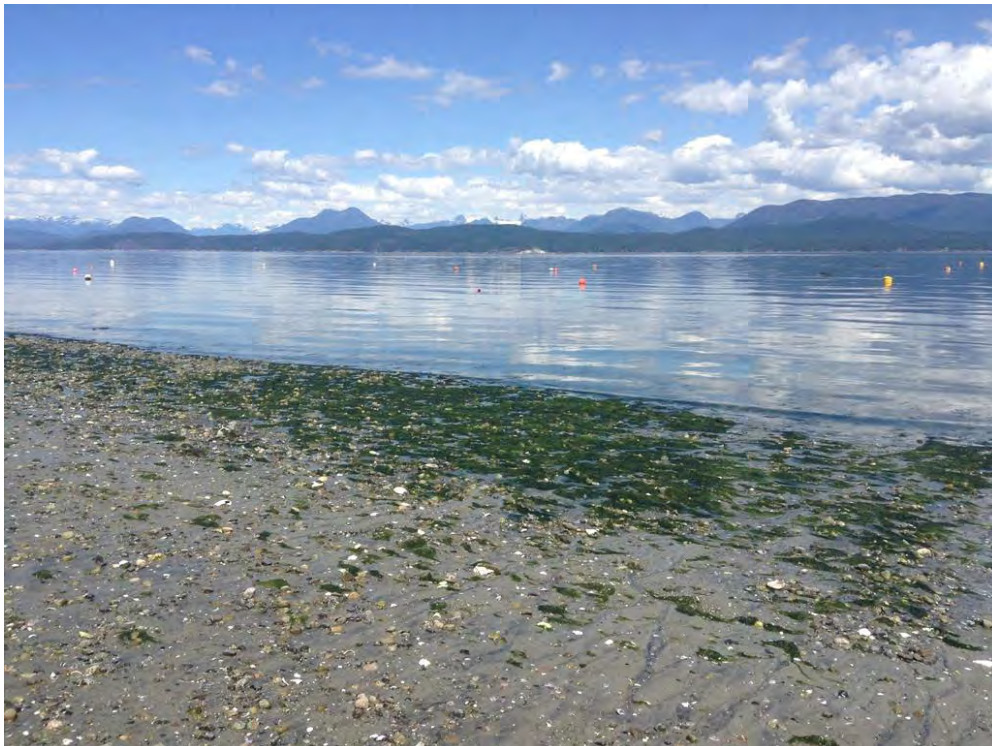
Photo: 36  
 Indian Point boat ramp, proposed as an alternative barge ramp location by some Savary Island residents.  
 ( Date Taken: May-12-16 1:56:10 PM, Latitude: 49°56'53.44", Longitude: -124°51'32.25" )

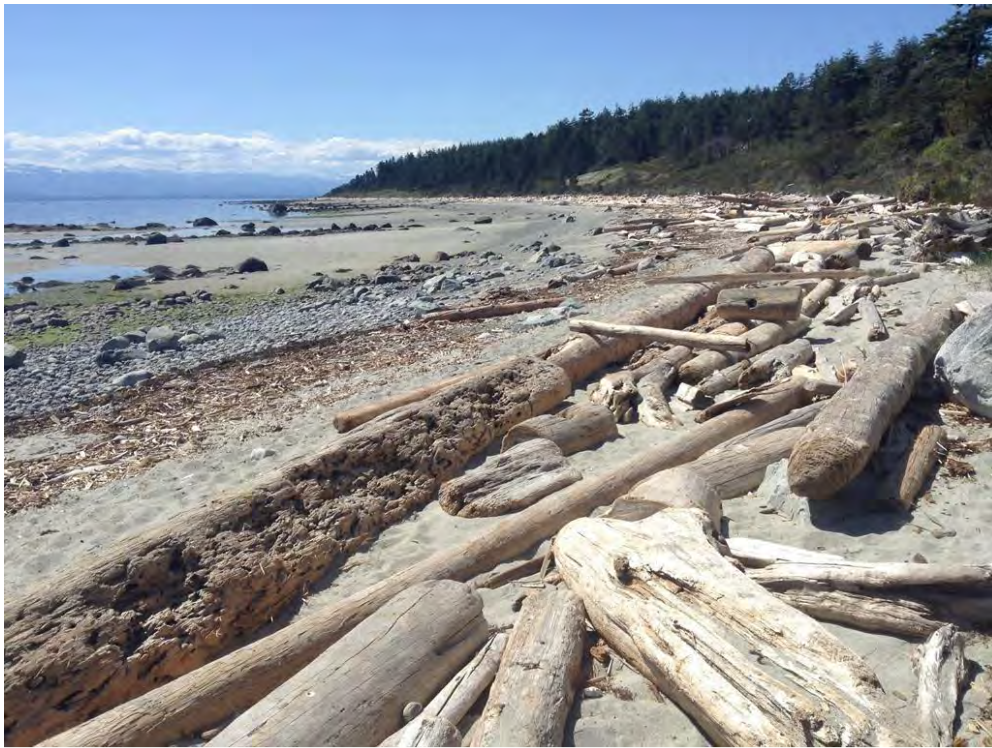
Photo: 41  
 Duck Bay; alternative barge ramp location proposed by some Savary Island residents.  
 ( Date Taken: May-12-16 2:32:17 PM, Latitude: 49°56'12.78", Longitude: -124°47'56.65" )

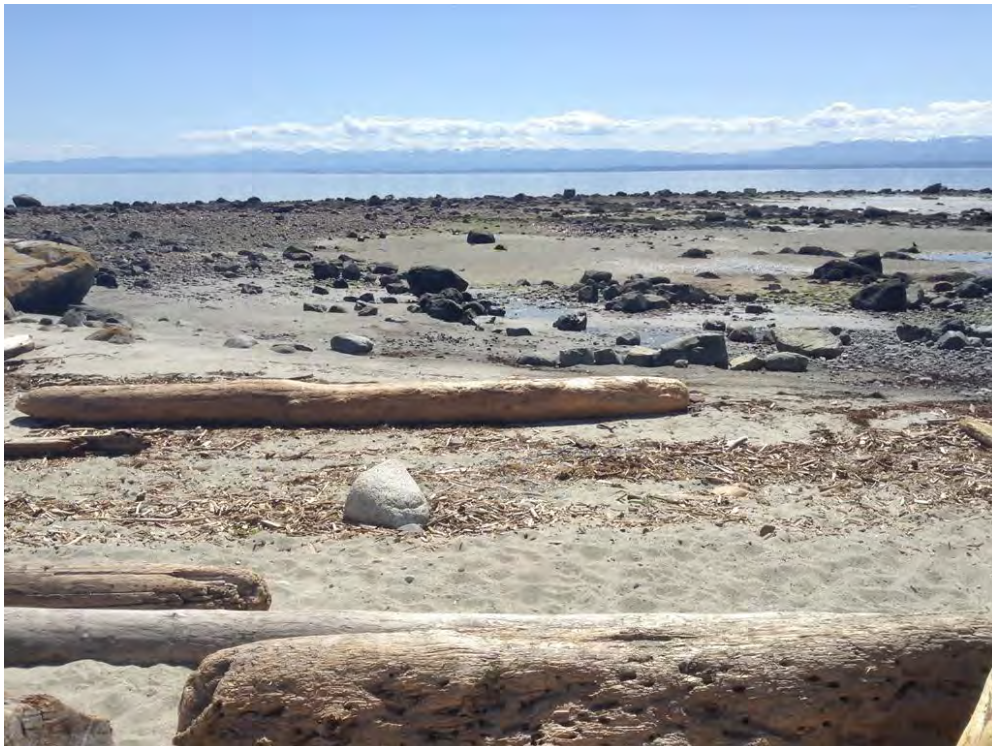
Photo: 42  
 Duck Bay; alternative barge ramp location proposed by some Savary Island residents.  
 ( Date Taken: May-12-16 2:32:39 PM, Latitude: 49°56'12.84", Longitude: -124°47'56.51" )

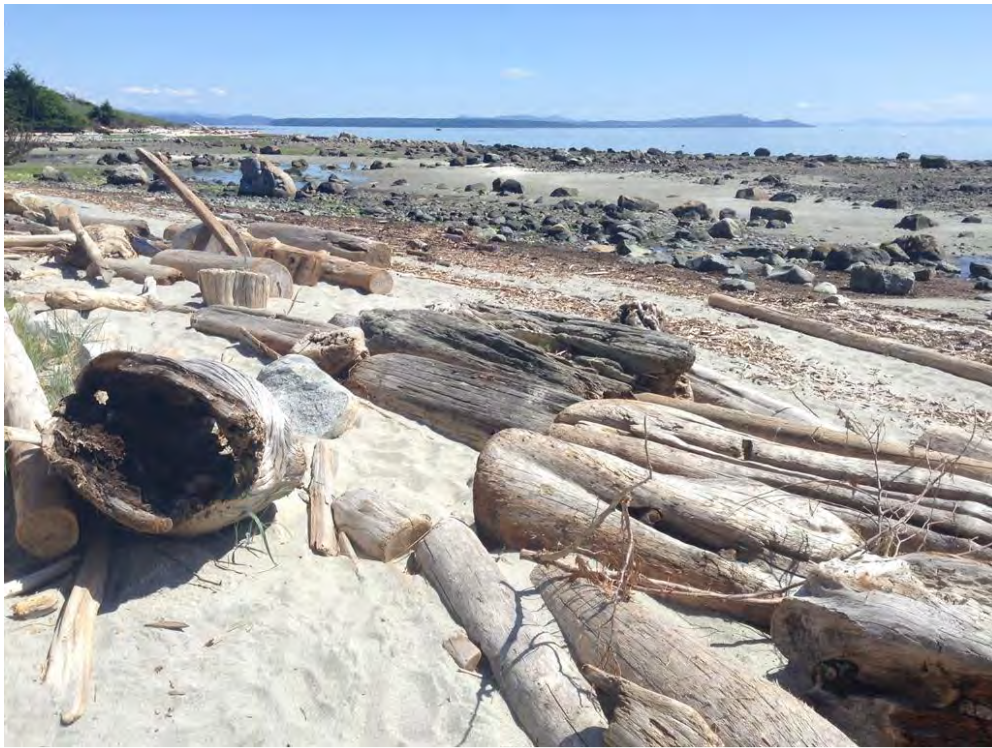
Photo: 43  
 Duck Bay; alternative barge ramp location proposed by some Savary Island residents.  
 ( Date Taken: May-12-16 2:32:57 PM, Latitude: 49°56'12.84", Longitude: -124°47'56.51" )

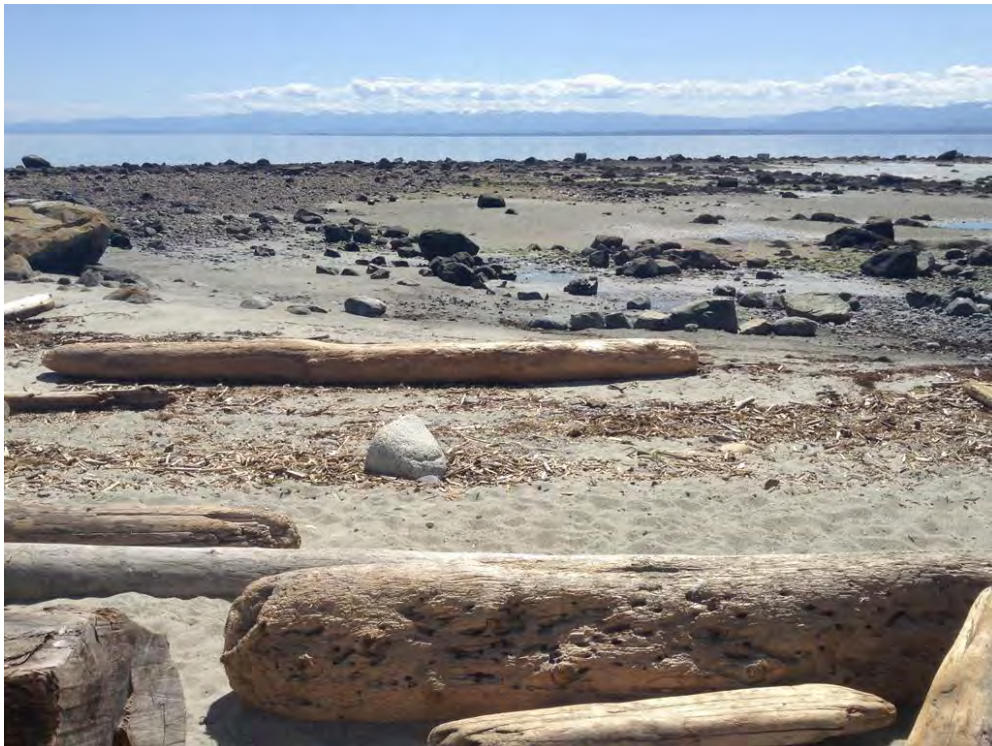
Photo: 44  
 Duck Bay; alternative barge ramp location proposed by some Savary Island residents.  
 ( Date Taken: May-12-16 2:33:18 PM, Latitude: 49°56'12.89", Longitude: -124°47'56.48" )
