Ministry of  
Transportation  
and Infrastructure

# Texada Island Drainage Study

Final Report

January 2024

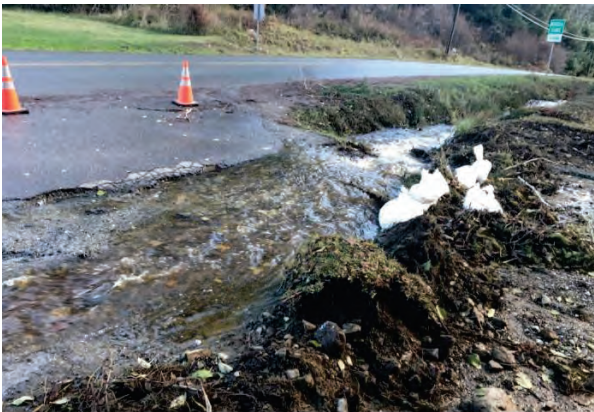
- A new crossing culvert under Airport Road was installed by the MoTI's maintenance contractor, Capilano Highways, in response to flooding in November 2021 with a noted deficiency of crossing culverts along Airport Road.
- An additional driveway culvert was installed under the driveway to the tennis court at Gillies Bay Road south of the intersection with Airport Road (see [Photo 3](#)) in response to the flooding in November 2021.

**PHOTO 3: AREA 4 - OVERFLOW OF DRIVEWAY CULVERT (MOTI)**

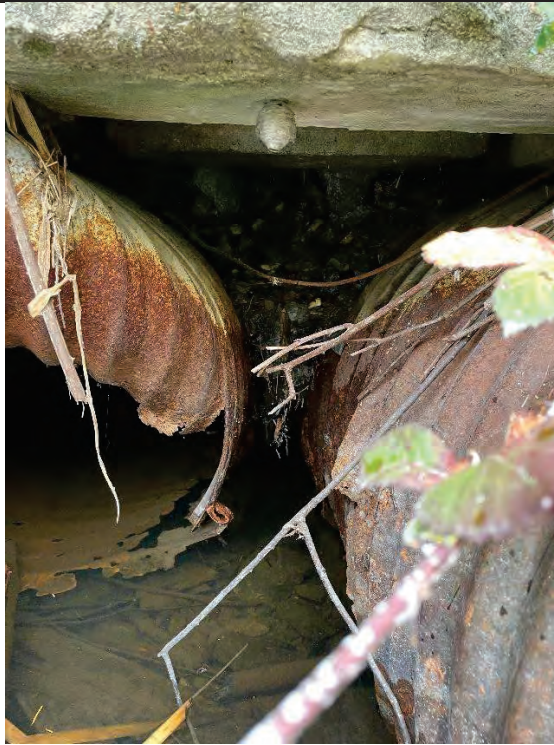
Culvert Inlet: CRB sitting on culverts, large cavity visible between twin pipes

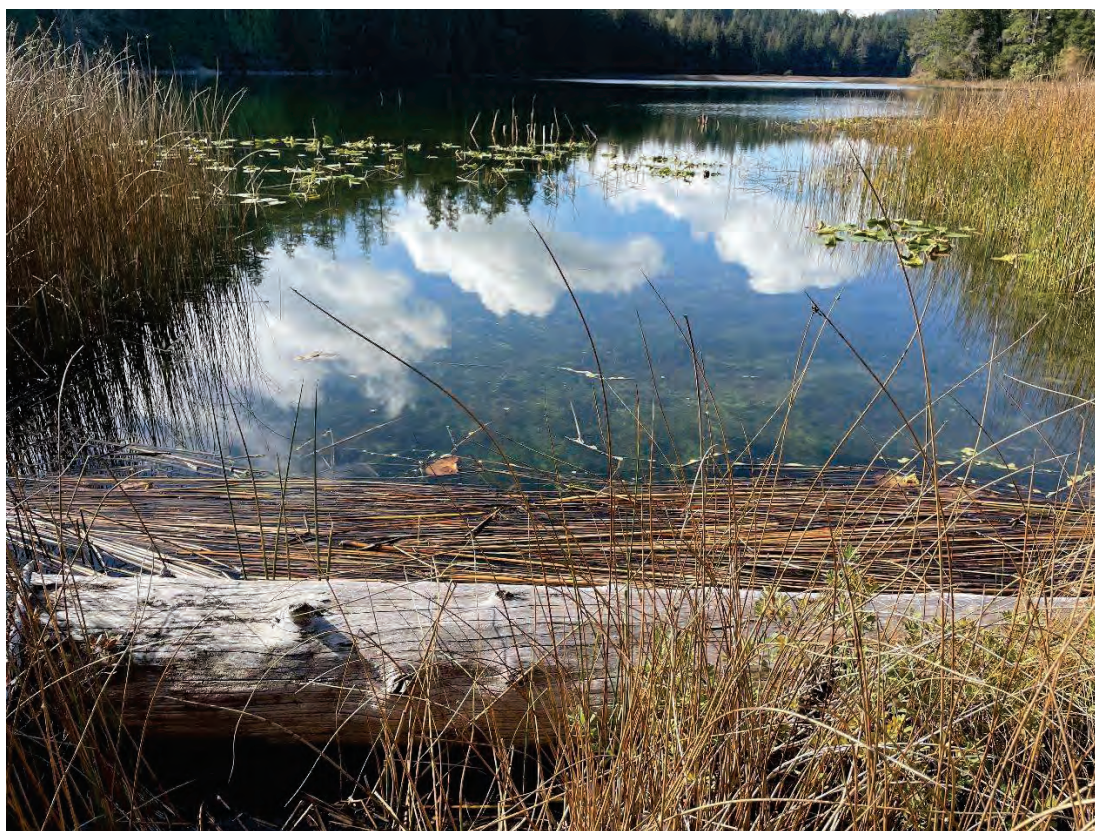
Upstream Channel: Culvert acts as outlet of Priest Lake crossing Priest Lake Rd & Gillies Bay Rd

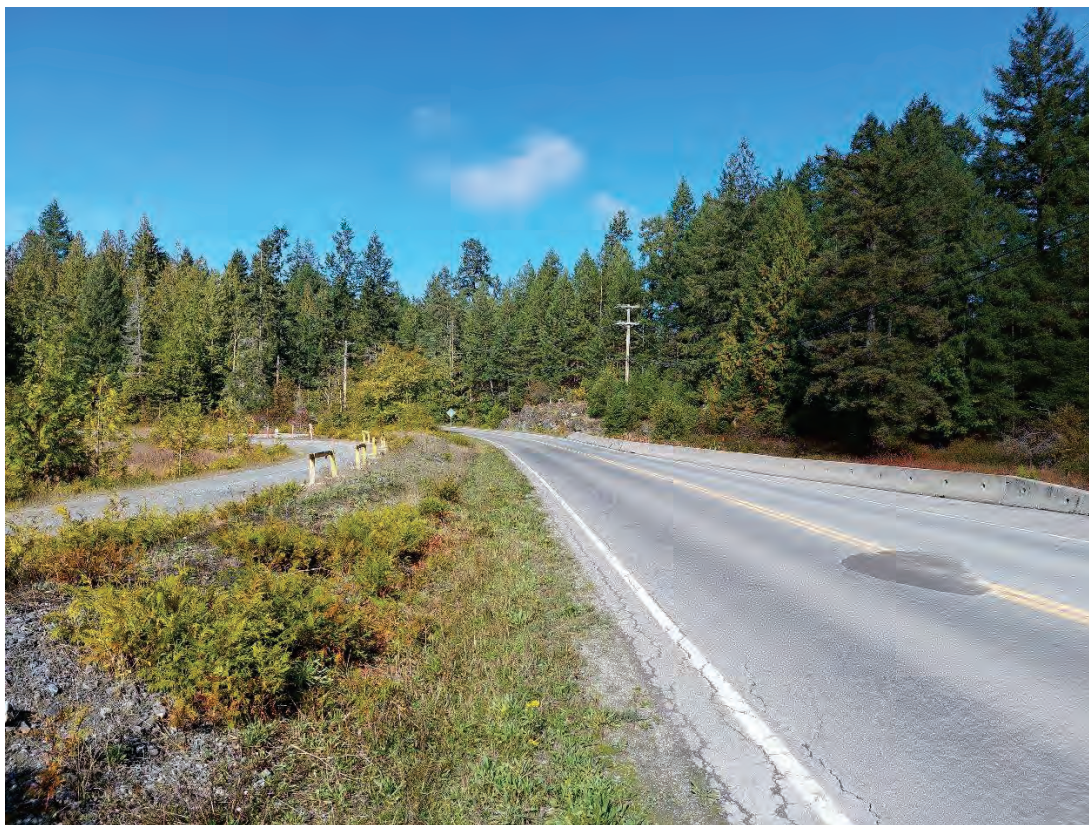
Pavement Surface: Priest Lake Rd (gravel) to the left, Gillies Bay Rd (paved) to the right

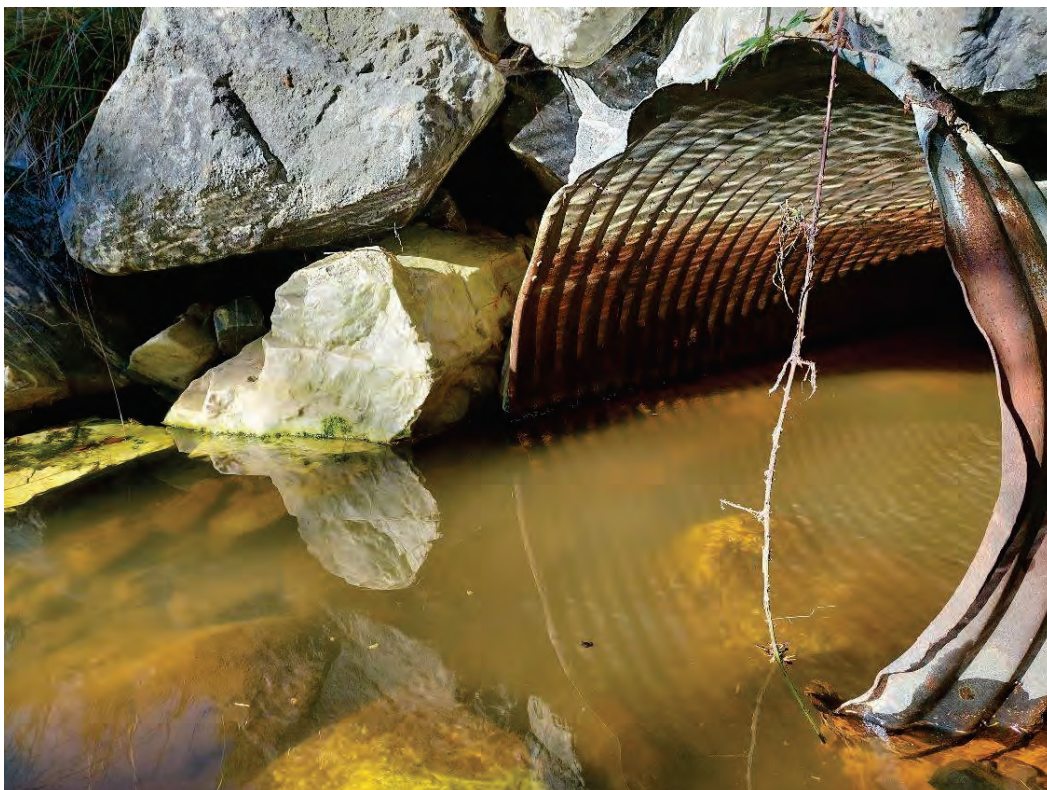
Culvert Outlet: 1200mm CSP pipe with riprap headwall

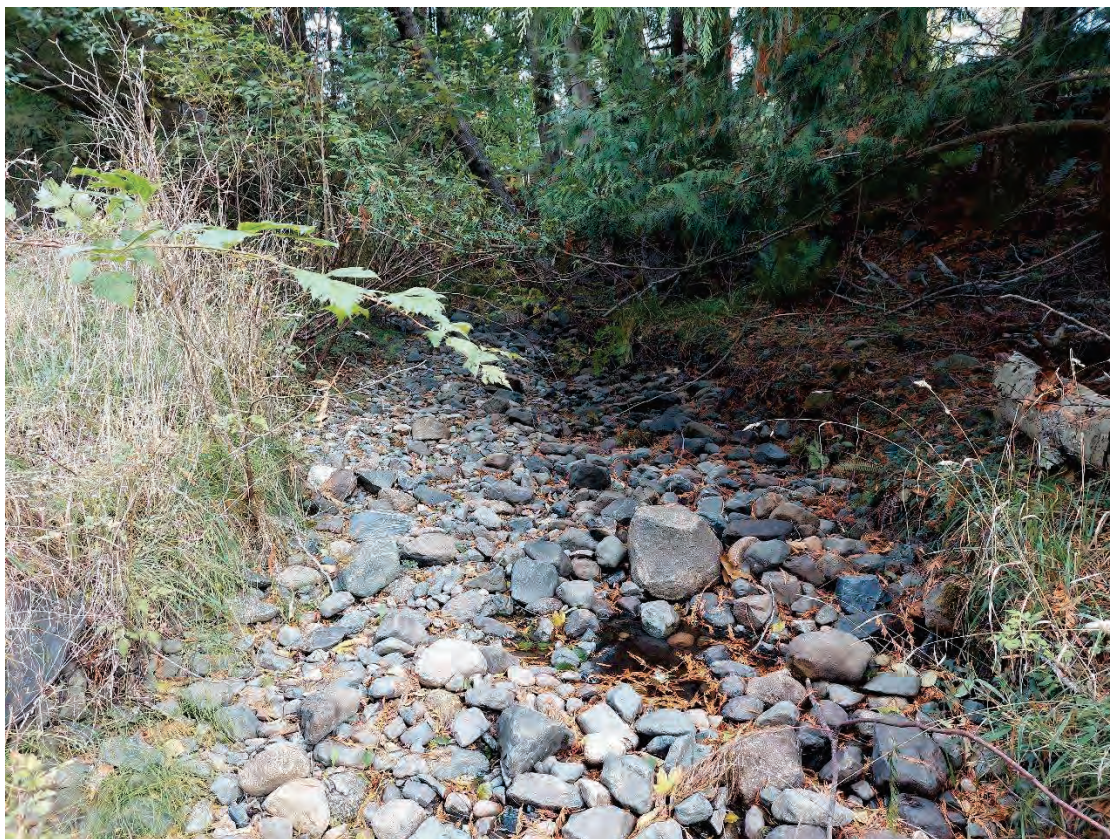
Upstream Channel facing US: Staaf Creek with minimal flow visible

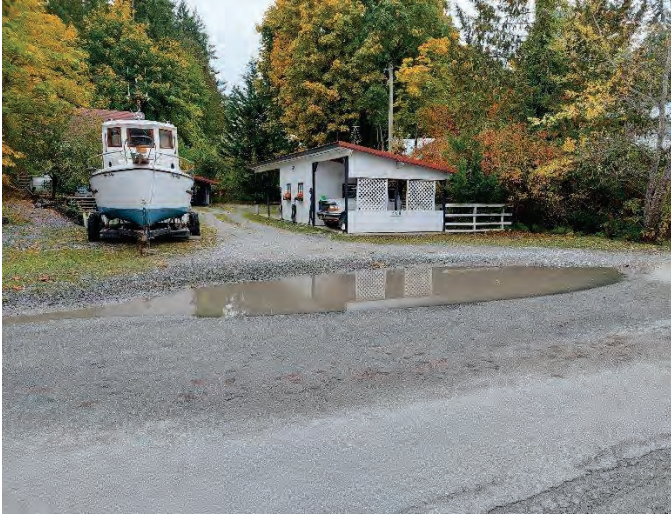
- A big puddle on the southside of 2058 Marble Road extending half into the lane was visible, potentially impacting traffic. An existing 450 mm CSP culvert (CHRIS: 2257259) immediately west conveying a small creek under Marble Road was inspected and found to be in fair condition.
- A circular 600 mm wood stave culvert (CHRIS: 3442931) was inspected crossing Marble Road west of Colburn Street and found in fair condition with significant flow at the time of inspection.
- A 600 mm CSP culvert that has been extended with a 450 mm HDPE pipe next to the Texada Island Boat Yard has been inspected and found to be in fair condition.

AREA 2 MARBLE RD: PUDDLE AT 2058 MARBLE RD SOUTHERN LANE

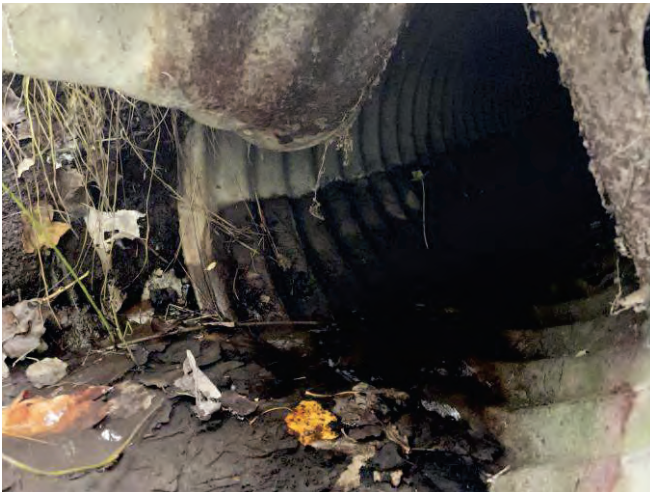
AREA 2 MARBLE RD: 450MM CSP CROSS CULVERT (2257259) LOOKING DOWNSTREAM

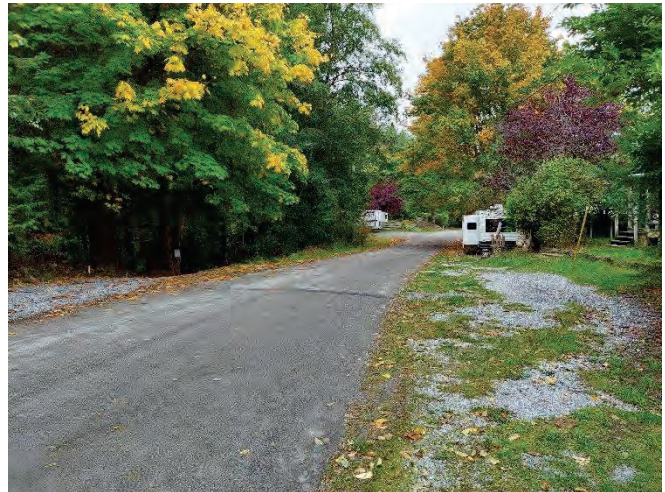
AREA 2 MARBLE RD: NO DRAINAGE ALONG PARTS OF MARBLE RD

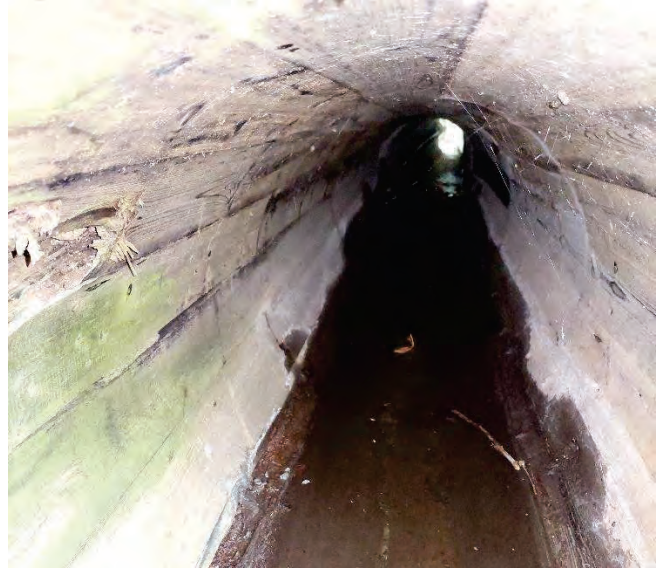
AREA 2 MARBLE RD: WOOD STAVE CULVERT (3442931) INTERIOR

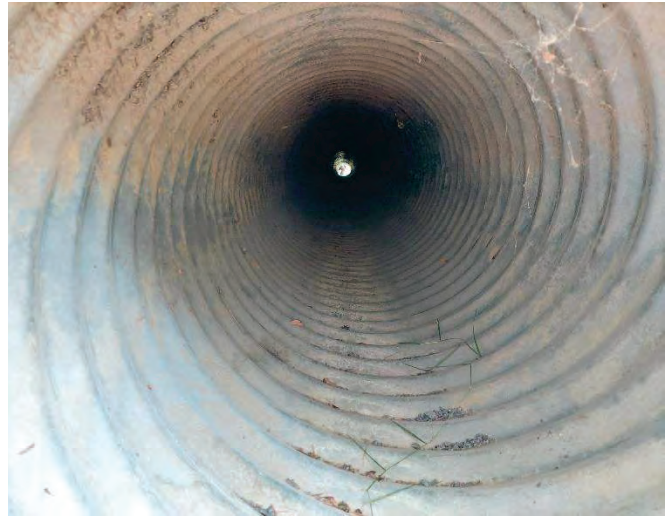
AREA 2 MARBLE RD: 600MM CSP INTERIOR FACING UPSTREAM

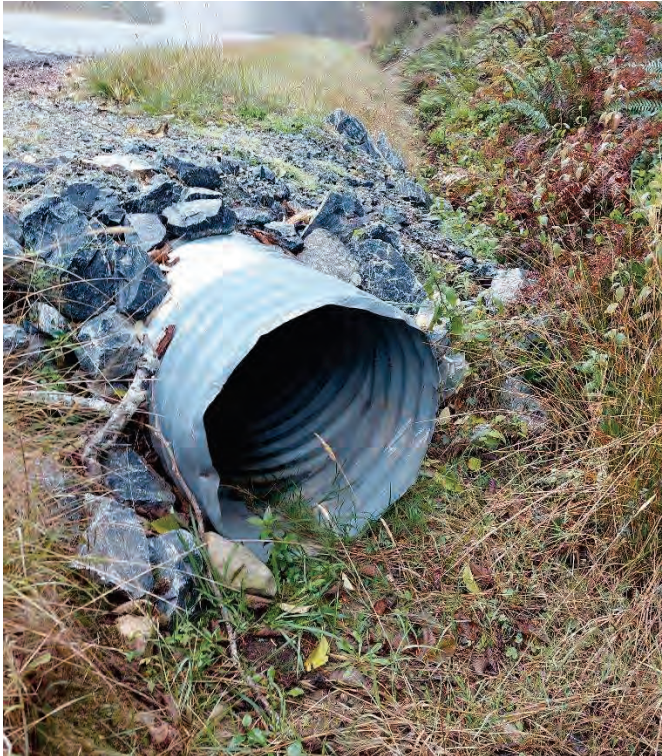
**AREA 4 AIRPORT RD: NEW CULVERT INLET WITH IMPROVISED CHECK DAM INSIDE ROADSIDE DITCH**

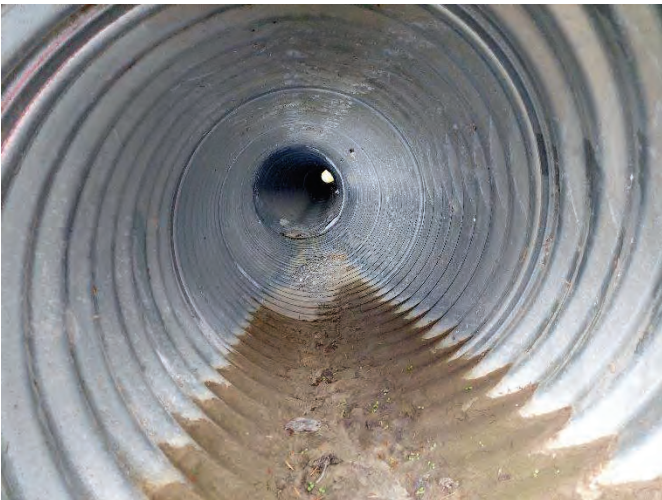
- The culvert pipe alignment is bent with minor pipe joint separation visible. The overall culvert condition appeared to be fair.
- A 300 mm CSP culvert (CHRIS: 2258675) was inspected at the water tank driveway with a heavily corroded pipe invert and in poor condition.

**AREA 4 AIRPORT RD: NEW CULVERT INTERIOR FROM OUTLET, VISIBLE PIPE JOINT SEPARATION AND MISALIGNED CULVERT**

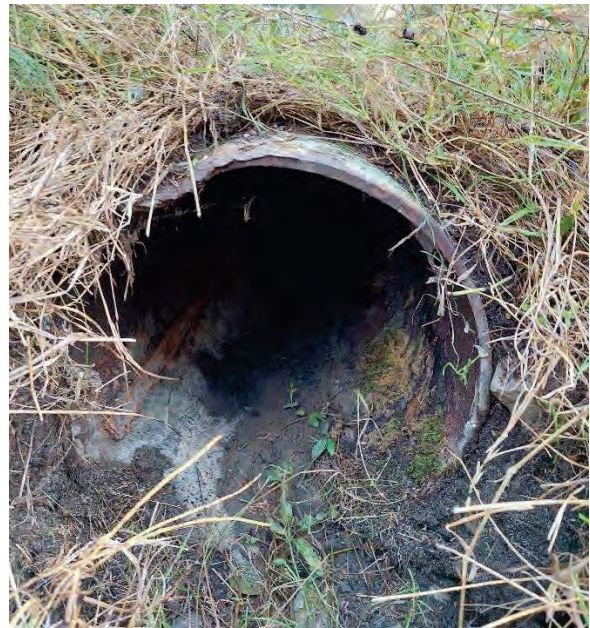
- A 450mm DI culvert was inspected south of the water tank with only surficial corrosion and in overall fair condition (49.682369°N, 124.490133°W).
- The western roadside ditch along Airport Road showed multiple locations with visible erosion and scour, likely from the high flows in the ditch due to the high slope between the water tank and Pine Street.

**AREA 4 AIRPORT RD: 450MM DI CULVERT INLET**

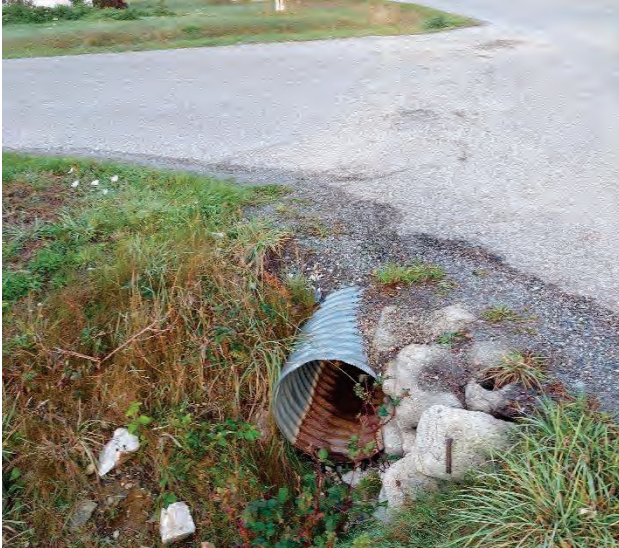
- A 600 mm CSP culvert (CHRIS 2256637) crossing under Pine Street was inspected with visible corrosion of the pipe invert and a damaged inlet but overall, in a fair condition.

AREA 4 AIRPORT RD: 600MM CSP CULVERT (2256637) UNDER PINE ST OUTLET

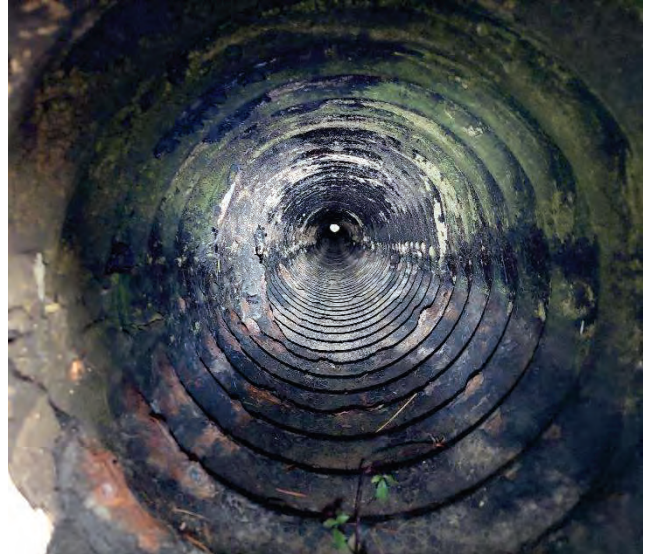
- A 300 mm CSP culvert (CHRIS: 2256020) crossing under Airport Road and conveying the roadside ditch flows along the westside of Gillies Bay Road. The culvert showed localized corrosion but appeared to be in fair condition.

AREA 4 AIRPORT RD: 300MM CSP CROSS CULVERT (2256020) UNDER AIRPORT RD AT GILLIES BAY RD

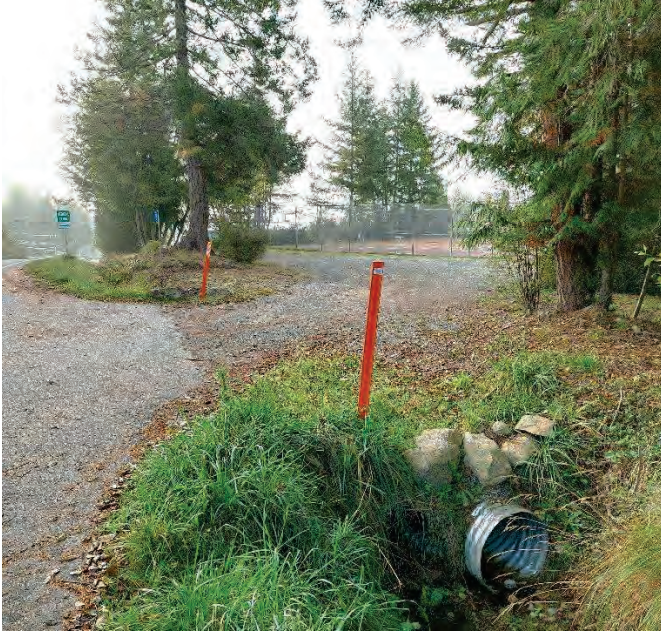
AREA 4 GILLIES BAY RD: TWIN 600MM CSP CULVERT INLET AT TENNIS COURT

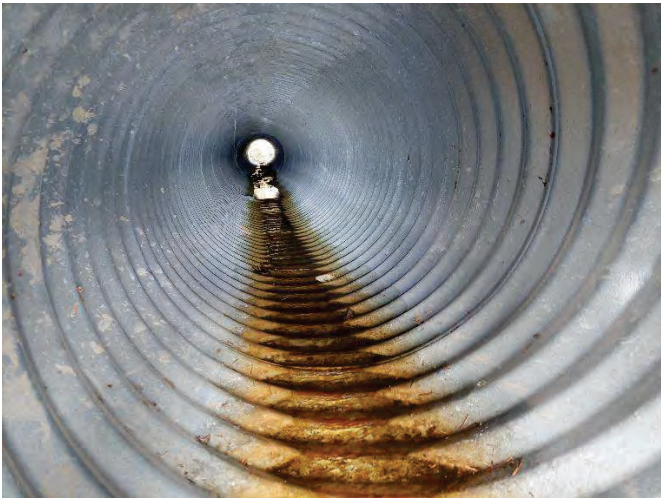
- The western pipe appeared to be recently installed and in good condition. The pipe appeared not be fully aligned with the ditch.
  - The eastern pipe appeared to be older with significant corrosion and loss of material and in poor condition.

AREA 4 GILLIES BAY RD: NEW WESTERN 600MM CSP CULVERT INTERIOR

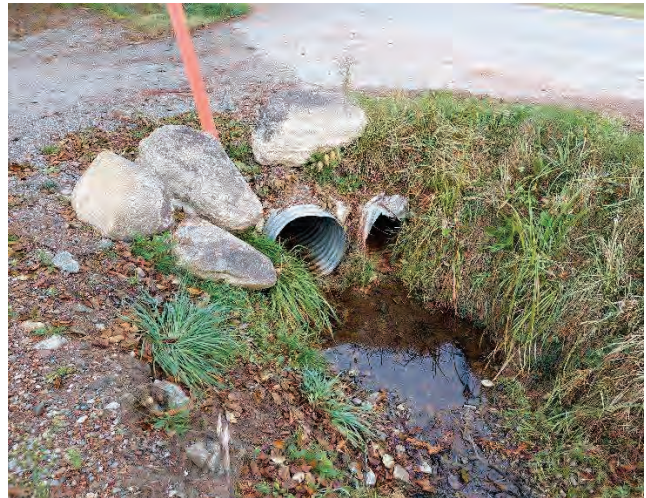
AREA 4 GILLIES BAY RD: TWIN 600MM CULVERT OUTLET

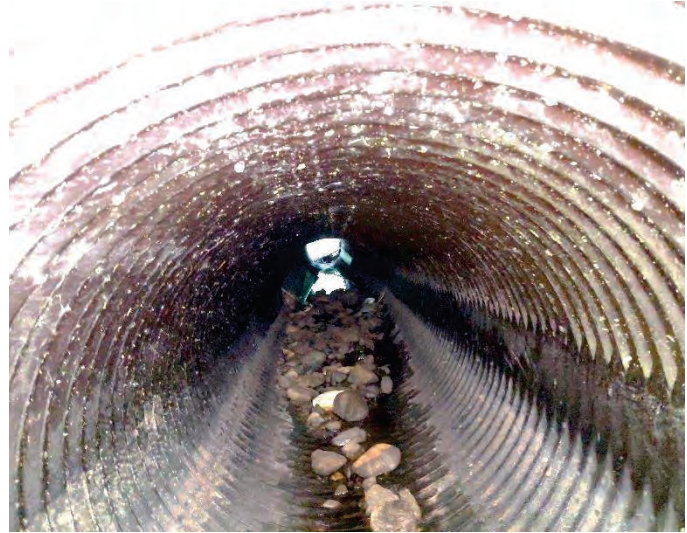
CULVERT 6 (2256019) INTERIOR: PIPE JOINT SEPARATION AND ROCK DEBRIS

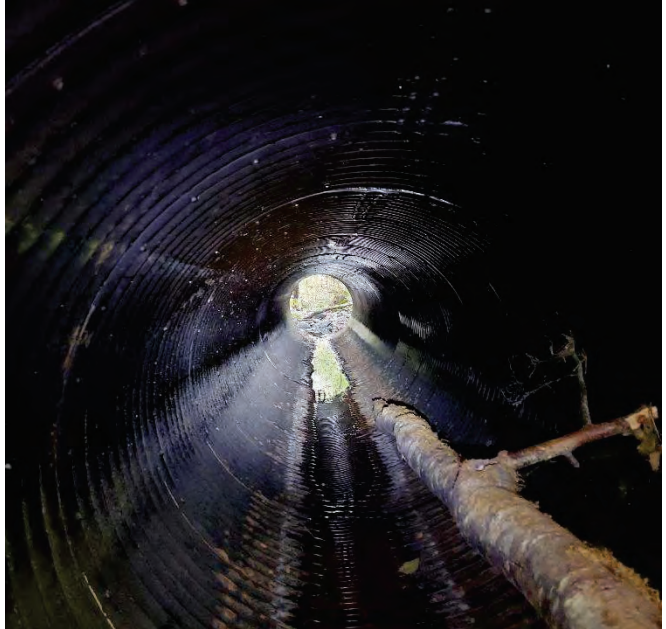
**CULVERT 9 (2256424) INTERIOR: PIPE COATING MOSTLY INTACT**

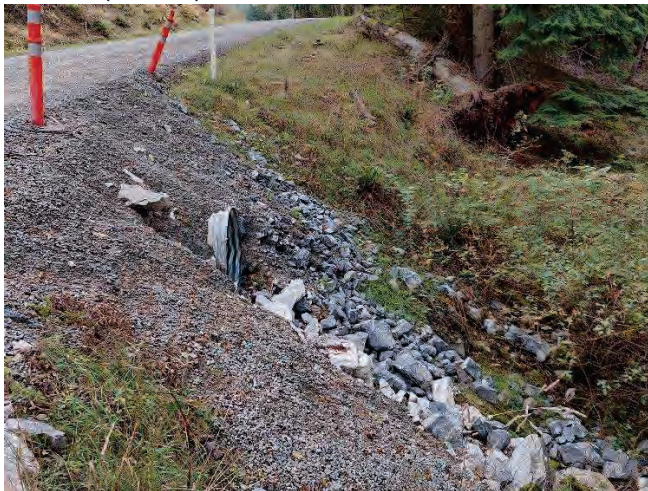
**CULVERT 11 (2254788) OUTLET: ERODING ROAD EMBANKMENT AT OUTLET**

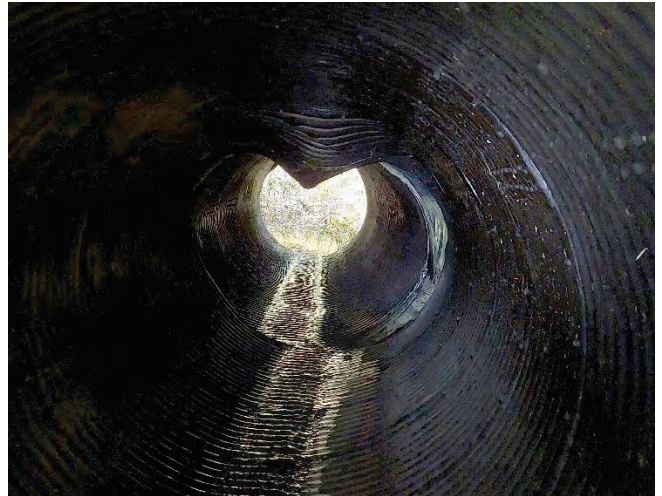
**CULVERT 12 (2255061) INLET: INLET BEND**
